PG&E Letter DCL-15-102

Docket No. 50-275, OL-DPR-80  
Docket No. 50-323, OL-DPR-82  
Diablo Canyon, Units 1 and 2  
Diablo Canyon Power Plant 10 CFR 71.95 Report Regarding EnergySolutions'  
Model 8-120B Shipping Cask

**Diablo Canyon Power Plant  
10 CFR 71.95 Report Regarding  
EnergySolutions' Model 8-120B Shipping Cask**

**Failure to Observe Certificate of Compliance Conditions  
for the 8-120B Vent Port Pre-Shipment Leak Test**

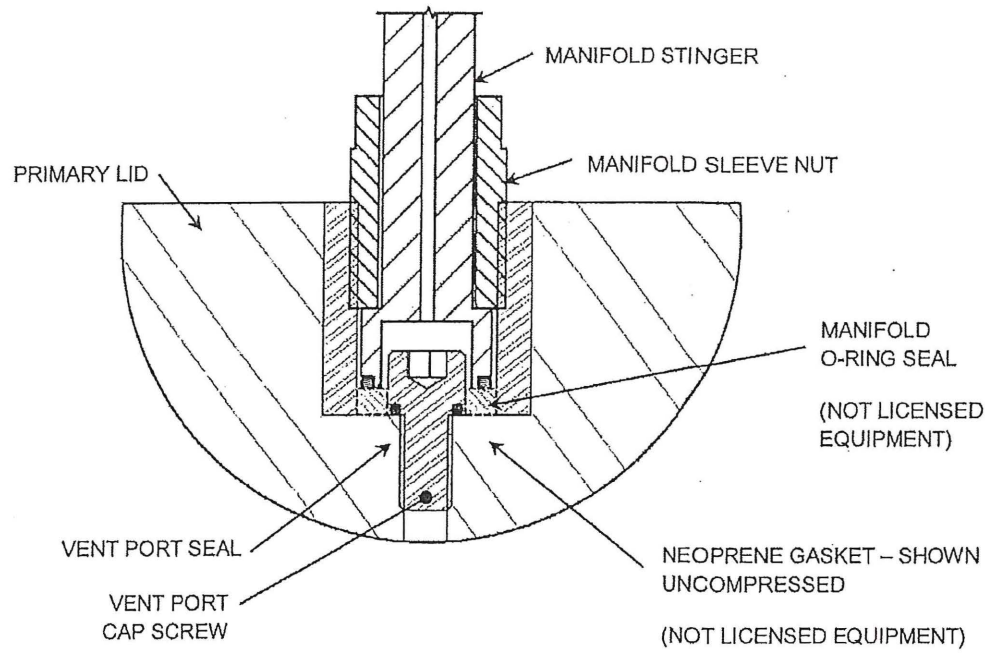
Details of the 8-120B Vent Port Leak Rate Test Setup

The neoprene gasket can constrict on the head of the vent port plug cap screw when it is compressed by the bottom end of the test manifold stinger, which could reduce the sensitivity of the pre-shipment leak test. Consequently, the vent port pre-shipment leak tests performed using the neoprene gasket may not have provided the required test sensitivity of  $1 \times 10^{-3}$  ref-cm<sup>3</sup>/sec.

On Monday June 1, 2015, an 8-120B cask user identified a concern that the neoprene gasket could potentially affect the integrity of the vent port seal pre-shipment leak test. Later that week EnergySolutions performed a bench test that confirmed that the neoprene gasket can constrict on the head of the vent port plug cap screw when it is compressed by the manifold, resulting in a reduction of the test sensitivity.

The pre-shipment leak test of the vent port is a pressure drop test performed using a dedicated test manifold. The test manifold is not a part of the licensed package. It includes a stinger (shown below), an O-ring seal that contacts the stinger and the bottom of the vent port hole, and a sleeve nut to compress the O-ring seal. The test manifold was designed so that it surrounds the vent port cap screw, leaving a small gap between itself and the vent port cap screw. The 8-120B cask fleet began to ship with a new lid design in September 2013, and operations staff noted more frequent difficulty getting the manifold to seal. It became desirable to find a better way to seal the bottom of the manifold in order to minimize operator exposure. They found that adding a neoprene gasket (also not part of the licensed package) under the base of the stinger as shown below helped reduce testing time and exposure.
