ZS-2015-0131

Subject: 10 CFR 71.95 Report on the 8-120B Cask

**Failure to Observe Certificate of Compliance Conditions for the 8-120B
Vent Port Pre-Shipment Leak Test**

Details of the 8-120B Vent Port Leak Rate Test Setup

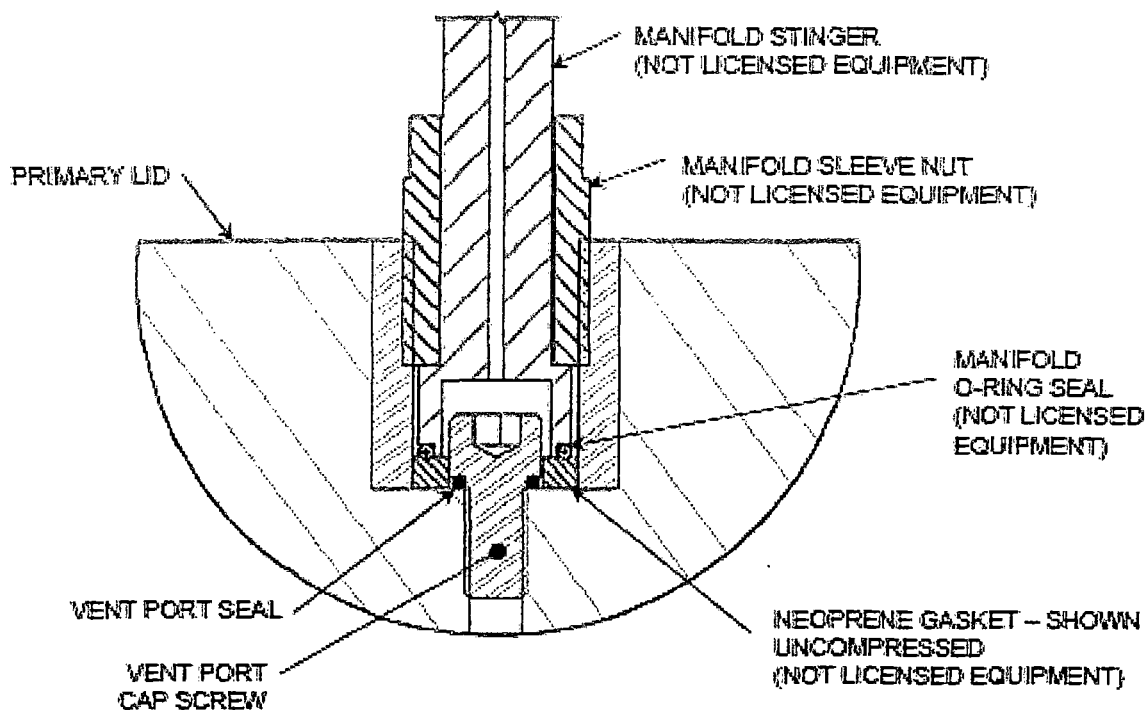
New 8-120B lids went into service in October 2013. It was found that the manifold sometimes had problems sealing with the vent port on these new lids. EnergySolutions personnel found that adding an extra neoprene gasket helped to reduce the false test failures. Since the pre-shipment leak rate test is performed in a radiation environment, false failures are undesirable because they increase the personnel exposure. The personnel did not realize that the gaskets had the potential to reduce the test sensitivity.

The neoprene gasket can constrict on the head of the vent port plug cap screw when it is compressed by the bottom end of the test manifold stinger, which could reduce the sensitivity of the pre-shipment leak test. Consequently, the vent port pre-shipment leak tests performed using the neoprene gasket may not have provided the required test sensitivity of 1×10^{-3} ref-cm³/sec.

The pre-shipment leak test of the vent port is a pressure drop test performed using a dedicated test manifold. The test manifold is not a part of the licensed package. It includes a stinger (shown below), an O-ring seal that contacts the stinger and the bottom of the vent port hole, and a sleeve nut to compress the O-ring seal. The test manifold was designed so that it surrounds the vent port cap screw, leaving a small gap between itself and the vent port cap screw. The 8-120B cask fleet began to ship with a new lid design in September 2013, and operations staff noted more frequent difficulty getting the manifold to seal. It became desirable to find a better way to seal the bottom of the manifold in order to minimize operator exposure. They found that adding a neoprene gasket (also not part of the licensed package) under the base of the stinger as shown below helped reduce testing time and exposure.
