SUBJECT: 10 CFR 71.95 Report Involving 8-120B Cask
Vermont Yankee Nuclear Power Station
Docket No. 50-271
License No. DPR-28

Subject: 10 CFR 71.95 Report on the 8-120B Cask

Failure to Observe Certificate of Compliance Conditions for the 8-120B Vent Port Pre-Shipment Leak Test

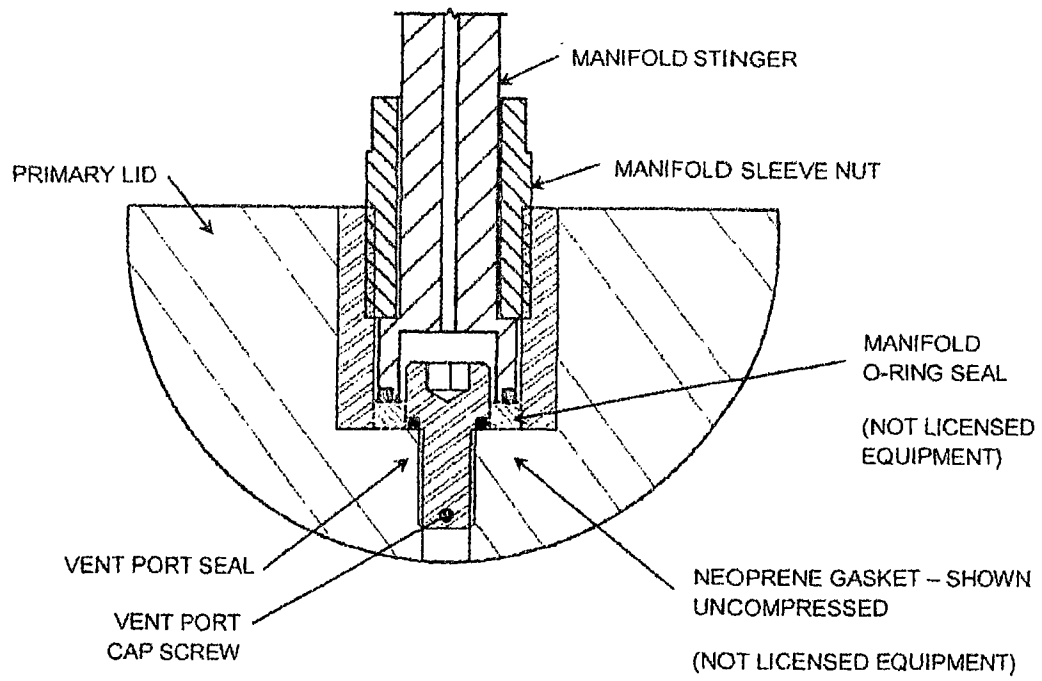
The neoprene gasket can constrict on the head of the vent port plug cap screw when it is compressed by the bottom end of the test manifold stinger, which could reduce the sensitivity of the pre-shipment leak test. Consequently, the vent port pre-shipment leak tests performed using the neoprene gasket may not have provided the required test sensitivity of 1×10^{-3} ref-cm³/sec.

On Monday June 1, 2015, an 8-120B cask user identified a concern that the neoprene gasket could potentially affect the integrity of the vent port seal pre-shipment leak test. Later that week *EnergySolutions* performed a bench test that confirmed that the neoprene gasket can constrict on the head of the vent port plug cap screw when it is compressed by the manifold, resulting in a reduction of the test sensitivity.

The pre-shipment leak test of the vent port is a pressure drop test performed using a dedicated test manifold. The test manifold is not a part of the licensed package. It includes a stinger (shown below), an O-ring seal that contacts the stinger and the bottom of the vent port hole, and a sleeve nut to compress the O-ring seal. The test manifold was designed so that it surrounds the vent port cap screw, leaving a small gap between itself and the vent port cap screw. The 8-120B cask fleet began to ship with a new lid design in September 2013, and operations staff noted more frequent difficulty getting the manifold to seal. It became desirable to find a better way to seal the bottom of the manifold in order to minimize operator exposure. They found that adding a neoprene gasket (also not part of the licensed package) under the base of the stinger as shown below helped reduce testing time and exposure.
