SUBJECT: Forwards responses to NRC 950901 RAI re GL 95-03,
"Circumferential Cracking of SG Tubes."

Subject: Oconee Nuclear Station Units 1, 2, & 3
Docket Nos. 50-269, 270, 287
Response to Request for Additional Information Concerning Generic Letter
95-03

OCONEE NUCLEAR STATION
RESPONSE TO RAI FOR GL 95-03

Response to Request for Additional Information Regarding Circumferential Cracking of Steam Generator Tubes - Oconee, Unit 1, 2, and 3

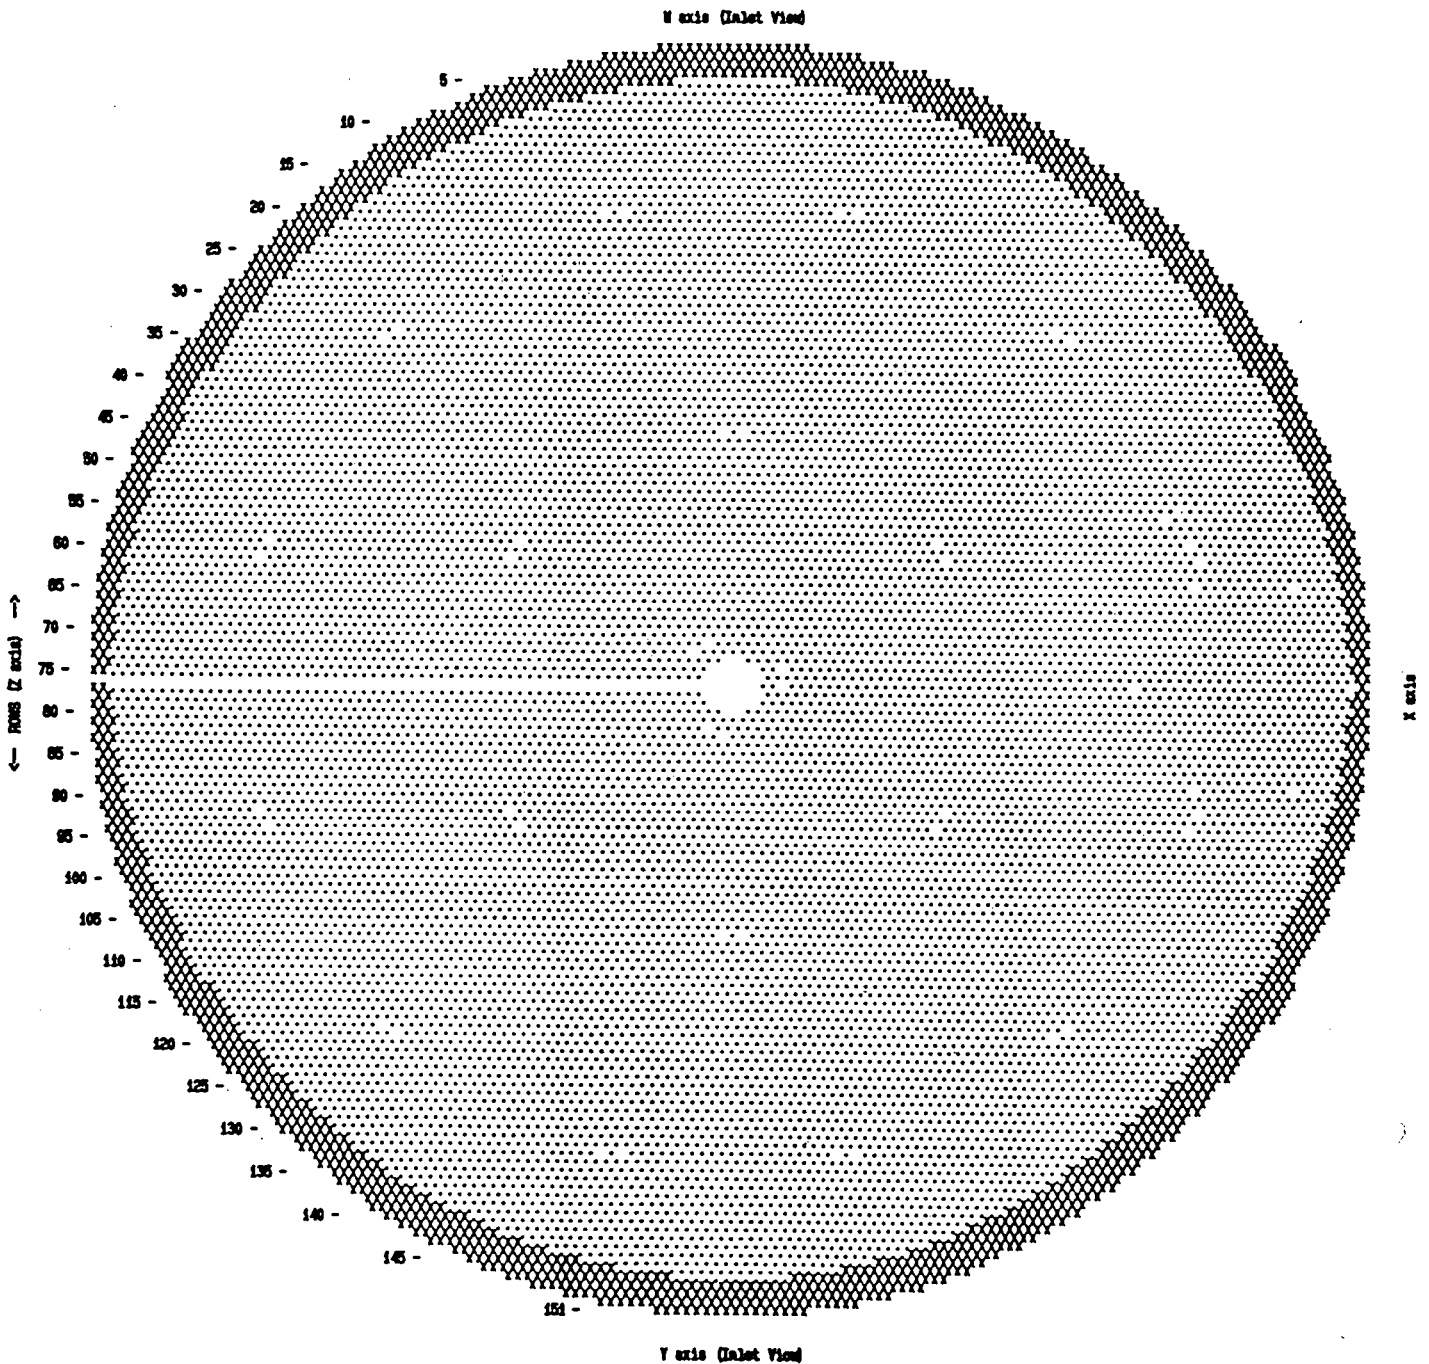
FIGURE 1

1. The B&W generic response indicated that all of the TSP's had broached holes. This information is correct except that there are drilled holes around the periphery of the 15th TSP as shown in figure 1.

DRILLED ONLY 15th TSP TUBE HOLES

x = 15th TSP DRILLED ONLY (1621)
