Subject: Duke Power Company  
Oconee Nuclear Station, Unit 1  
Docket No. 50-269  
Third Ten Year Inservice Inspection Interval  
Request for Relief No. 96-05

**OCONEE NUCLEAR STATION**  
**Unit 1**  
**Third Ten Year Inspection Interval**

**Request # 96-05**

**EVALUATION OF INDICATIONS  
IN THE OCONEE UNIT 1  
REACTOR COOLANT PUMP MAIN FLANGE**

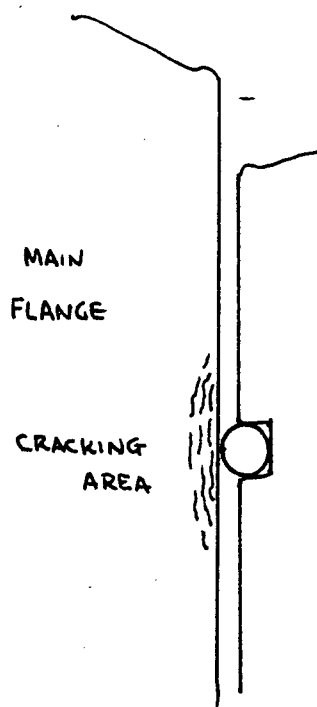
Figure 2 Sketch Showing the Region of Cracking in the Bore

During the fall outage of Oconee Unit 1 a leak was discovered at the bore of the reactor coolant pump main flange. The main flange is cast stainless steel, and the geometry is shown in Figure 1. Investigation of the leak led to the conclusion that it had resulted from a series of small cracks on the inner bore of the main flange which had occurred on both sides of an O-ring seal on the bore, causing a bypass of the seal, as shown in Figure 2.

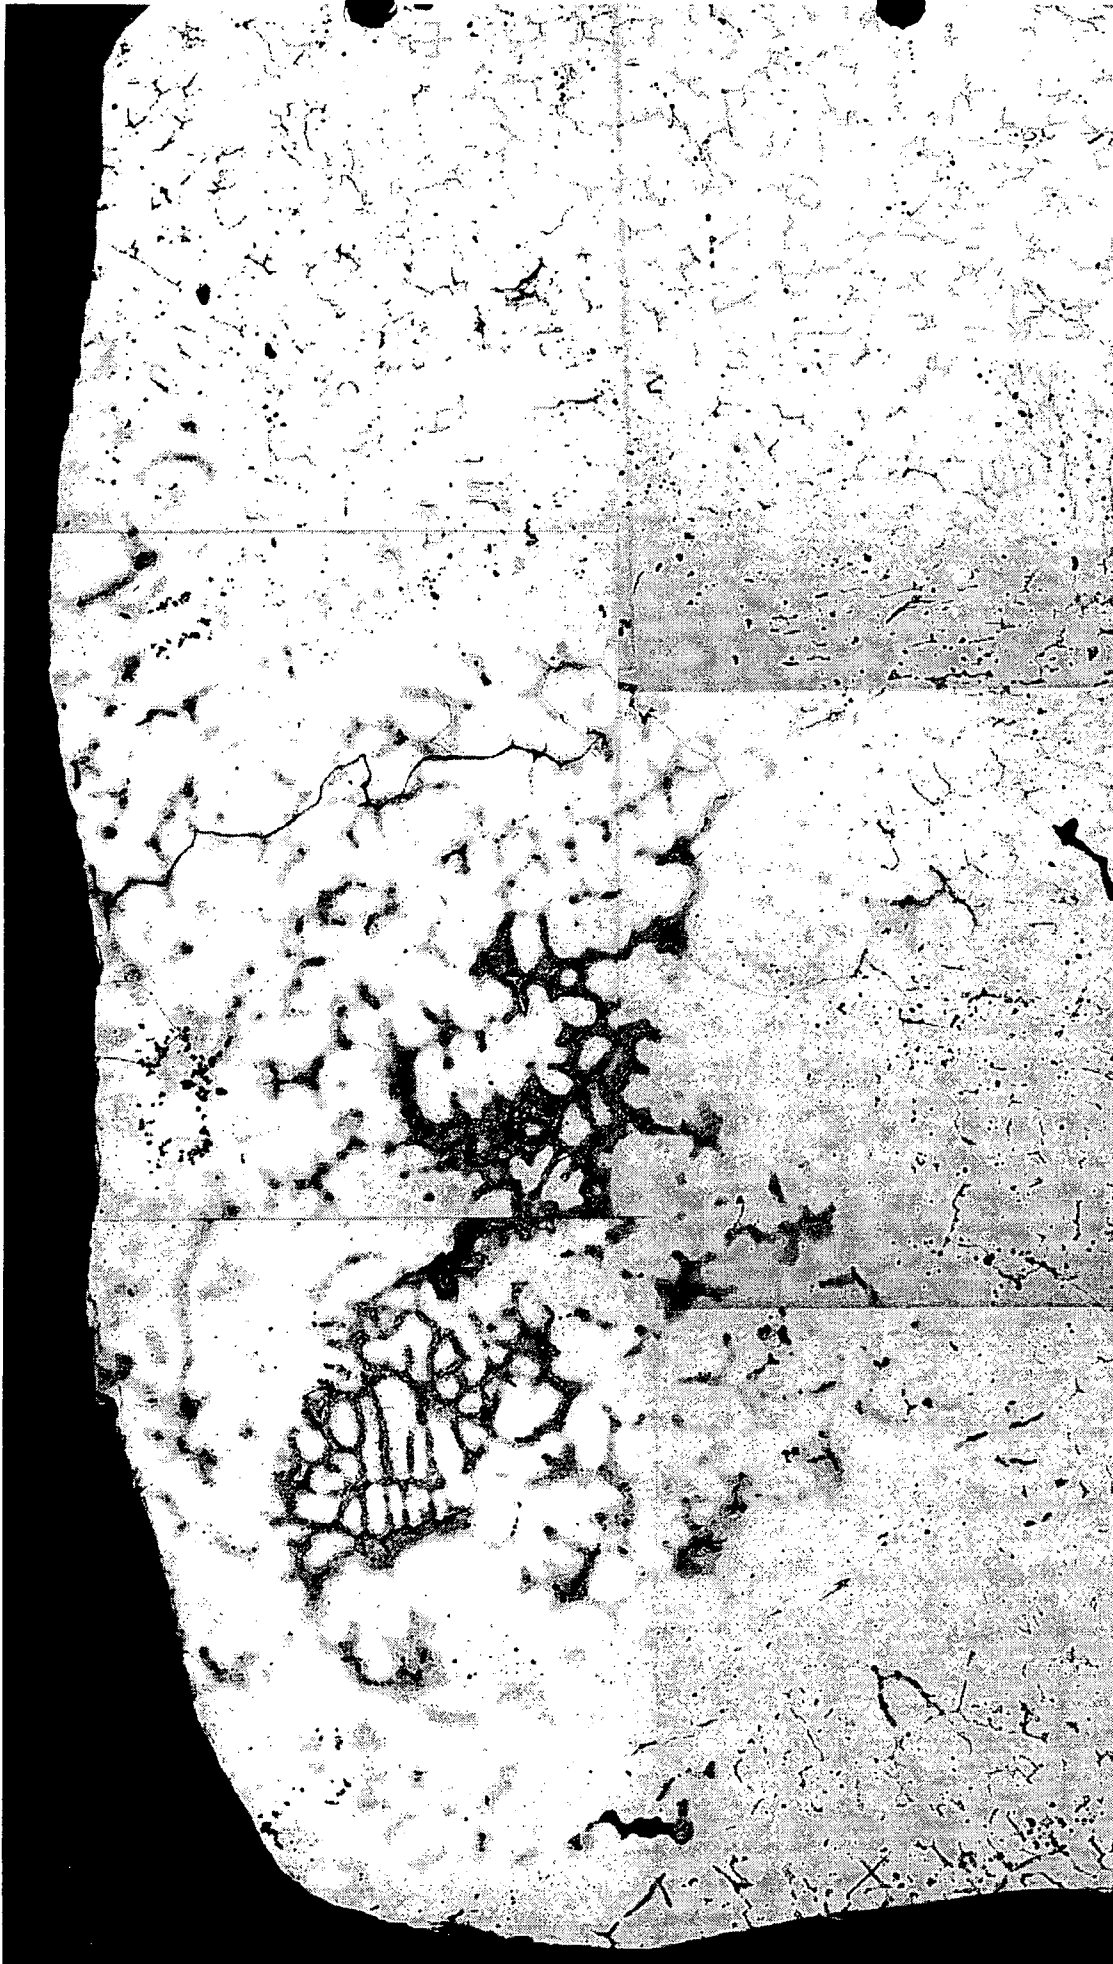
Figure 3: Low magnification (20X) photomicrograph of the flange surface surrounding indication #1, using a glyceregia etch.

Standard metallographic procedures were used to prepare a section through the cracked area, parallel to the flange surface. The etchant used to reveal the structure was glyceric acid. A low magnification (20x) photomicrograph of the area around the crack is shown in the attached Figure 3. The cracking is discontinuous and appears to be at grain boundaries and associated with the darker etching, segregated regions. The cracking is typical of shrinkage cracking observed in castings and weldments, especially when the delta ferrite content is low as seen in this area.

The major phase in the cracked region was shown to be the same composition as in the good microstructure, but with intense Cr segregation. This segregation shows as a darker etching region around islands of a second phase which has 50% or greater Cr content. Subsequent preparation of the specimen and etching in Emmanuel's etch resulted in this phase being stained blue, indicative of sigma phase. Many of the smaller cracks follow this second phase. Other cracks follow the Cr segregated region. Work in progress and planned includes the following:

The cracking is typical of shrinkage cracking in cast or weld metal. The cracking is fully contained within a number of areas of low or zero delta ferrite. This was confirmed in the laboratory examination of the boat sample, and on the main flange itself through use of a Severn Gage. The uncracked region is typical of a good quality CF8 stainless steel casting

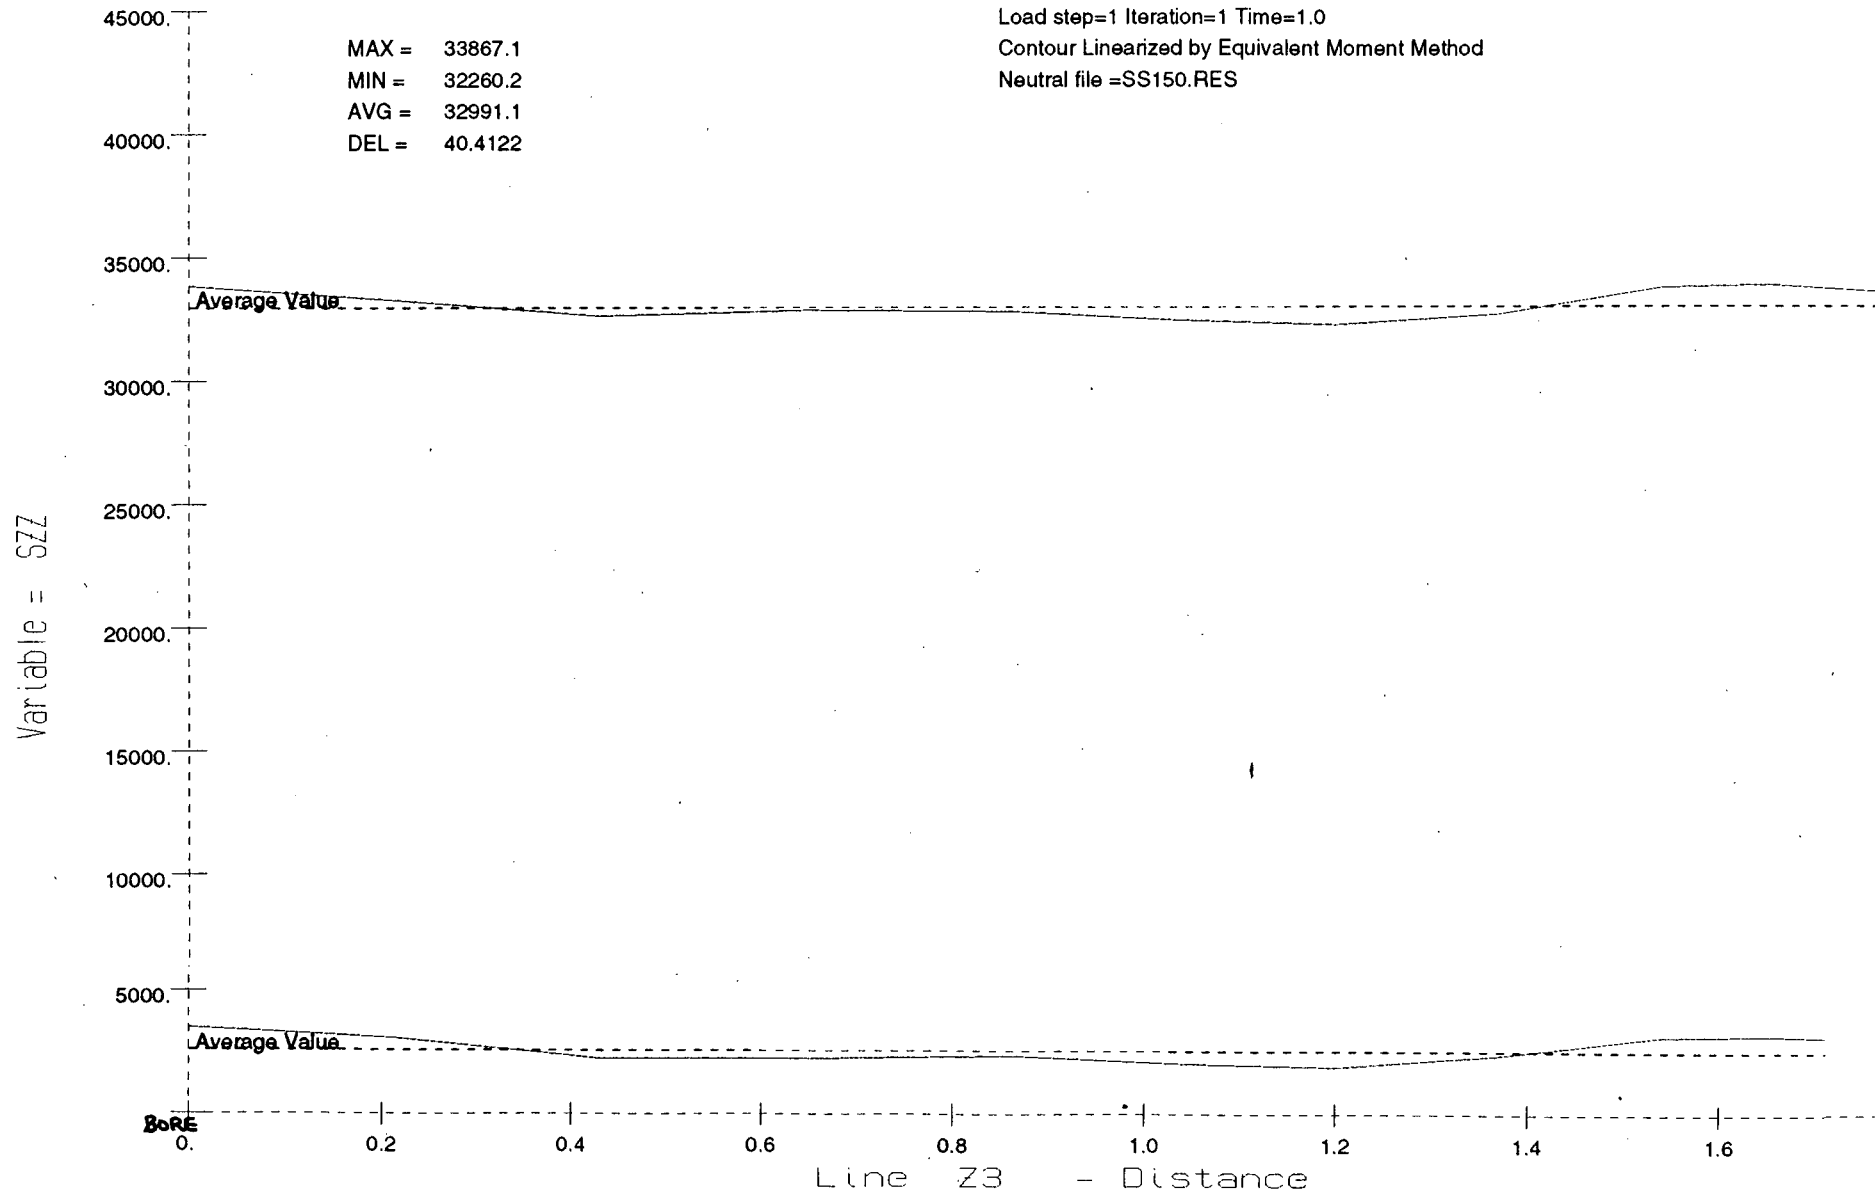
Figure 8 Stress Distribution Through the Flange From the Bore to the Bolt Circle

As can be seen in Figure 8, the hoop stresses are effectively constant between the bore and the seal housing bolt hole. For use in the fracture mechanics evaluations, the maximum hoop stresses in this location were found to be 33.0 ksi.

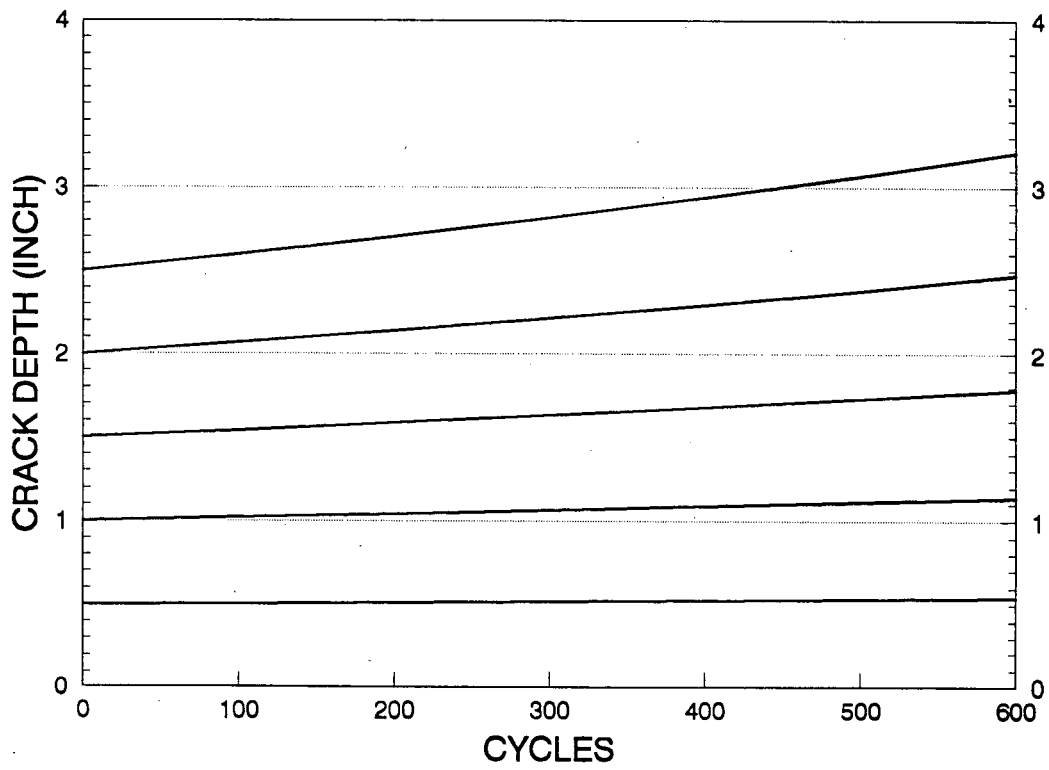
Figure 9 Fatigue Crack Growth Results

The stresses were conservatively assumed to be constant through the flange thickness, and semi-elliptic surface flaws of various depths were assumed to exist. Crack growth was then calculated as a function of the number of startup-shutdown cycles, of which there are 200 during the pump design life. Flaws were postulated with depths from 0.5 to 2.5 inches, and the crack growth law used was that from Section XI, Appendix C, for stainless steel, with a factor of two added to conservatively account for the water environment. The results of this calculation are shown in Figure 9, for up to six hundred cycles, which is three times the design number of cycles. The results show that crack growth is negligible for all but the very largest flaws, even for 600 cycles. This indicates that this region has a very large tolerance for the presence of flaws, and that it is very unlikely that fatigue crack growth is the cause of the cracking. This is consistent with the metallurgical finding that the cracking originated during the fabrication process.

A fracture evaluation was completed to determine the tolerance of the main flange bore region for the presence of cracks. Results showed a very large tolerance for the presence of cracks, and the fatigue crack growth calculations showed that even relatively large flaws would be unlikely to propagate.

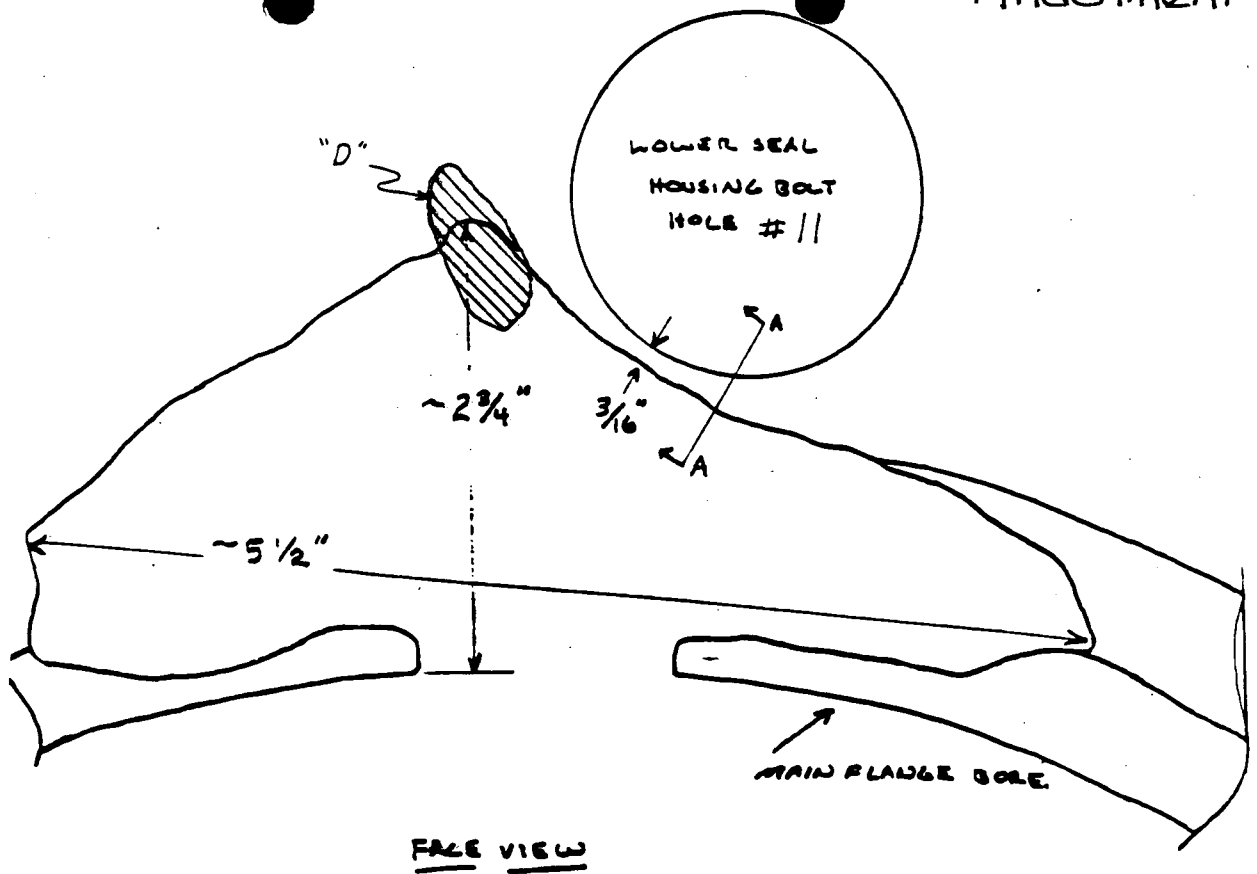
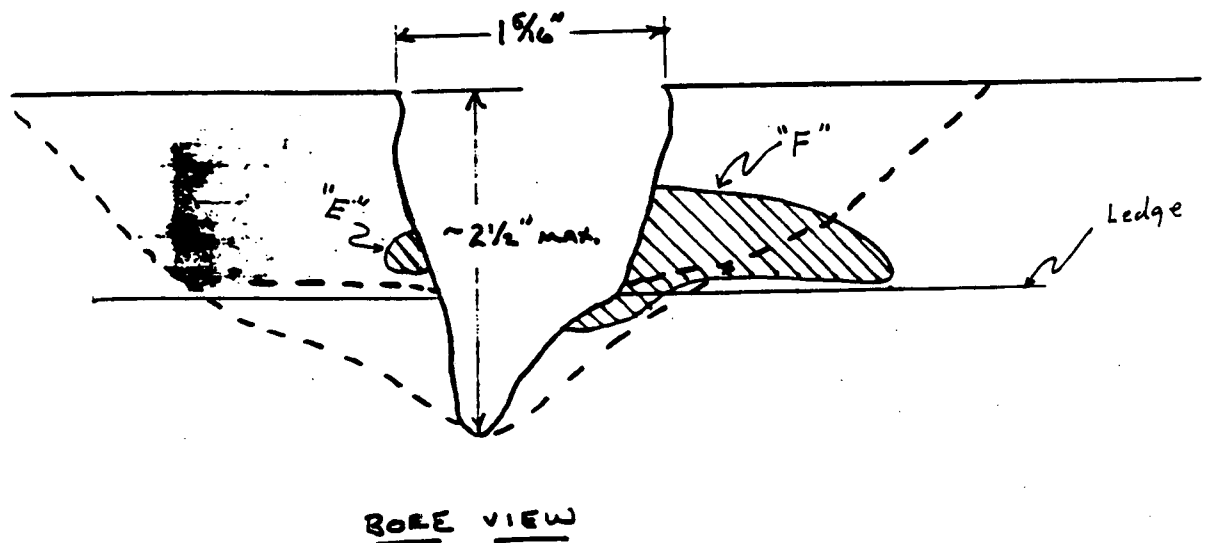
Figure A-1 Location of Low Ferrite Regions D, E and F

The survey at the flange found that the vast majority of the surface read  $> 15$  FN. Six areas on the flange were found to read below 5 FN. Three were located adjacent to the cavity where indications #1, 2 and 3 were located. (Areas D, E and F are shown in Figure A-1.) One was located in the region of indication #4, which has not been removed (Area C, shown in Figure A-2). The other two were adjacent to bolt holes #10 and #12 (Areas A and B, shown in Figure A-2). The largest of these was circular, about 2" in diameter. On the removed sample, the area of the indication was  $< 5$  FN. Readings away from the indication were between 7.5 FN and 12.5 FN.

Groove left after  
removal of PT indication #1, 2 & 3

Approximate Areas  
Reading less than  
5% Ferrite (5FN)

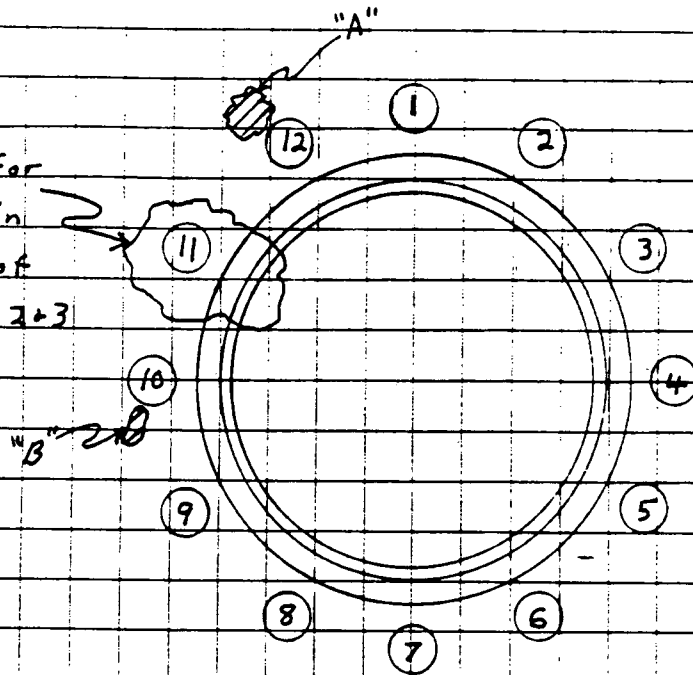
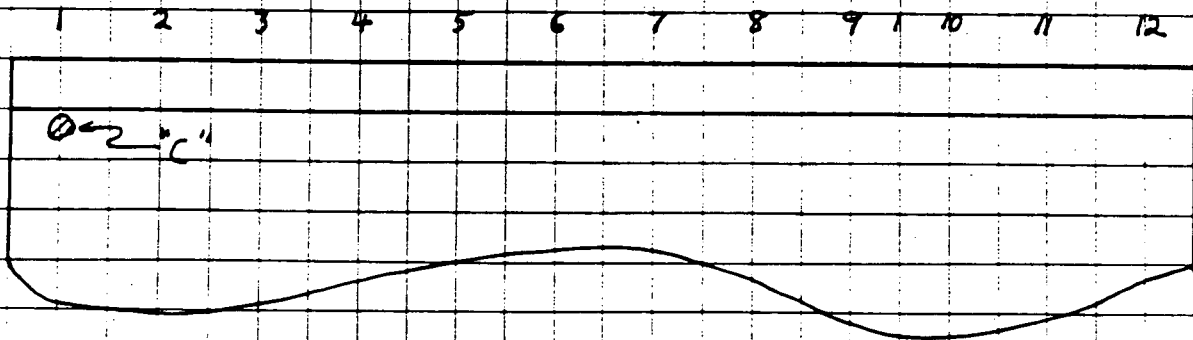
Figure A-2 Location of Low Ferrite Regions A, B and C

Approximate Areas  
Reading Less Than  
5% Ferrite (5FN)

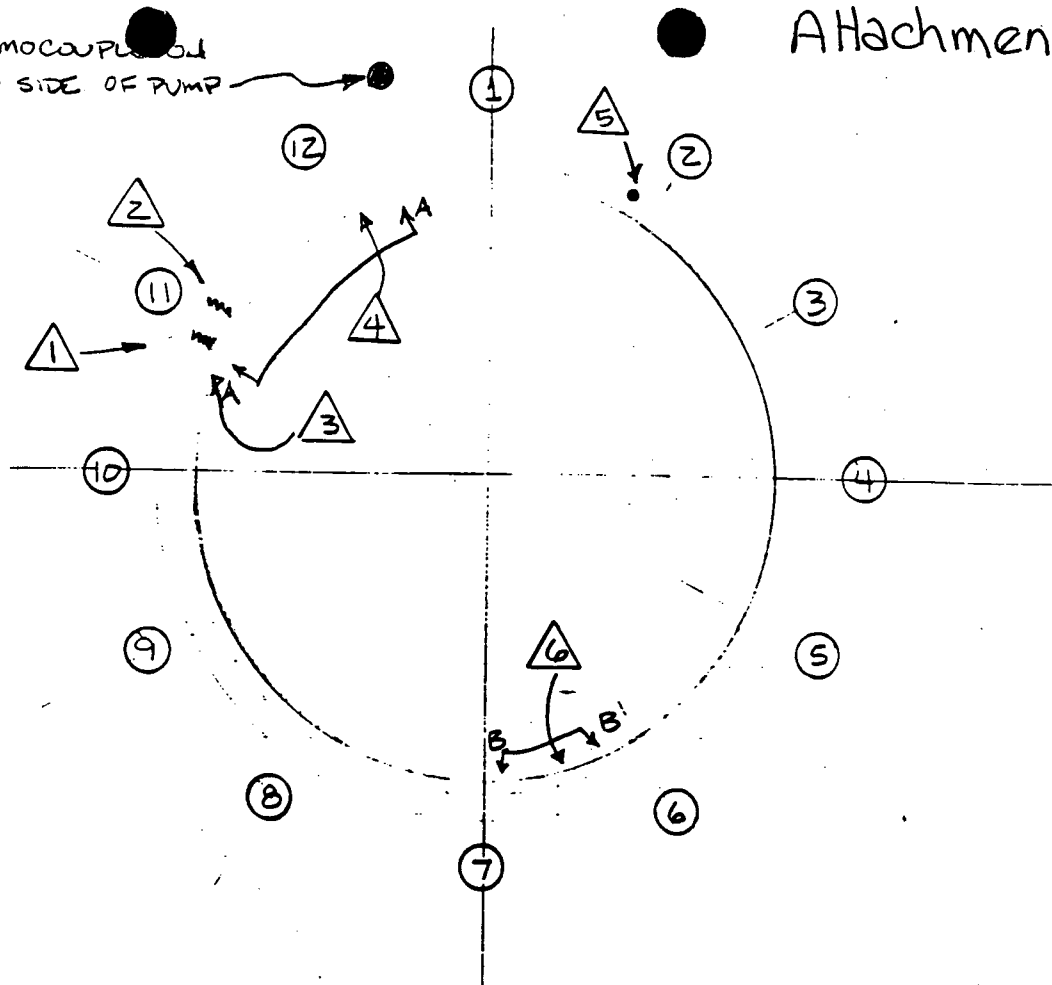
Figure A-3 Top View of the Main Flange showing Liquid Penetrant Indications

- ① 5" FROM HOLE 10 ON FLANGE SURFACE IN GASKET GROOVE. (0.7" LONG)
- ② 1/2" FROM HOLE 11 ON FLANGE SURFACE IN GASKET GROOVE. (0.35" LONG)
- ③ 4" FROM HOLE 10 0.85" FROM TOP, ON FLANGE BORE SURFACE (0.45" LONG)
- ④ 2" FROM HOLE 12 2.8" FROM TOP, ON FLANGE BORE SURFACE (0.7" LONG)
- ⑤ 4 1/2" FROM HOLE 1 ON FLANGE SURFACE IN GASKET GROOVE. (0.3" X 0.5" ROUNDED)
- ⑥ 4 1/4" FROM HOLE 6 ON FLANGE BORE SURFACE 3" FROM THE TOP (0.25" LONG.)

Three grooves which were left after removal of the indications required weld repair. One groove consistent of indications #1, 2 and 3, and there was one groove for indication #4 and one groove for indication #5. Indication #6 was basically a shallow surface indication and, not being across a sealing surface, was removed but not weld repaired.

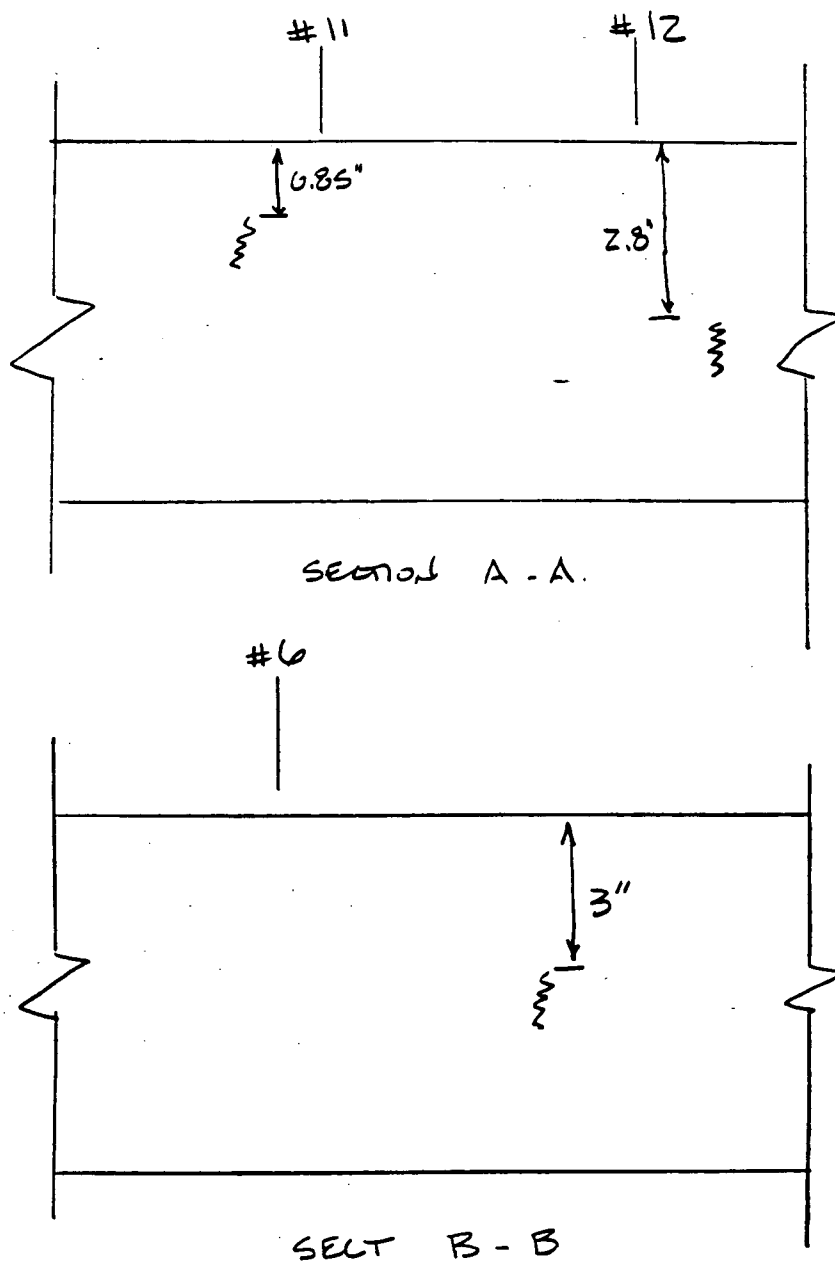
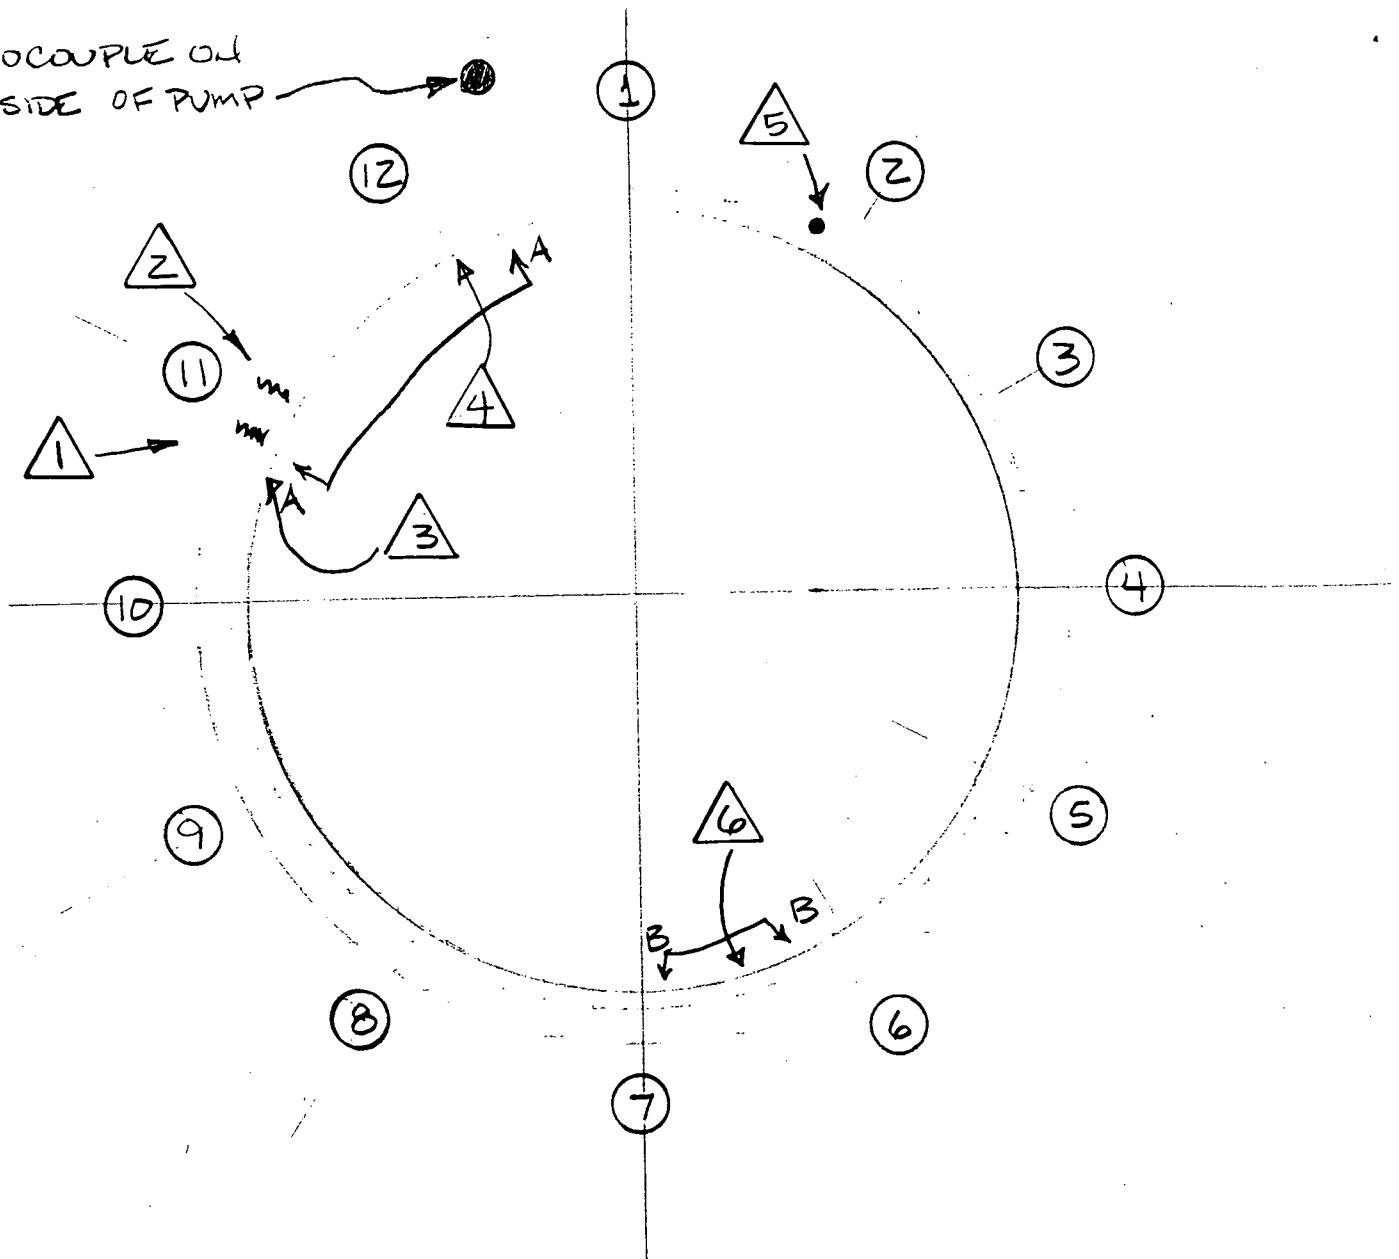
Figure A-4 Bore View of the Main Flange, Showing Liquid Penetrant Indications

- ① 5" FROM HOLE 10 ON FLANGE SURFACE IN GASKET GROOVE. (0.7" LONG)
- ② 1/2" FROM HOLE 11 ON FLANGE SURFACE IN GASKET GROOVE. (0.35" LONG)
- ③ 4" FROM HOLE 10 0.85" FROM TOP, ON FLANGE BORE SURFACE (0.45" LONG)
- ④ 2" FROM HOLE 12 2.8" FROM TOP, ON FLANGE BORE SURFACE (0.7" LONG)

- △ 5. 4 1/2" FROM HOLE 1- ON FLANGE SURFACE IN GASKET GROOVE. (0.3" x 0.5" ROUNDED)
- △ 6. 4 1/4" FROM HOLE 6 ON FLANGE BORE SURFACE 3" FROM THE TOP (0.25" LONG.)
