Donald C. Cook Nuclear Plant Unit 2
Proposed Alternative to the
American Society of Mechanical Engineers Code, Section XI
Repair Requirements

10 CFR 50.55a Relief Request Number ISIR-4-06

**Proposed Alternative in Accordance with 10 CFR 50.55a(a)(3)(ii)
Hardship or Unusual Difficulty without Compensating Increase in
Level of Quality or Safety**

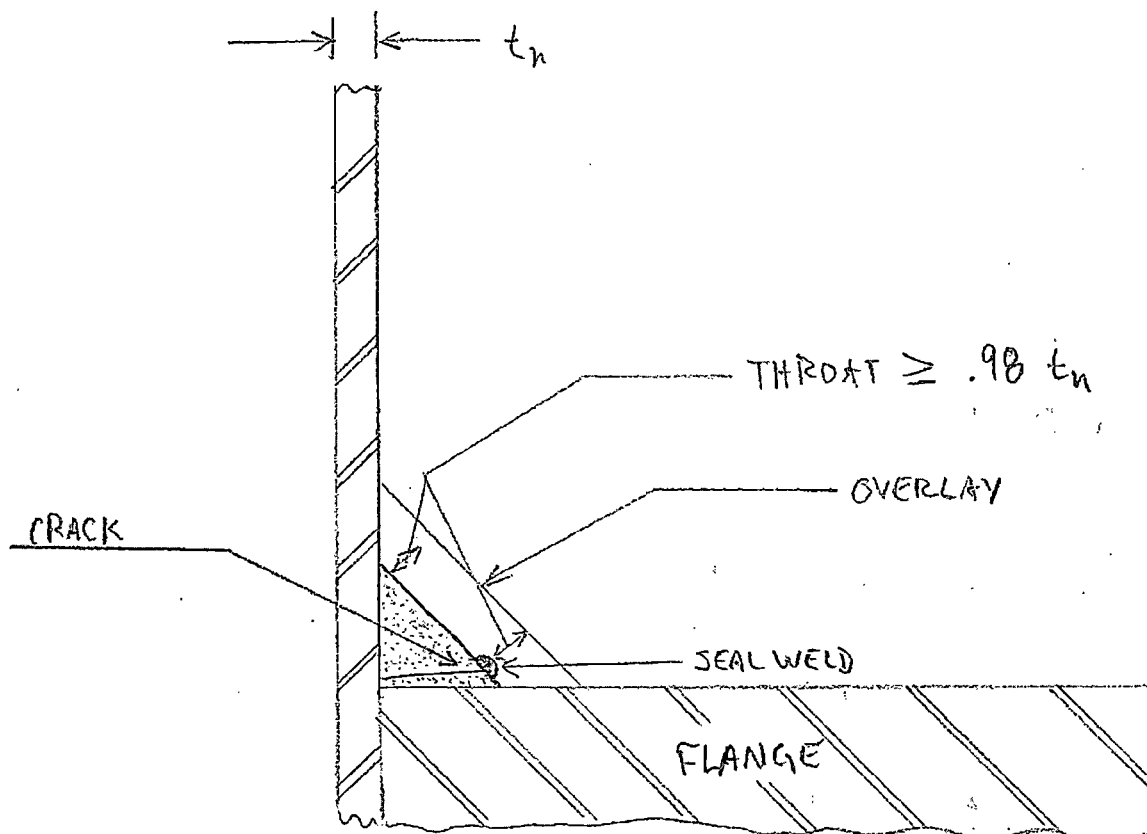
Proposed Overlay

- The through wall defect is on the toe flange side of the weld which most likely propagated from the root of the weld.
- A sketch of the pipe, flange, existing weld and overlay, and an isometric drawing marked to show the flange with the leak are provided in Section 7 of this attachment.
- The flange and pipe material are listed in the following table.

The leak will first be seal welded with 309L filler material. The seal weld will be examined visually (VT-1) and dye penetrant tested prior to performing the weld overlay.

The remaining weld passes will use ER308L/E308L as specified in the American Electric Power (AEP) weld manual, which is compatible with the stainless base metals. The remaining weld passes may be also completed with ER309L/E309L filler metal as specified in the AEP weld manual as compatible filler material with the stainless base metals used. The possible process and filler/rod combinations are shown in the following table.

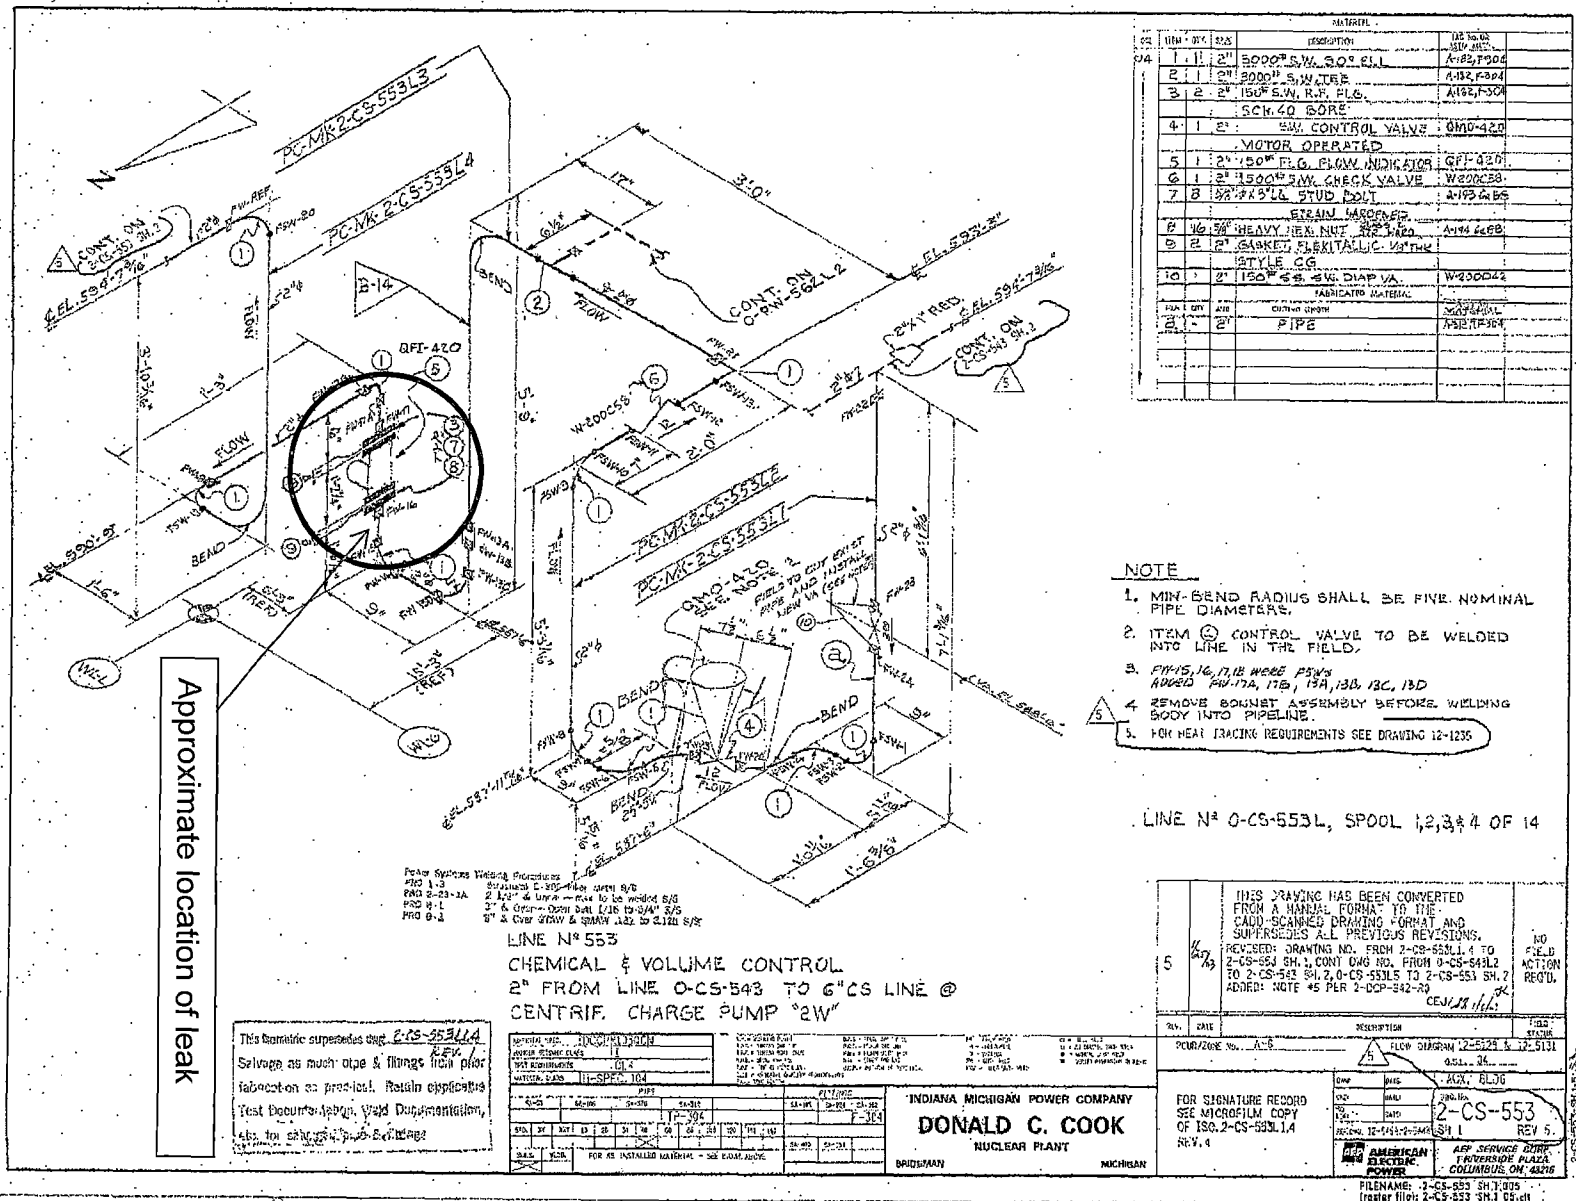
The affected component is socket weld FW-17 attaching a flange fitting to Chemical and Volume Control System Boric Acid Makeup System American Society of Mechanical Engineers (ASME) Code Class III two-inch piping downstream of a flow indication instrument 2-QFI-420 in Donald C. Cook Nuclear Plant Unit 2.
