Duke Energy Carolina, LLC (Duke Energy)
Catawba Nuclear Station (CNS), Units 1 and 2
Docket Nos. 50-413 and 50-414
Renewed License Nos. NPF-35 and NPF-52

SUBJECT: 10 CFR 71.95 Report on the 8-120B Cask for the Catawba Nuclear Station,
Units 1 and 2

**Failure to Observe Certificate of Compliance Conditions
for the 8-120B Vent Port Pre-Shipment Leak Test**

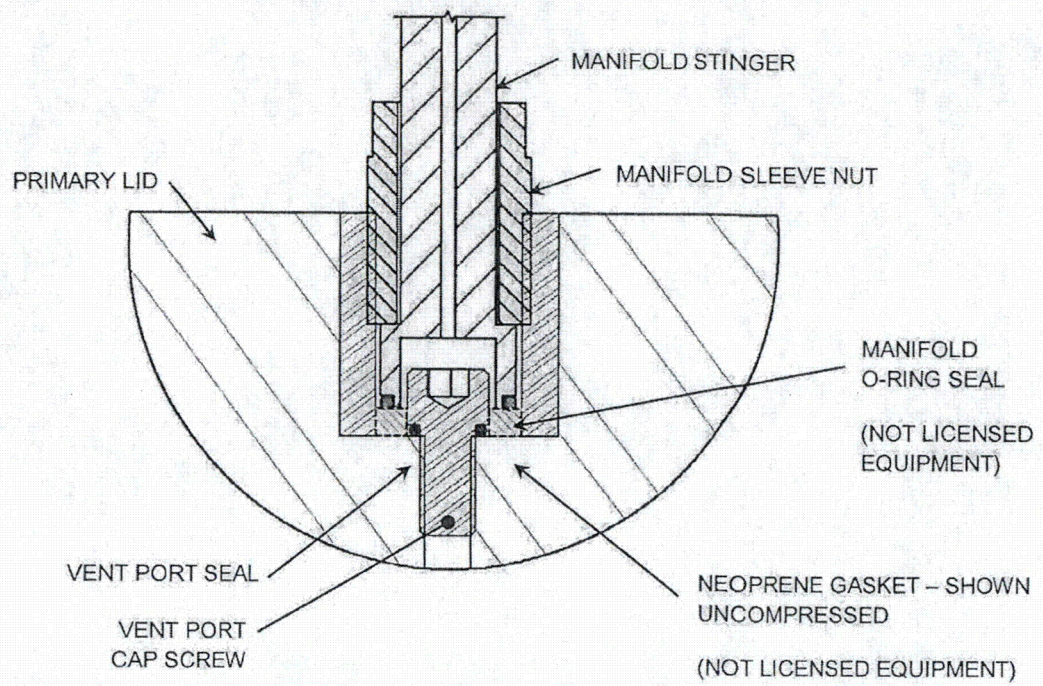
The neoprene gasket can constrict on the head of the vent port plug cap screw when it is compressed by the bottom end of the test manifold stinger, which could reduce the sensitivity of the pre-shipment leak test. Consequently, the vent port pre-shipment leak tests performed using the neoprene gasket may not have provided the required test sensitivity of 1×10^{-3} ref-cm³/sec.

On Monday June 1, 2015, an 8-120B cask user identified a concern that the neoprene gasket could potentially affect the integrity of the vent port seal pre-shipment leak test. Later that week EnergySolutions performed a bench test that confirmed that the neoprene gasket can constrict on the head of the vent port plug cap screw when it is compressed by the manifold, resulting in a reduction of the test sensitivity.

The pre-shipment leak test of the vent port is a pressure drop test performed using a dedicated test manifold. The test manifold is not a part of the licensed package. It includes a stinger (shown below), an O-ring seal that contacts the stinger and the bottom of the vent port hole, and a sleeve nut to compress the O-ring seal. The test manifold was designed so that it surrounds the vent port cap screw, leaving a small gap between itself and the vent port cap screw. The 8-120B cask fleet began to ship with a new lid design in September 2013, and operations staff noted more frequent difficulty getting the manifold to seal. It became desirable to find a better way to seal the bottom of the manifold in order to minimize operator exposure. They found that adding a neoprene gasket (also not part of the licensed package) under the base of the stinger as shown below helped reduce testing time and exposure.

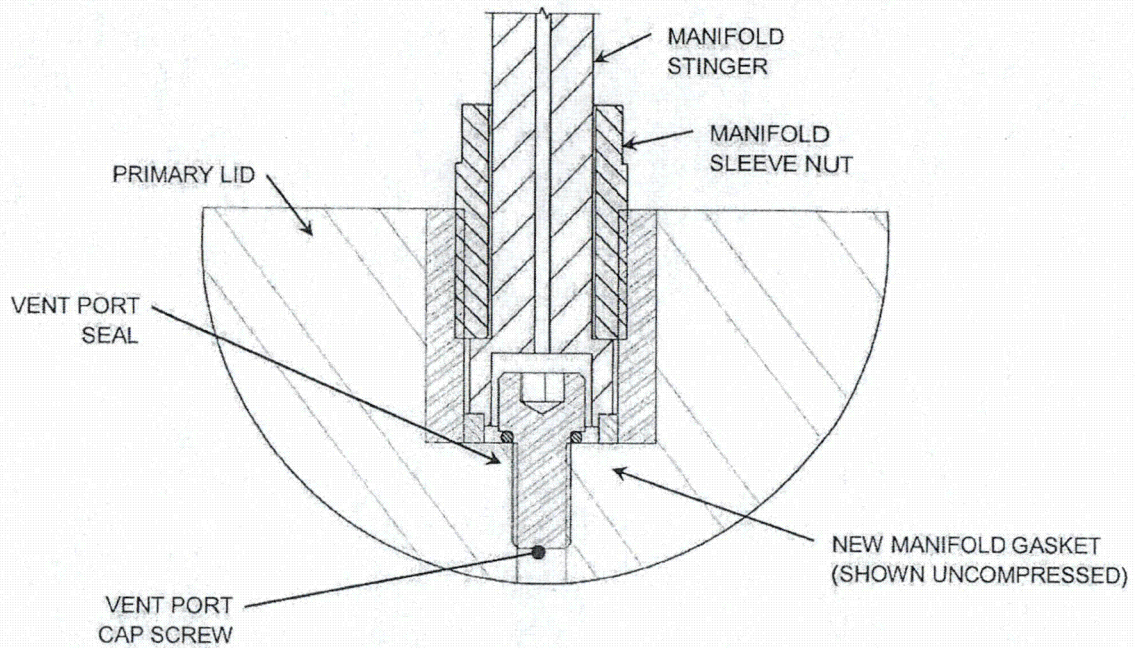
Corrective Action – Modified Test Seal

The new manifold gasket design, shown below, replaces the manifold O-ring seal and neoprene gasket previously used with a neoprene gasket that fits within the notch at the base of the manifold stinger.

- EnergySolutions notified all 8-120B cask users with upcoming shipments to require use of a new procedure, in conjunction with the new manifold gasket design, for pre-shipment leak testing of the vent port seal on all future shipments.
- EnergySolutions designed and tested new manifold gasket design that does not constrict onto the head of the vent port plus screw when compressed, and therefore it does not reduce the test sensitivity. The new gaskets have been distributed to all upcoming shipment users. The new manifold gasket design is shown in Attachment 1.

The EnergySolutions drawing for the 8-120B air drop manifold have been revised to include the new gasket seal, and the air pressure drop test procedure TR-TP-002 has been revised to incorporate the new pre-shipment leak test procedure for the vent port. Use of the new procedure and the new manifold gasket will assure that the pre-shipment leak test satisfies the required test sensitivity and that the manifold gasket is removed from the test port after completing the pre-shipment leak test.
