SUBJECT: Forwards response to NRC requests for info re non-nuclear instrumentation/integrated control sys failures. Corrective actions should preclude recurrence of event similar to Crystal River. No OL mods necessary.

March 12, 1980

Subject: Oconee Nuclear Station  
Docket Nos. 50-269, -270, -287

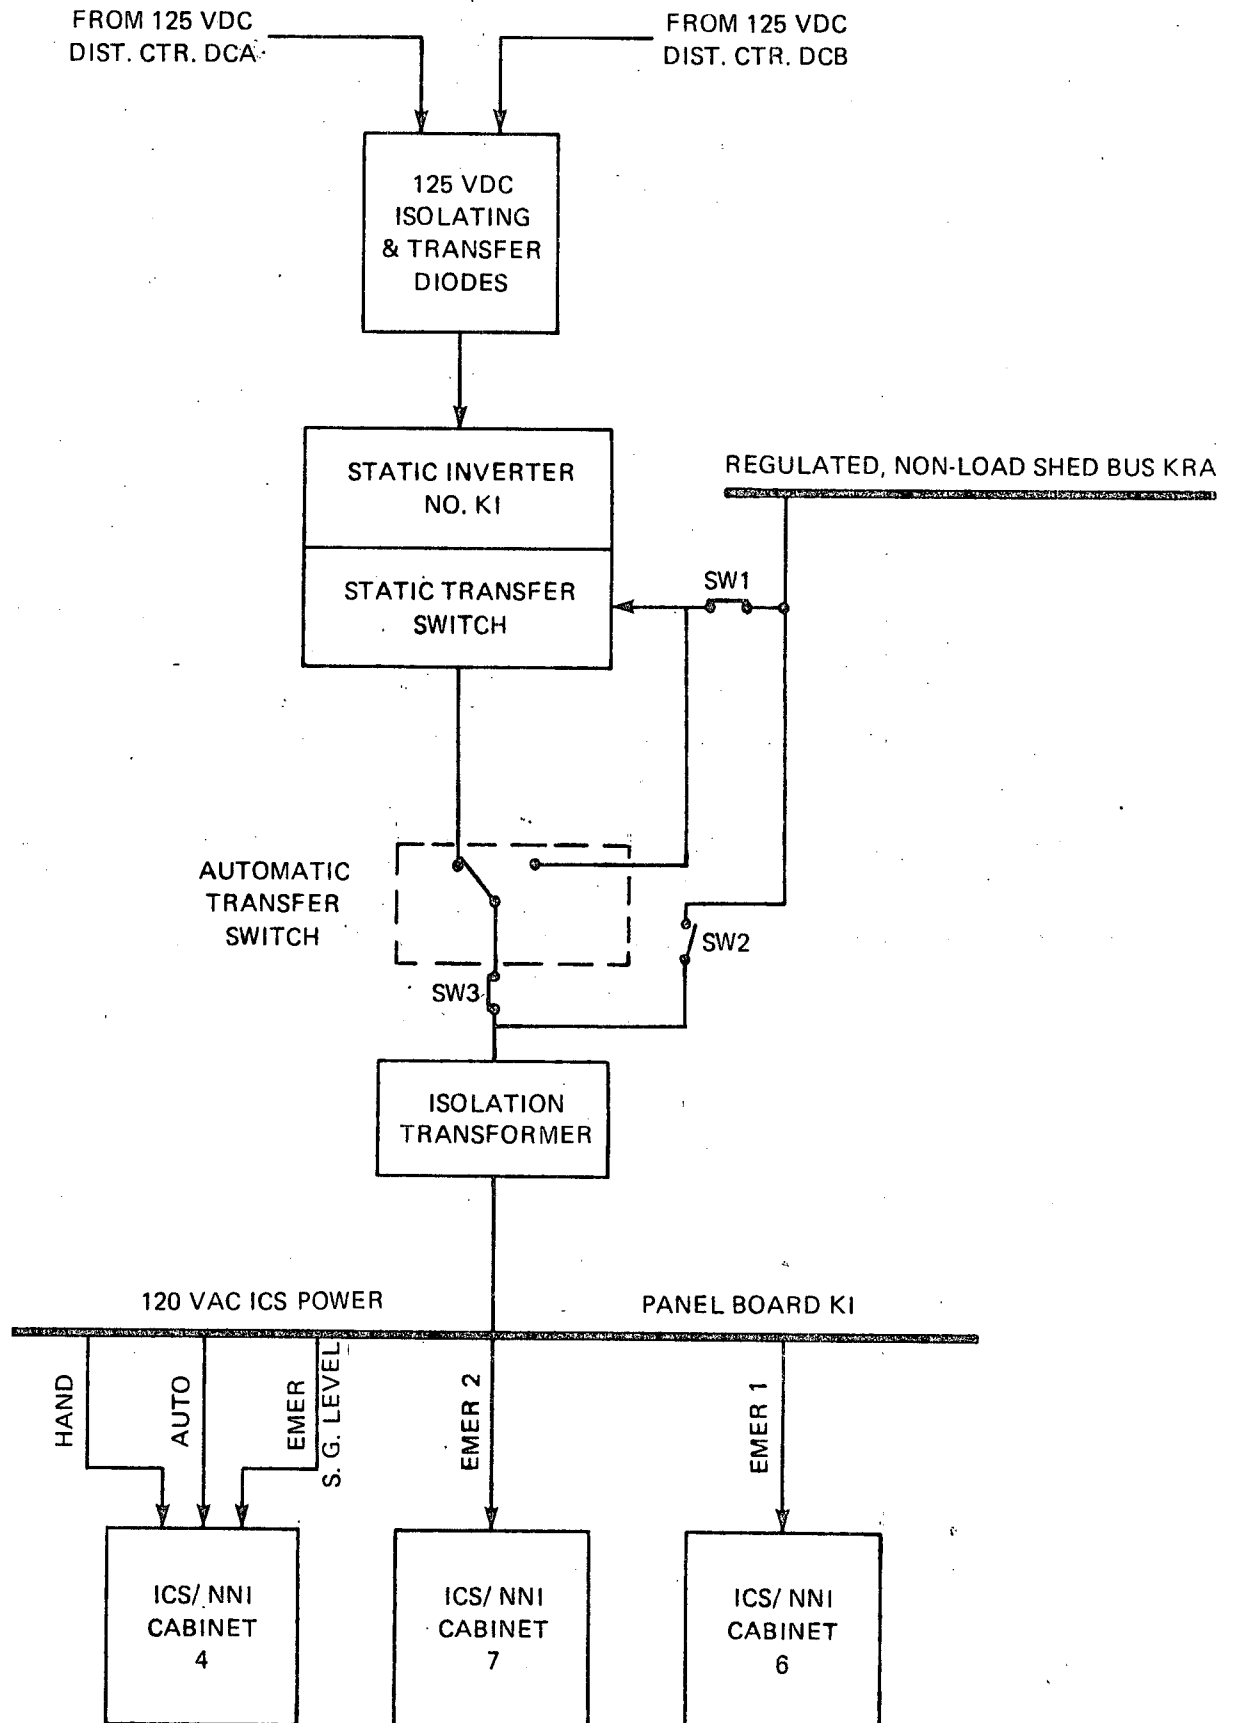
FIGURE 1  
OCONEE NUCLEAR STATION  
TYPICAL ICS/NNI AC SUPPLY

The ICS/NNI system at Oconee is powered from a dedicated static inverter system which receives a DC input from the vital instrumentation and control batteries and a backup AC input from a regulated non-load shed bus. (Refer to the attached Figure 1.) On November 10, the static switch on the output of the inverter system failed preventing either the inverter source or the backup source from feeding the integrated control system. In this particular instance, power was restored by manually switching the backup source to panel 3KI. This was accomplished by the operator such that the ICS system was without power for approximately 2 1/2 minutes. To eliminate the need for a manual transfer and to improve the integrity of this AC supply, an automatic transfer switch has been added such that on an inverter or static switch failure, the inverter static switch system will be bypassed and regulated non-load shed power supplied to panel board 3KI through the automatic power transfer switch. This automatic transfer takes place in less than 1.2 seconds and eliminates the need for manual transfer.

Following the November 10 transient at Oconee 3, automatic transfer switches have been installed on Units 1 and 3 at Oconee to automatically transfer the NNI/ICS system to non-load shed power on a loss of the inverter/static switch power supply system. This transfer takes place in approximately 1.2 seconds. This modification will be completed on Oconee 2 during the current refueling outage.
