SUBJECT: LER 89-006-00: on 890804, improper relay setting due to design deficiency could trip 2B reactor bldg spray pump.
 W/8 ltr.

Subject: Oconee Nuclear Station
Docket Nos. 50-269, -270, -287
LER 270/89-06

LICENSEE EVENT REPORT (LER)

Trip Proper Relay Setting, Due to Design Deficiency, Could Trip 2B Reactor Building Spray Pump During LOCA/LOOP Event

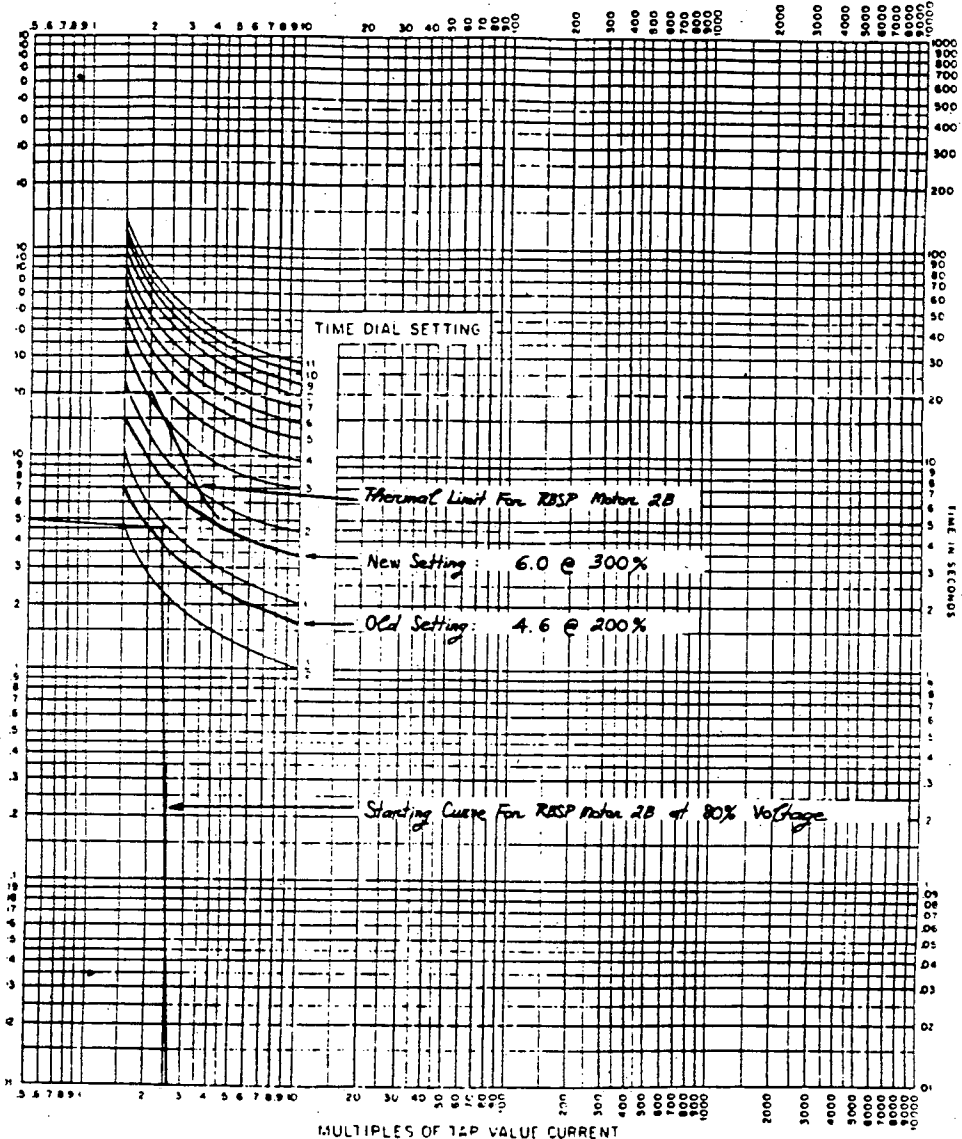
TYPE CO-5 LONG TIME OVERCURRENT RELAY
TYPICAL 50/60 CYCLE CURRENT TIME CURVES

The potential for the 2B Reactor Building Spray Pump Motor to trip with an overcurrent relay setting of 4.6 seconds @ 200% was only present during a Loss Of Coolant Accident (LOCA)/Loss Of Offsite Power (LOOP) scenario. The motor manufacturer guarantees the motor to start at a minimum of 80% rated voltage. During the initial phases of a LOCA/LOOP, the voltage at the RBS Pump Motor terminal dips to 81%, while during a LOCA, the startup voltage dips to approximately 87%. The difference in these startup voltages is due to the fact that a LOCA-only unit is immediately powered from the switchyard while a LOCA/LOOP unit would be powered from a Keowee Hydro unit [EIIS:EK] through transformer CT-4 [EIIS:XFMR] and the standby buses. The previous overcurrent relay setpoint of 4.6 seconds @ 200% was not sufficient to allow the motor to fully start during the reduced starting voltage of the LOCA/LOOP, but was sufficient to allow the motor to fully start during the LOCA startup voltage.

As shown above the voltage at the RSP pump motor terminal dips to 81% under a LOCA/LOOP scenario. This should be adequate for the motor to start since it is guaranteed by the motor manufacturer to start at 80% voltage.

The raising of the relay setpoint to 6.0 seconds @ 300% allows the motor to successfully start at starting voltages of less than 80%. In addition, the new setpoint does not exceed the thermal damage limit for the motor which ensures that the motor will not be damaged due to the additional starting time.
