SUBJECT: LER 90-001-00:on 900913,manual reactor trip while
 subcritical after 2A feedwater pump trip.

Subject: Oconee Nuclear Station
Docket Nos. 50-269, -270, -287
LER 270/90-01

LICENSEE EVENT REPORT (LER)

FACILITY NAME (1) Oconee Nuclear Station, Unit 2										DOCKET NUMBER (2) 0 5 0 0 0 2 7 0										PAGE (3) 1 OF 11																																	
TITLE (4) Manual Reactor Trip While Subcritical After 2A Feedwater Pump Trip Due to Equipment Malfunction																																																					
EVENT DATE (5)									LER NUMBER (6)									REPORT DATE (7)									OTHER FACILITIES INVOLVED (8)																										
MONTH			DAY			YEAR			YEAR			SEQUENTIAL NUMBER			REVISION NUMBER			MONTH			DAY			YEAR			FACILITY NAMES												DOCKET NUMBER(S)														
0 9			1 3			9 0			9 0			0 0			1			0 0			1 0			1 5			9 0															0 5 0 0 0											
OPERATING MODE (9) N									THIS REPORT IS SUBMITTED PURSUANT TO THE REQUIREMENTS OF 10 CFR §: (Check one or more of the following) (11)																																												
POWER LEVEL (10) - 0 -									20.402(b)									20.405(c)									<input checked="" type="checkbox"/> 50.73(a)(2)(iv)									73.71(b)

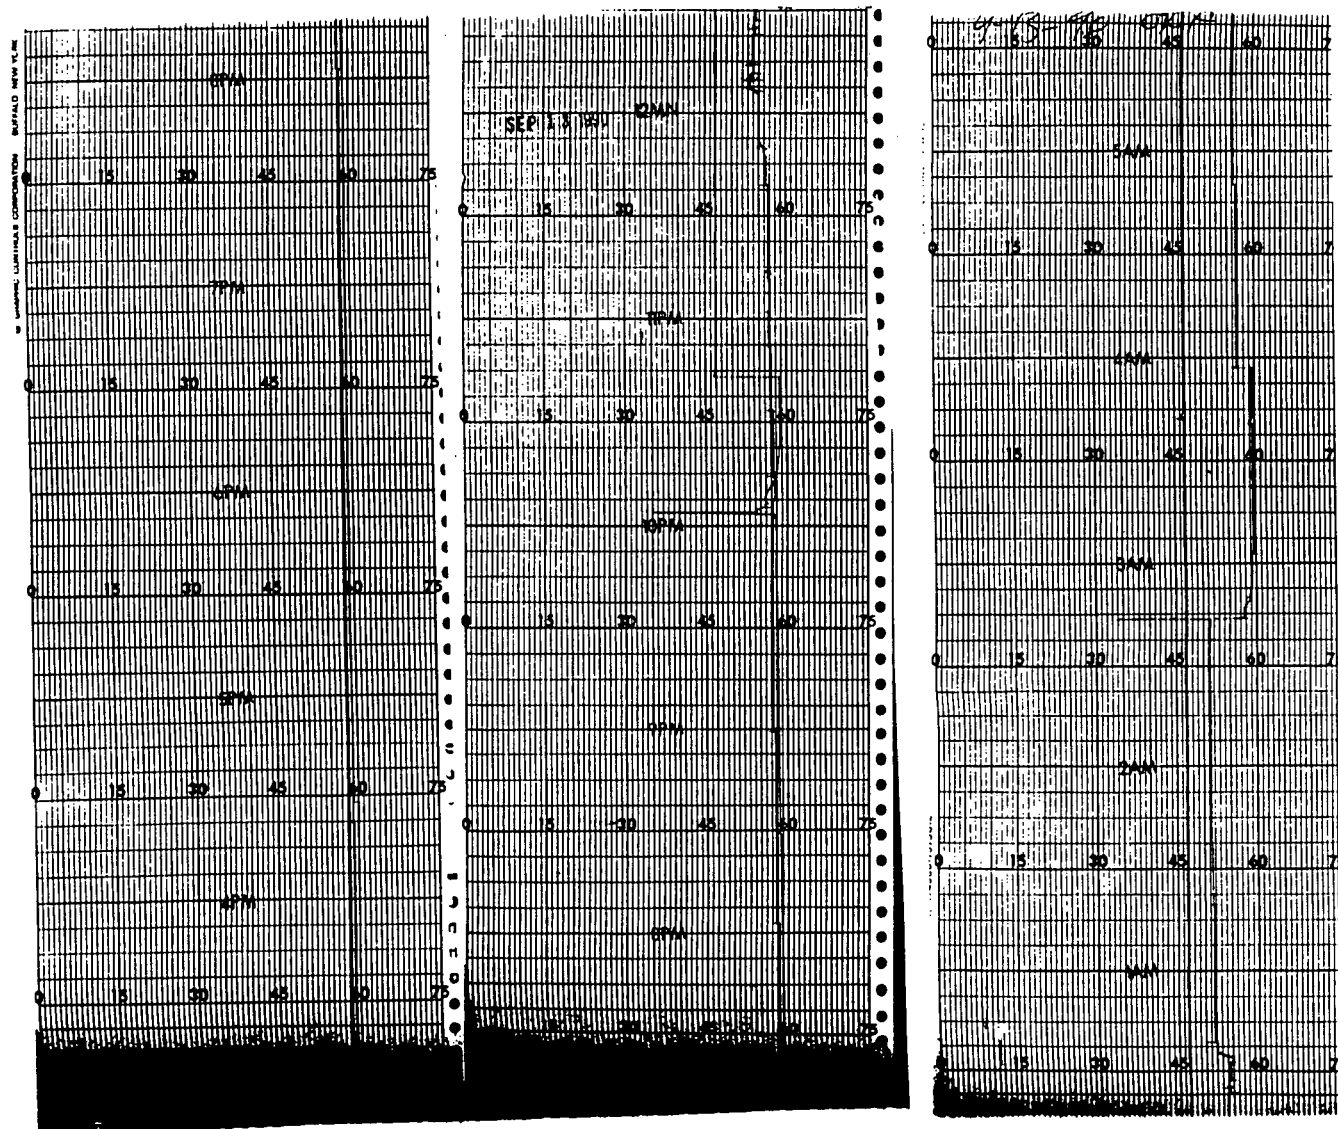
ATTACHMENT 1

Upon the 2A FWPT trip, Control Oil Pressure decreased (Att. #1) below the pressure required to automatically start both the Auxiliary Oil Pump (AOP) and the Emergency Bearing Oil Pump (EBOP). The control oil pressure recovered immediately upon the start of the AOP. Five seconds after the trip, a pressure switch alarm indicated that the EBOP started.

The Operations Unit 2 Shift personnel, prior to restarting the 2A FWPT, investigated the cause of the 2A FWPT trip. They noted the dip in control oil pressure on the strip chart and that both the auxiliary oil pump and

An investigation of the Control Oil Pressure strip chart indicates that the pressure control for 2A FWPT had been erratic prior to this event (Att. #1). The 2A FWPT control oil pressure, rather than a steady pressure decrease, decreased in step increments.

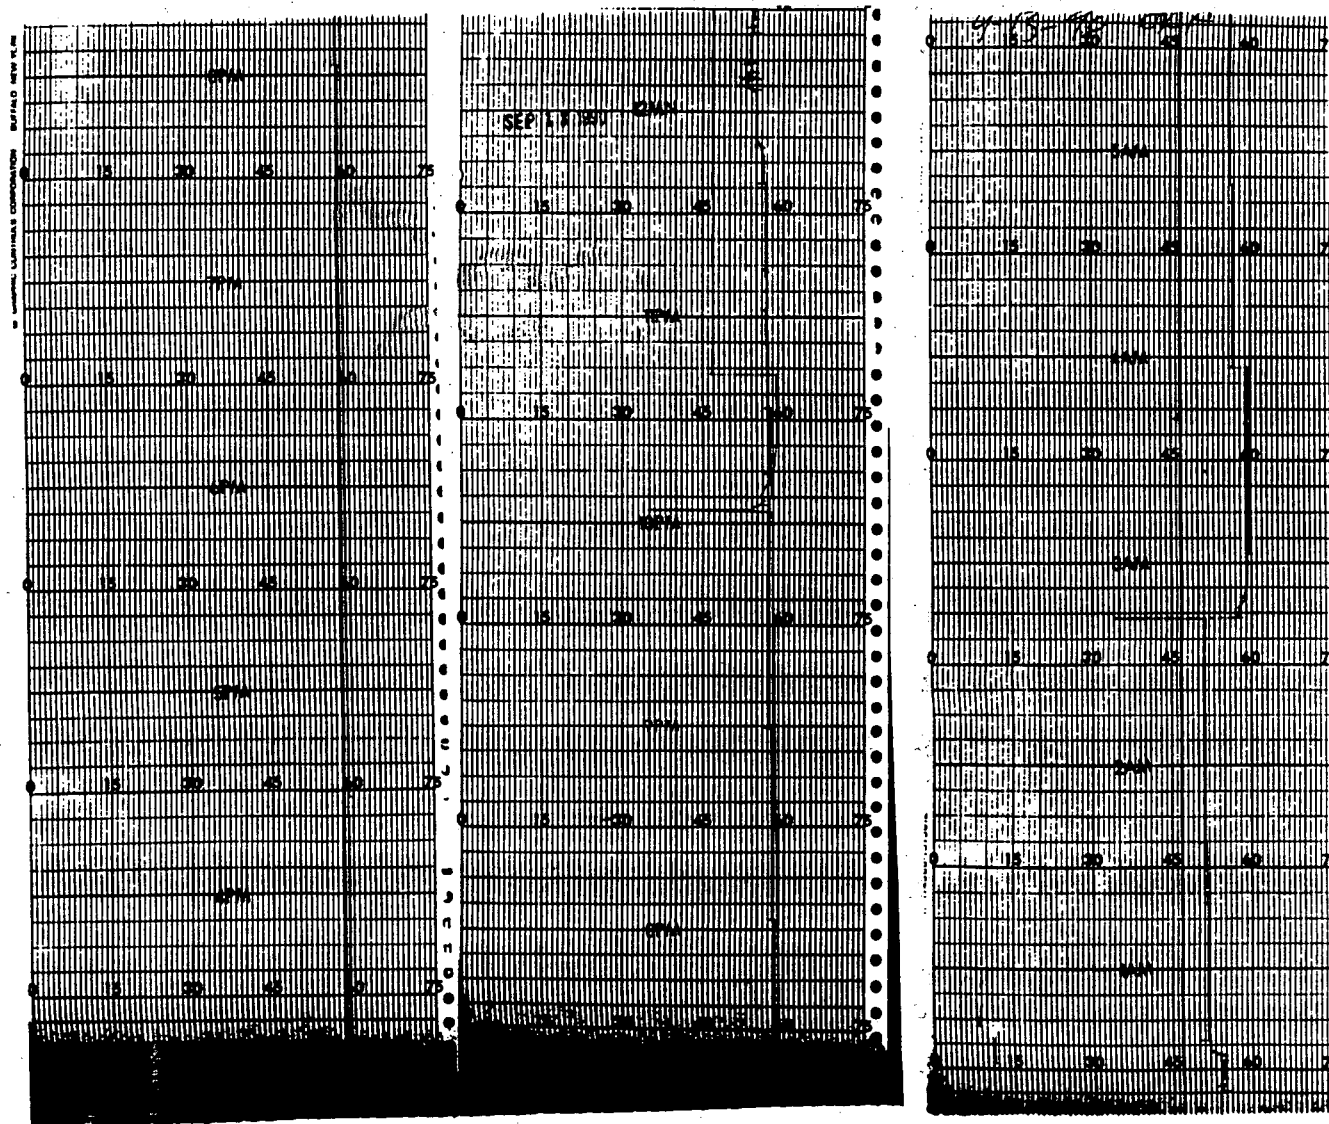
ATTACHMENT 1

The Operations Unit 2 Shift personnel, prior to restarting the 2A FWPT, investigated the cause of the 2A FWPT trip. They noted the dip in control oil pressure on the strip chart and that both the auxiliary oil pump and
