Subject: Oconee Nuclear Station, Unit 2
Docket No. 50-270
Special Report Concerning High Pressure
Injection Train Rendered Automatically
Inoperable Due To Inappropriate Operator Actions

Oconee Nuclear Station, Unit 2

High Pressure Injection Train Rendered Automatically Inoperable Due to Inappropriate Operator Actions

PIR# 2-090-0081

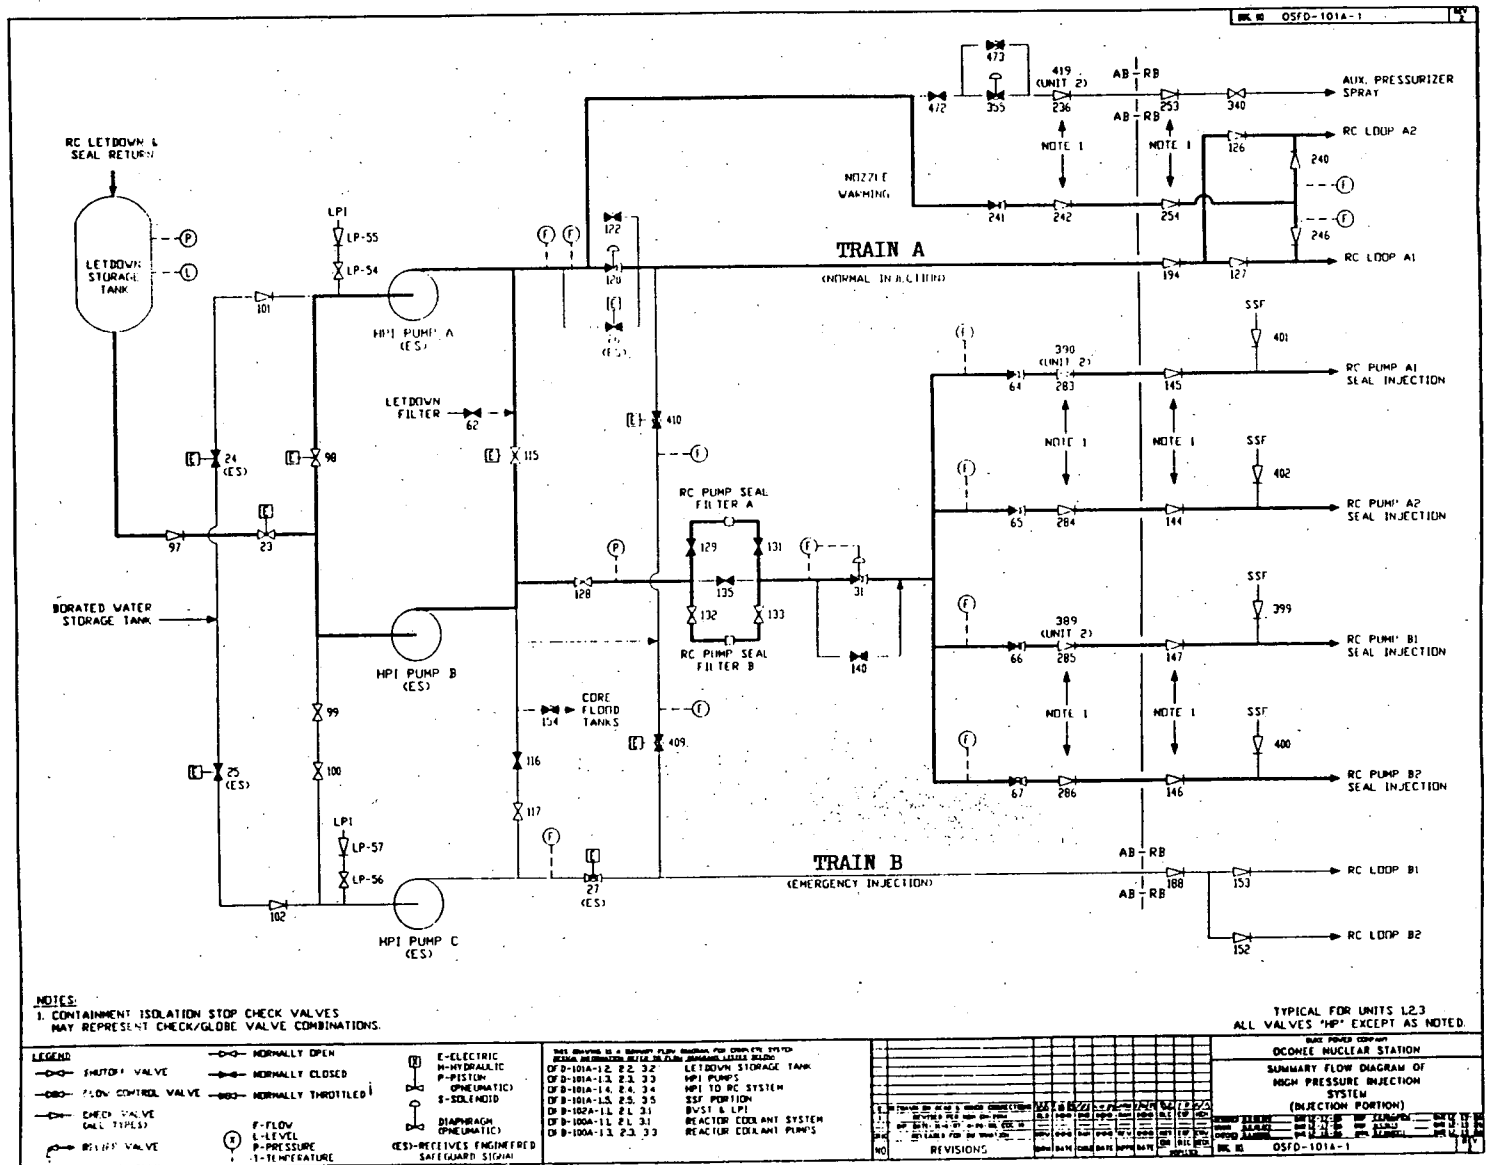
ATTACHMENT 1

Oconee Unit 2 has three HPI pumps [EIIS:P] (pumps A, B, and C). The three pumps are installed in parallel with a cross connecting header on the discharge of the pumps capable of furnishing either or both HPI Trains A and B (see attachment 1 drawing). During normal operation, one pump is required to supply normal makeup and reactor coolant pump seal injection. A second pump functions automatically as a backup. The third pump is used only for emergency injection. The HPI pumps are powered from the 4160V switchgear. All three pumps receive an automatic Engineered Safeguard [EIIS:JE] actuation signal on low Reactor Coolant System [EIIS:AB] pressure and/or high reactor building [EIIS:NH] pressure.

At 1212 hours, the 2C HPI pump breaker was racked out by the assigned Non Licensed Operator to permit pump lubrication. This action, which removed the 2C pump from service, without having first aligned the 2B HPI pump to the "B" HPI train, caused an apparent violation of TS 3.3.1 c (2) in that only one HPI train (A Train) was capable of automatic injection.
