Subject: Spring 2015 – 180 Day Steam Generator Report

**STEAM GENERATOR TUBE INSPECTION REPORT, CALVERT CLIFFS
UNIT 2, REFUELING OUTAGE 21**

**Calvert Cliffs Nuclear Power Plant
August 25, 2015**

Calvert Cliffs Nuclear Power Plant Unit 2 CC2R21 Spring 2015 Steam Generator Inspection

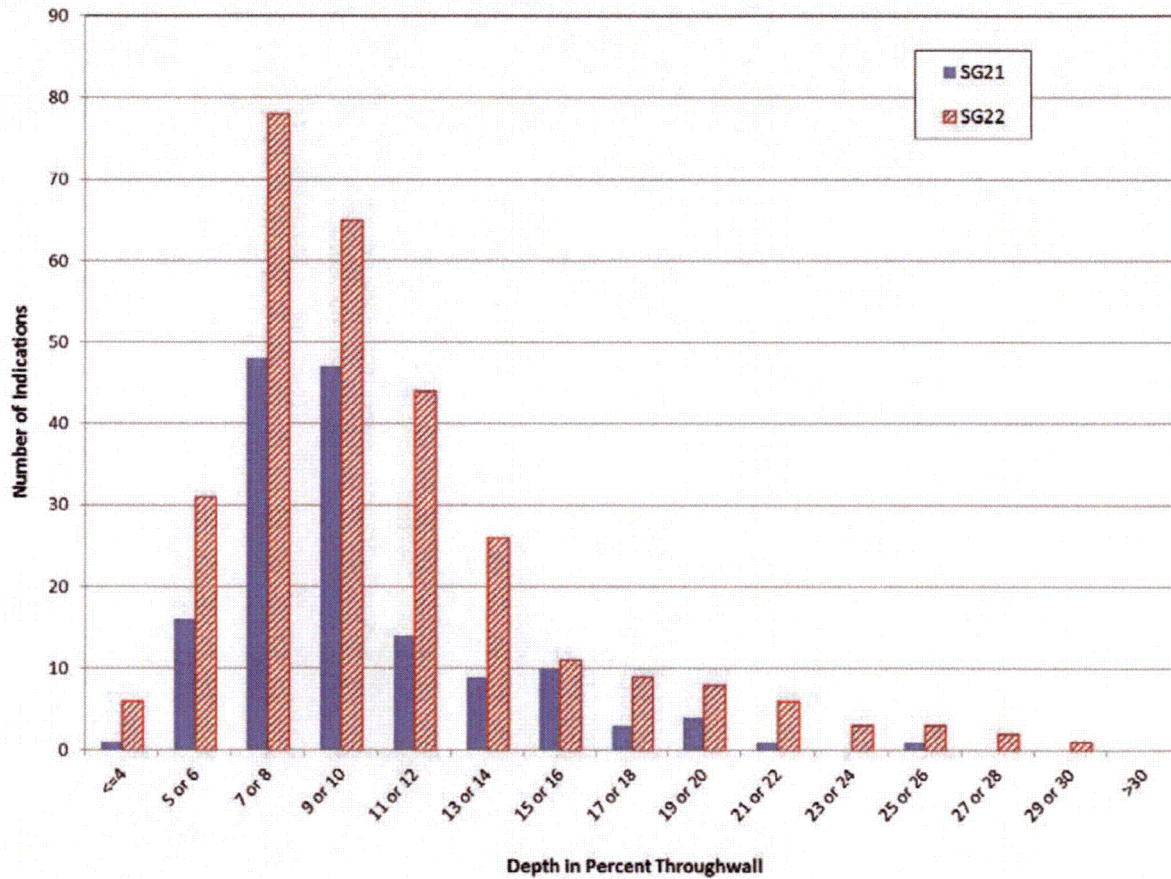
5.1.2 Figure 1 – Distribution of Fan Bar Wear Depth

Figure 1 provides the distribution of fan bar wear depths for both steam generators as reported with the bobbin coil probe. As shown in the figure, SG22 contained more indications. A majority of the indication in both SG's are less than 20% TW.

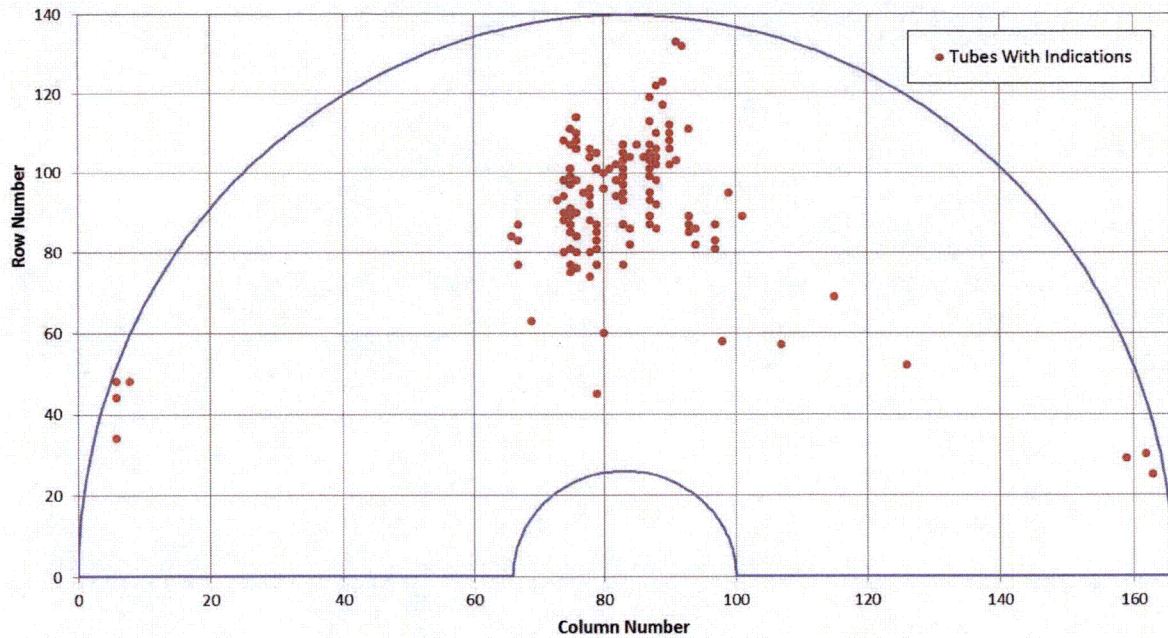
5.1.3 Figure 2 – SG 21 Fan Bar Wear Map

Figures 2 and 3 provide tube map locations of the reported FBW. Although the tube maps shown in Figures 2 and 3 provide a view of the tubesheet primary face from the hot leg side, both the hot leg and cold leg FBW indications are included on each map. Most of the wear continues to occur in longer tubes (i.e., larger U-bend radius), clustered towards the center-most tube columns.

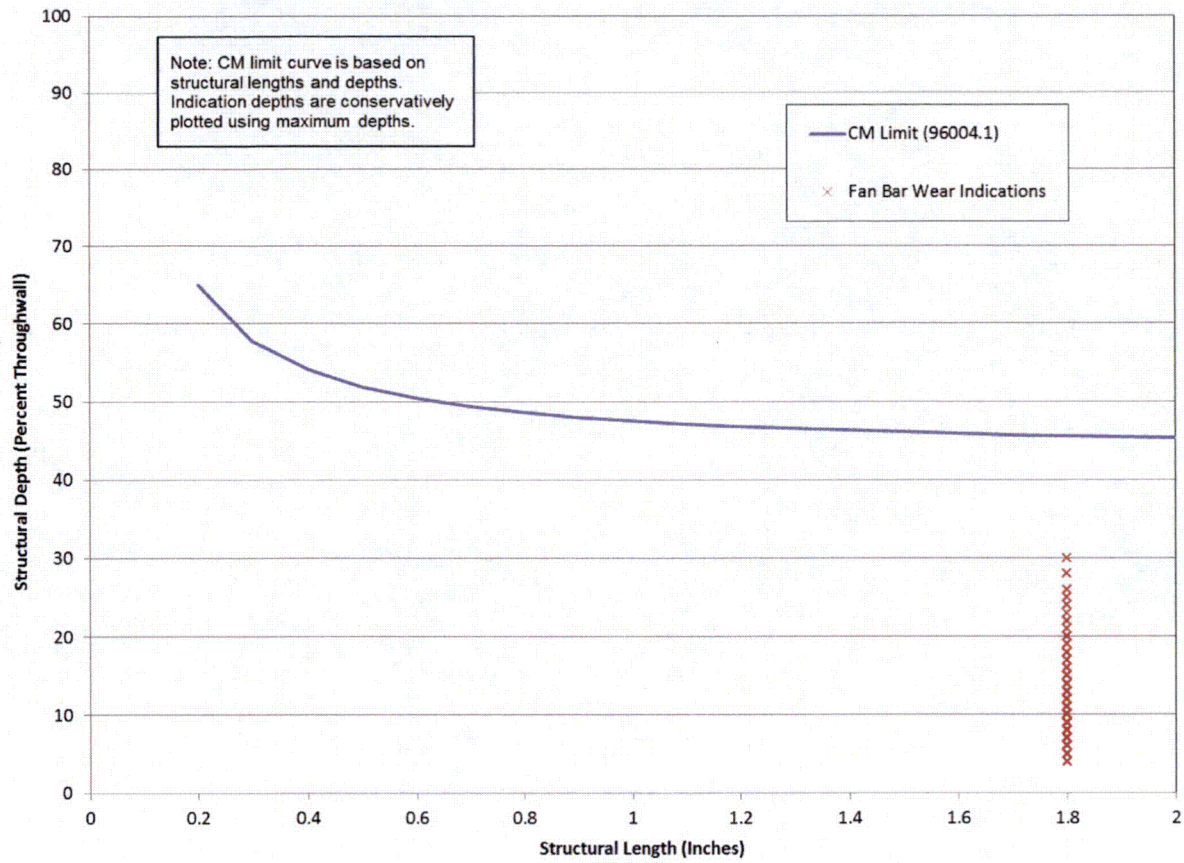
8.3.1 Figure 4 – Condition Monitoring Results for Fan Bar Wear

Based on the sizing parameters for this technique, the CM curve shown in Figure 4 was generated and documented in the Degradation Assessment (DA). Each of the fan bar wear indications were conservatively plotted at an axial length of 1.8 inches based on current and previous length sizing of the deepest indications. As shown, all indications lie well below the CM curve. Hence, structural integrity of the fan bar wear indications is demonstrated.

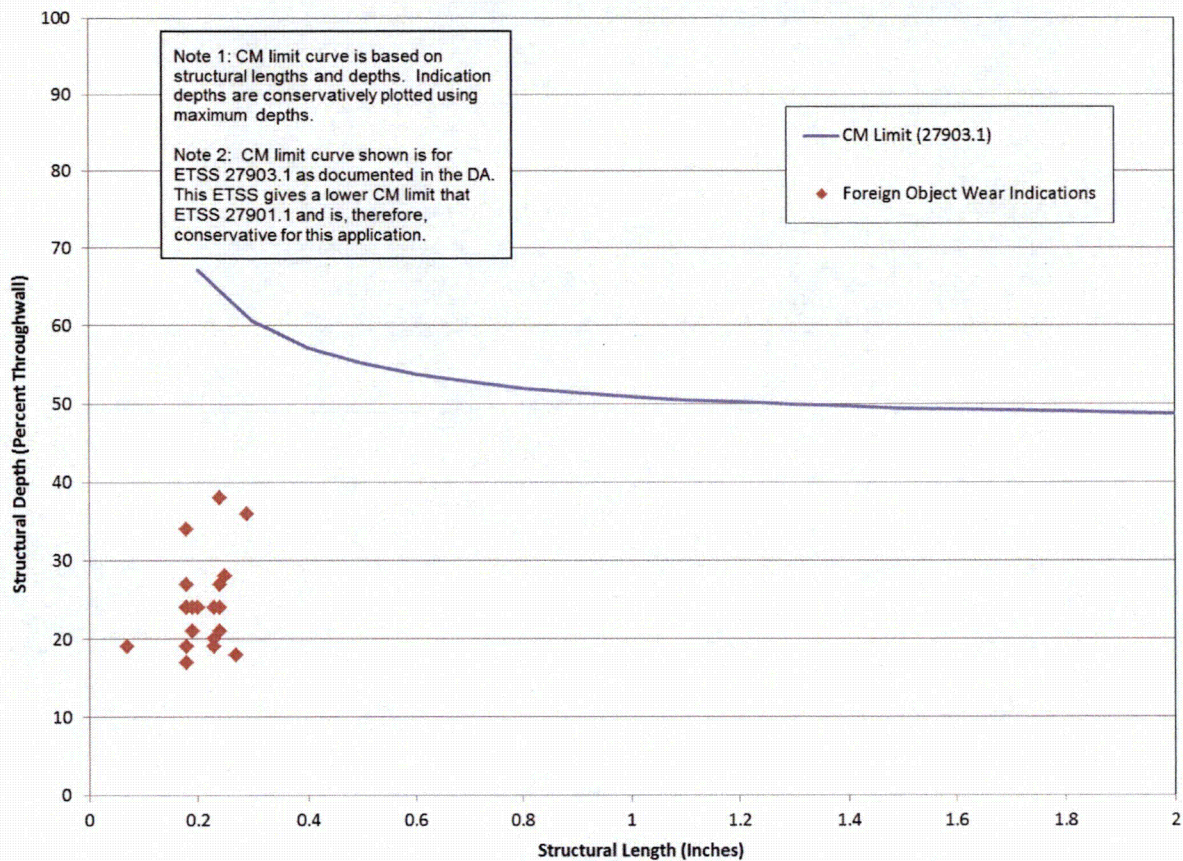
8.3.2 Figure 5 – Condition Monitoring for Foreign Object Wear

As documented in the DA, ETSS 27903.1 provides a lower CM limit compared to the other 2790X series of techniques. Hence, use of the CM limit curve from the DA is appropriate and conservative for the evaluation of foreign object wear at Calvert Cliffs Unit 2. Figure 5 shows the condition monitoring results for foreign object wear. As shown, all indications lie well below the CM curve. Hence, structural integrity of the foreign object wear indications is demonstrated.

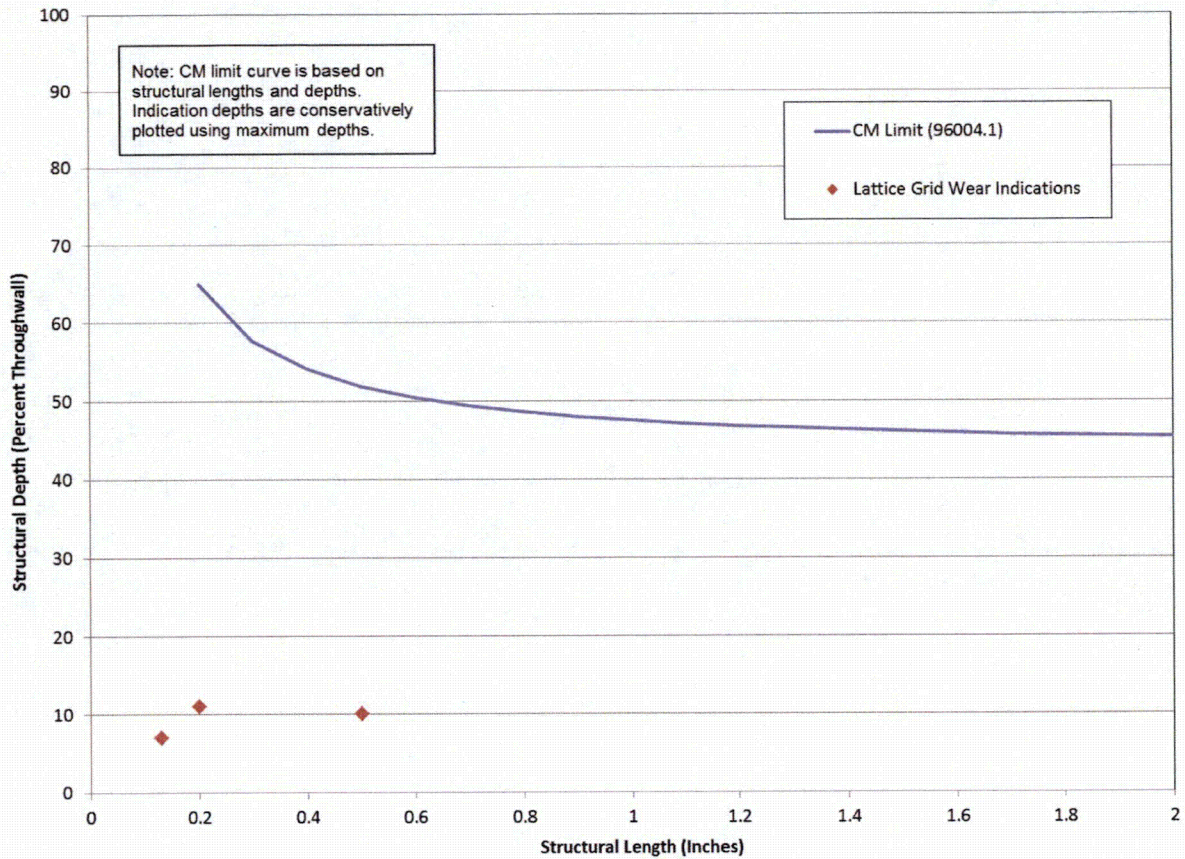
8.3.3 Figure 6 – Condition Monitoring for Lattice Grid Wear

Based on the sizing parameters for this technique, the CM curve shown in Figure 6 was generated and documented in the DA. Since all three of the lattice grid wear indications were inspected with +Point™, the lengths measured from the +Point™ inspections are reflected in the figure. As shown, all indications lie well below the CM curve. Hence, structural integrity of the lattice grid wear indications is demonstrated.
