Subject: Oconee Nuclear Station
Docket Nos. 50-269, -270, -287
Licensee Event Report 270/96-04, Revision 1
Problem Investigation Process No.: 2-096-1828

Oconee Nuclear Station, Unit 2

Secondary Drain Line Rupture Results In A Manual Reactor Trip

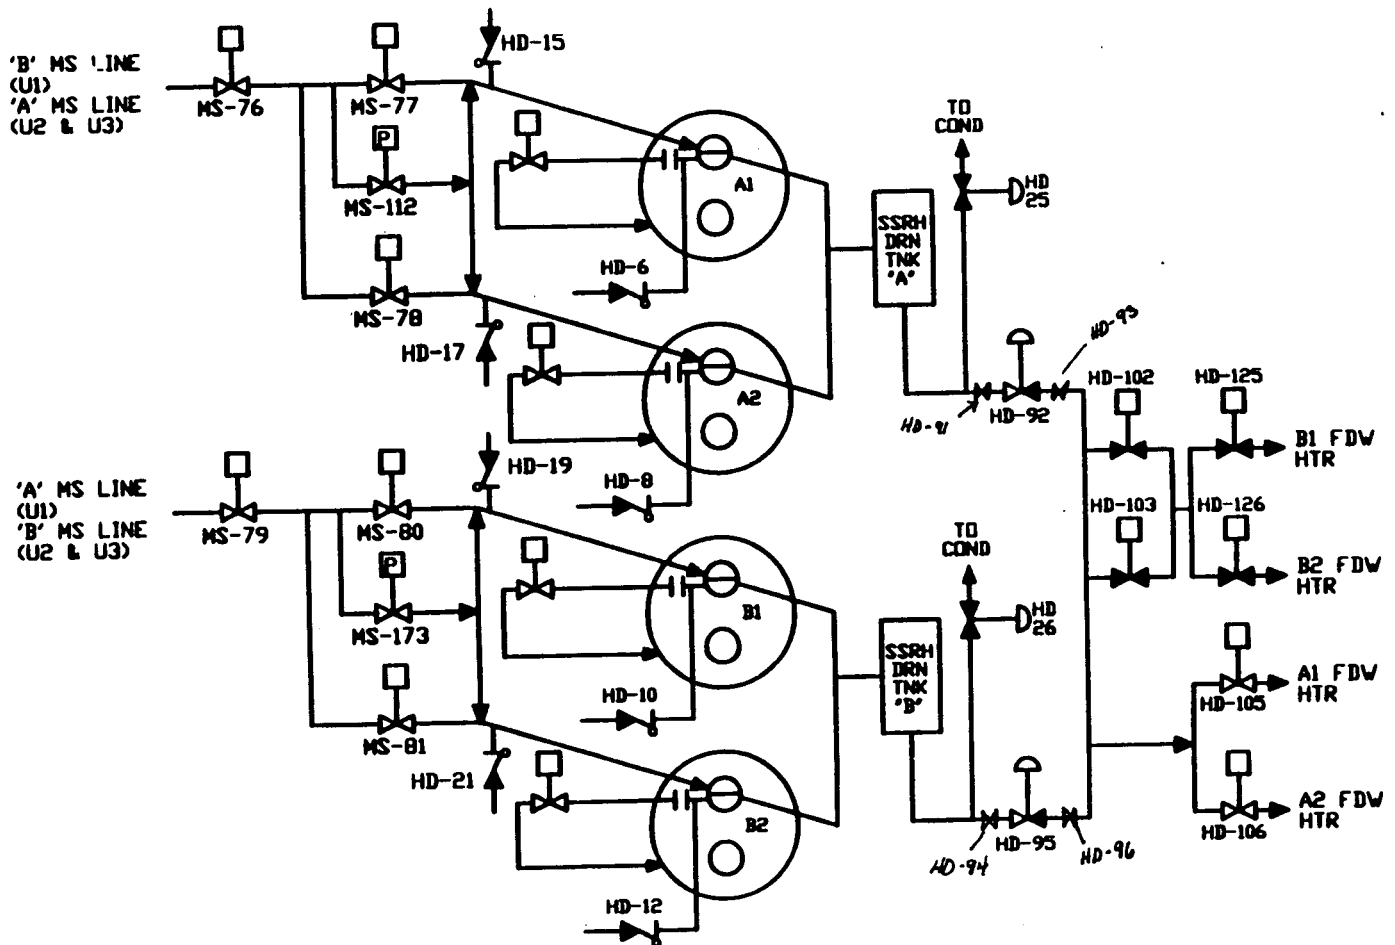
Attachment 1

On September 24, 1996, the Unit 2 Operations Coordinator verbally reminded the Unit 2 Shift Supervisor to open 2HD-91 and 2HD-94 at approximately 600 Mwe. (See Attachment 1)
