REGULATORY INFORMATION DISTRIBUTION SYSTEM (RIDS)

SUBJECT: LER 91-002-00: on 910408, flow transmitter found inoperable.
 Insp revealed that flow transmitter orifice of HPI Loop A
 installed backwards during 1980 installation. Indicated flow
 limit reversed & new orifices installed. W/910508 ltr.

Subject: Oconee Nuclear Station
Docket Nos. 50-269, -270, -287
LER 270/91-02

FACILITY NAME (1) Oconee Nuclear Station, Unit 2										DOCKET NUMBER (2) 0 5 0 0 0 2 7 0										PAGE (3) 1 OF 0 9																													
TITLE (4) Flow Orifice Installed Backwards Due to Unknown Cause Results in Degraded Emergency Core Cooling System During Certain Small Break Loss of Coolant Accident Scenarios																																																	
EVENT DATE (5)										LER NUMBER (6)										REPORT DATE (7)										OTHER FACILITIES INVOLVED (8)																			
MONTH			DAY			YEAR			YEAR			SEQUENTIAL NUMBER			REVISION NUMBER			MONTH			DAY			YEAR			FACILITY NAMES										DOCKET NUMBER(S)												
0 4			0 8			9 1			9 1			0 0 2			0 0 0 5			0 8			9 1													0 5 0 0 0															
OPERATING MODE (9) N										THIS REPORT IS SUBMITTED PURSUANT TO THE REQUIREMENTS OF 10 CFR 8: (C

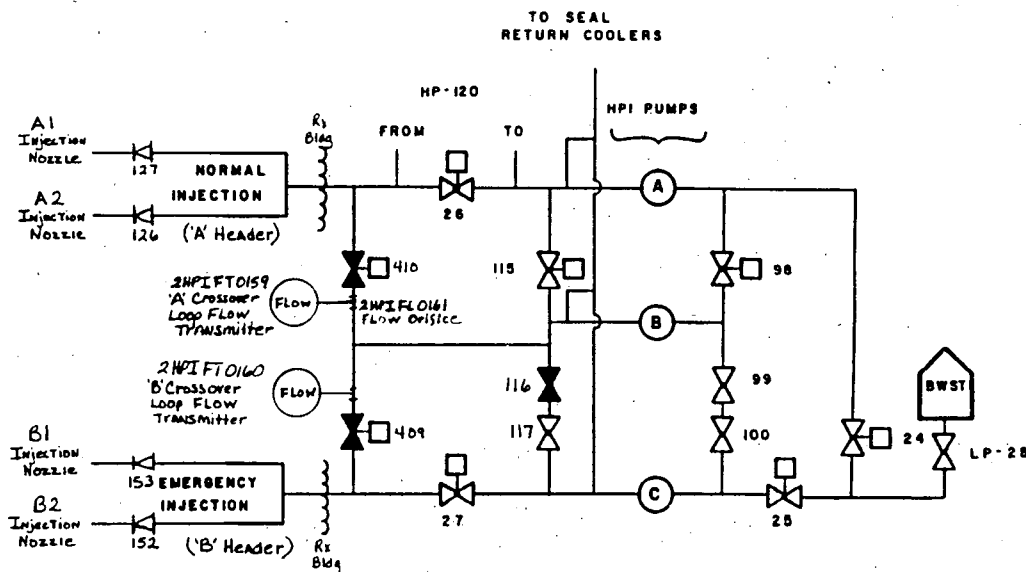
ATTACHMENT 1

The HPI System is also a part of the Emergency Core Cooling System (ECCS) which mitigates the consequences of loss of coolant accidents (LOCA). The HPI System prevents uncovering of the core for smaller break sizes, where high RCS pressure is maintained, and delays the uncovering of the core for intermediate break sizes. The HPI System, during emergency operation, supplies borated water to the RCS from the Borated Water Storage Tank (BWST). The HPI System has three parallel HPI pumps that have the capability to take suction from the BWST. The HPI pumps have the capability to discharge through two redundant flow paths into the RCS, utilizing four injection nozzles (two per flowpath). The injection nozzles are located on each of the reactor inlet pipes downstream of the Reactor Coolant Pumps. Each HPI flowpath is connected by piping and associated valves at each HPI pump discharge header, making up the 'A' and 'B' Crossover Flow loops. This cross-connect provides for remote manual alignment to ensure flow to the core through both HPI trains should a single failure of an HPI pump or HPI injection valve prevent automatic injection through one train. (See Attachment 1)

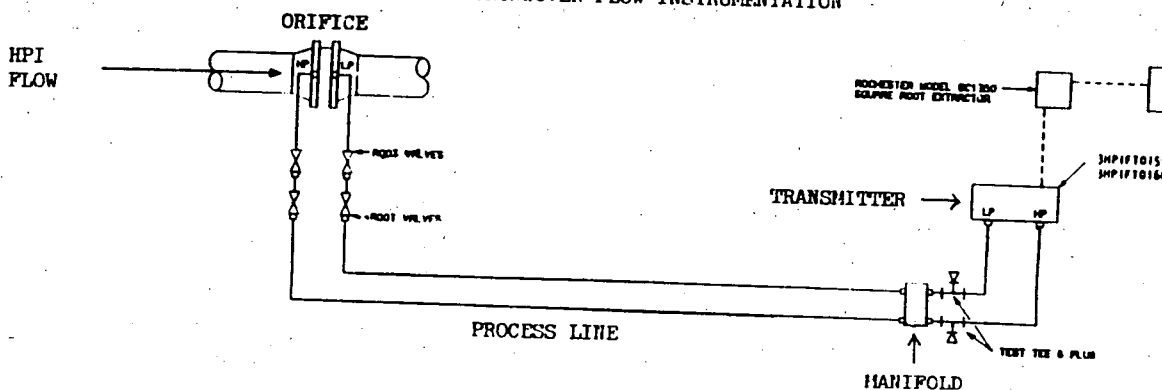
ATTACHMENT 2

An orifice plate is commonly used as a primary flow element, and produces a differential pressure from which a flow rate can be determined. Orifice plates usually have a handle on which pertinent data is permanently marked, such as orifice diameter, flange size, pressure rating, and as appropriate, the word "Inlet". On a beveled edge orifice plate that is properly installed, the word "Inlet" faces the inlet direction and the beveled edge faces the outlet direction. A beveled edge orifice plate that is installed backwards would provide a lower differential pressure across the flow element, resulting in a flow rate measurement that is lower than the actual flow rate.

As a corrective action for the event of the crossed impulse lines on Unit 3, Work Requests were issued for the other two Oconee Units to verify that the transmitters were connected to the process line correctly and to verify that the flow orifice plates were installed correctly. On April 8, 1991, at 1700 hours, Unit 2 HPI Crossover Flow orifice 2HPIFE0161, the primary flow element feeding 2HPIFT0159 flow transmitter, was discovered to be installed backwards.

The orifice plate that was found installed backwards was confirmed, by the identification number imprinted on the orifice, to be the same one that was installed in 1980. The orifice plate has the imprinted mark of "Inlet" stamped on the exposed portion of the plate and is facing the outlet direction of the flange in relation to the direction of flow within the piping. No other documentation was found that indicated that the orifice plate had ever been removed since the initial installation. However, this is not conclusive evidence that the orifice plate was never removed since 1980, although an extensive search of work history records was performed.

**HIGH PRESSURE INJECTION PUMP
CROSSOVER FLOW INSTRUMENTATION**

1. The reversed flow orifice will be reinstalled in the correct position during the next outage of sufficient duration.
2. All other flow orifices that are installed in safety related systems on all three units will be inspected to ensure correct installation.
3. Mechanical personnel having responsibility for installation of orifices, will be trained on the importance of proper installation and given training concerning the installation of basic types of orifices emphasizing the guidelines set forth in NRC Information Notice 90-69.
4. The Nuclear Station Modification Program will ensure that procedures to install orifice plates include instructions that define the direction of flow within the piping.
