SUBJECT: LER 91-002-01:on 910408,flow orifice installed backwards & would give inaccurate rate.Cause unknown.EOP revised to limit maximum indicated flow & other flow orifices installed in safety related sys.

Subject: Oconee Nuclear Station
Docket Nos. 50-269, -270, -287
LER 270/91-02, Revision 1

Oconee Nuclear Station, Unit 2

Flow Orifice Installed Backwards Due to Unknown Cause Results in Degraded Emergency Core Cooling System During Certain Small Break Loss of Coolant Accident Scenarios

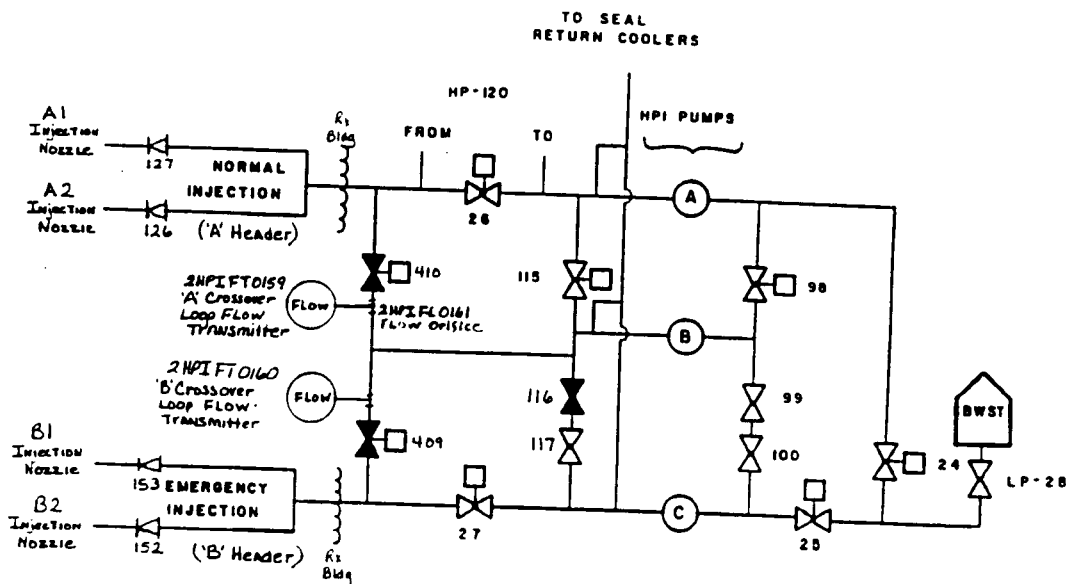
ATTACHMENT 1

The HPI System is also a part of the Emergency Core Cooling System (ECCS) which mitigates the consequences of loss of coolant accidents (LOCA). The HPI System prevents uncovering of the core for smaller break sizes, where high RCS pressure is maintained, and delays the uncovering of the core for intermediate break sizes. The HPI System, during emergency operation, supplies borated water to the RCS from the Borated Water Storage Tank (BWST). The HPI System has three parallel HPI pumps that have the capability to take suction from the BWST. The HPI pumps have the capability to discharge through two redundant flow paths into the RCS, utilizing four injection nozzles (two per flowpath). The injection nozzles are located on each of the reactor inlet pipes downstream of the Reactor Coolant Pumps. Each HPI flowpath is connected by piping and associated valves at each HPI pump discharge header, making up the 'A' and 'B' Crossover Flow loops. This cross-connect provides for remote manual alignment to ensure flow to the core through both HPI trains should a single failure of an HPI pump or HPI injection valve prevent automatic injection through one train. (See Attachment 1)

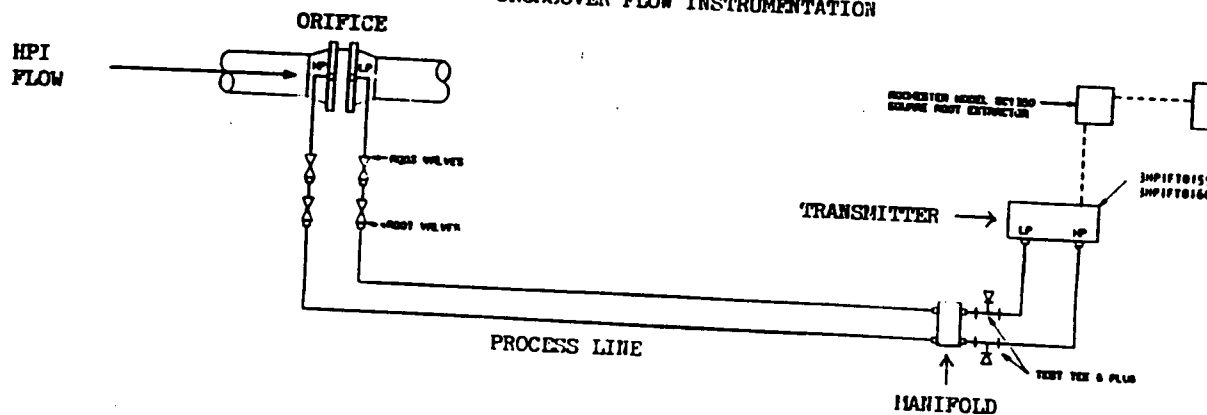
ATTACHMENT 2

As a corrective action for the event of the crossed impulse lines on Unit 3, Work Requests were issued for the other two Oconee Units to verify that the transmitters were connected to the process line correctly and to verify that the flow orifice plates were installed correctly. On April 8, 1991, at 1700 hours, Unit 2 HPI Crossover Flow orifice 2HPIFE0161, the primary flow element feeding 2HPIFT0159 flow transmitter, was discovered to be installed backwards.

The orifice plate that was found installed backwards was confirmed, by the identification number imprinted on the orifice, to be the same one that was installed in 1980. The orifice plate has the imprinted mark of "Inlet" stamped on the exposed portion of the plate and is facing the outlet direction of the flange in relation to the direction of flow within the piping. No other documentation was found that indicated that the orifice plate had ever been removed since the initial installation. However, this is not conclusive evidence that the orifice plate was never removed since 1980, although an extensive search of work history records was performed.

HIGH PRESSURE INJECTION PUMP CROSSOVER FLOW INSTRUMENTATION

1. The reversed flow orifice will be reinstalled in the correct position during the next outage of sufficient duration.
2. All other flow orifices that are installed in safety related systems on all three units will be inspected to ensure correct installation.
3. Mechanical personnel having responsibility for installation of orifices, will be trained on the importance of proper installation and given training concerning the installation of basic types of orifices emphasizing the guidelines set forth in NRC Information Notice 90-65.
4. The Nuclear Station Modification Program will ensure that procedures to install orifice plates include instructions that define the direction of flow within the piping.
