SUBJECT: LER 91-003-00:on 910416,both trains of HPI sys, (ECCS) declared inoperable due to excessive LDST pressure.Cause unknown.Excessive hydrogen vented into GWD sys to reduce LDST pressure.W/910516 ltr.

Subject: Oconee Nuclear Station
Docket Nos. 50-269, -270, -287
LER 270/91-03

LICENSEE EVENT REPORT (LER)

FACILITY NAME (1) Oconee Nuclear Station, Unit 2										DOCKET NUMBER (2) 0 5 0 0 0 2 7 1 0										PAGE (3) 1 OF 1				
TITLE (4) Excessive Letdown Storage Tank Pressure for Unknown Reason Makes High Pressure Injection System Inoperable																								
EVENT DATE (5)			LER NUMBER (6)				REPORT DATE (7)			OTHER FACILITIES INVOLVED (8)														
MONTH	DAY	YEAR	YEAR	SEQUENTIAL NUMBER	REVISION NUMBER	MONTH	DAY	YEAR	FACILITY NAMES						DOCKET NUMBER(S)									
0	4	1	6	9	1	9	1	0	0	3	0	0	0	5	1	6	9	1	0 5 0 0 0					
OPERATING MODE (9) N		THIS REPORT IS SUBMITTED PURSUANT TO THE REQUIREMENTS OF 10 CFR §. (Check one or more of the following) (11)																						
POWER LEVEL (10) 1 0 0		20.402(b)				20.406(c)				50.73(e)(2)(iv)				73.71(b)

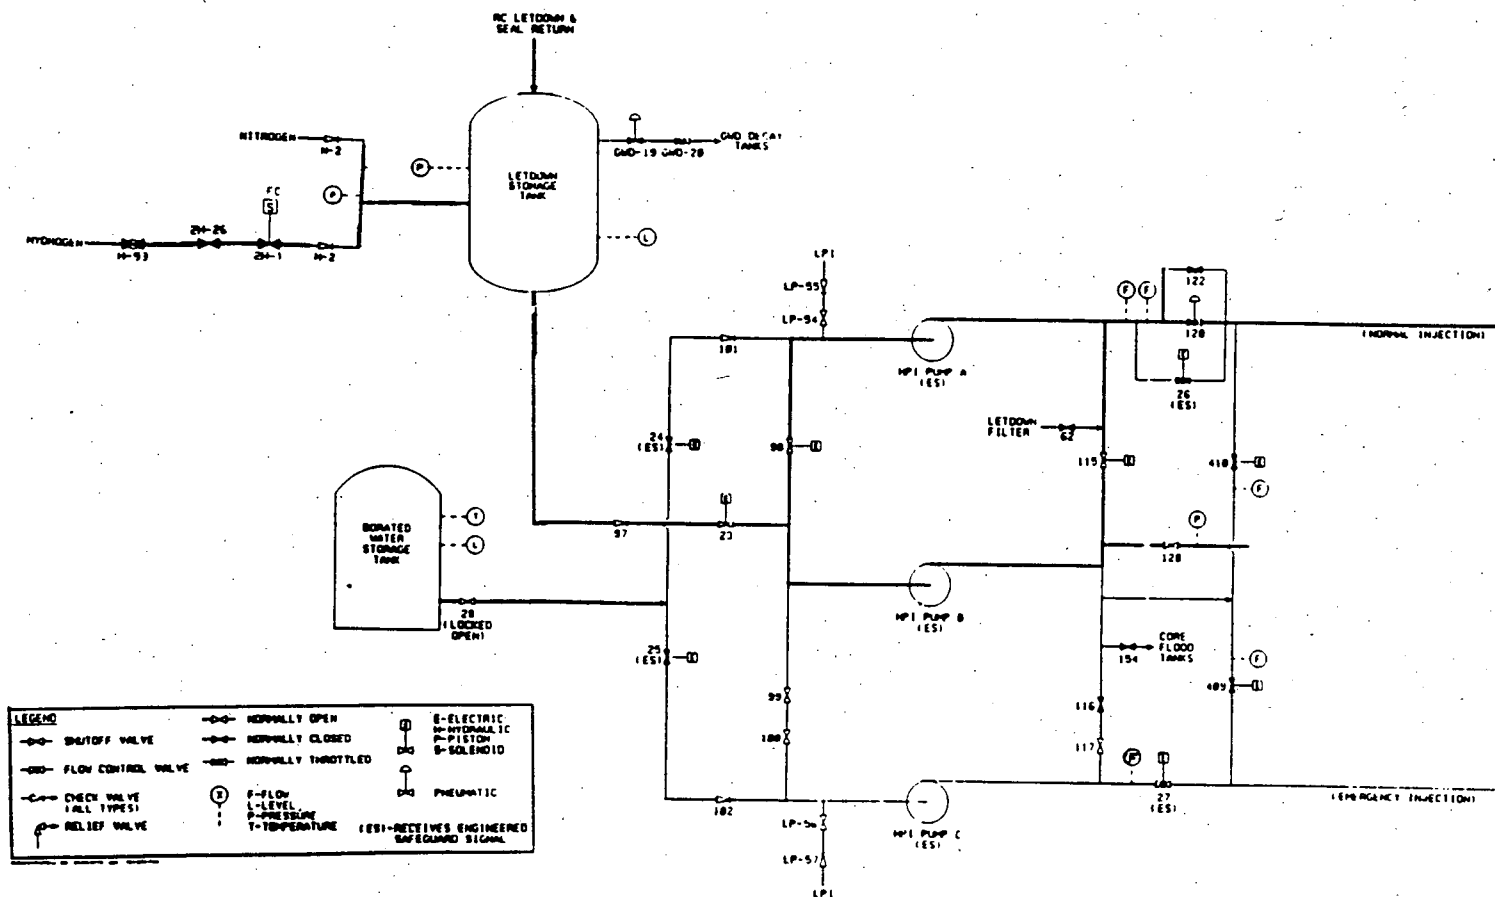
ATTACHMENT B

The HPI System is also a part of the Emergency Core Cooling System (ECCS) which mitigates the consequences of loss of coolant accidents (LOCA). The HPI System prevents uncovering of the core for smaller break sizes, where high RCS pressure is maintained, and delays the uncovering of the core for intermediate break sizes. The HPI System, during emergency operation, supplies borated water to the RCS from the Borated Water Storage Tank (BWST). The HPI System has three parallel HPI pumps that have the capability to take suction from the BWST and to discharge through two redundant flow paths into the RCS, utilizing four injection nozzles (two per flow path). The injection nozzles are located on each of the reactor inlet pipes downstream of the Reactor Coolant Pumps. (See Attachment B)
