SUBJECT: LER 92-002-00: on 920210, TS violation occurred due to
 pressurizer safety relief valve actuation. Caused by setpoint
 error. Test procedures changed. W/920325 ltr.

Oconee Nuclear Station, Unit 2

Pressurizer Safety Relief Valve Actuation Setpoint Error Due To
Defective Procedure Results In A Technical Specification Violation

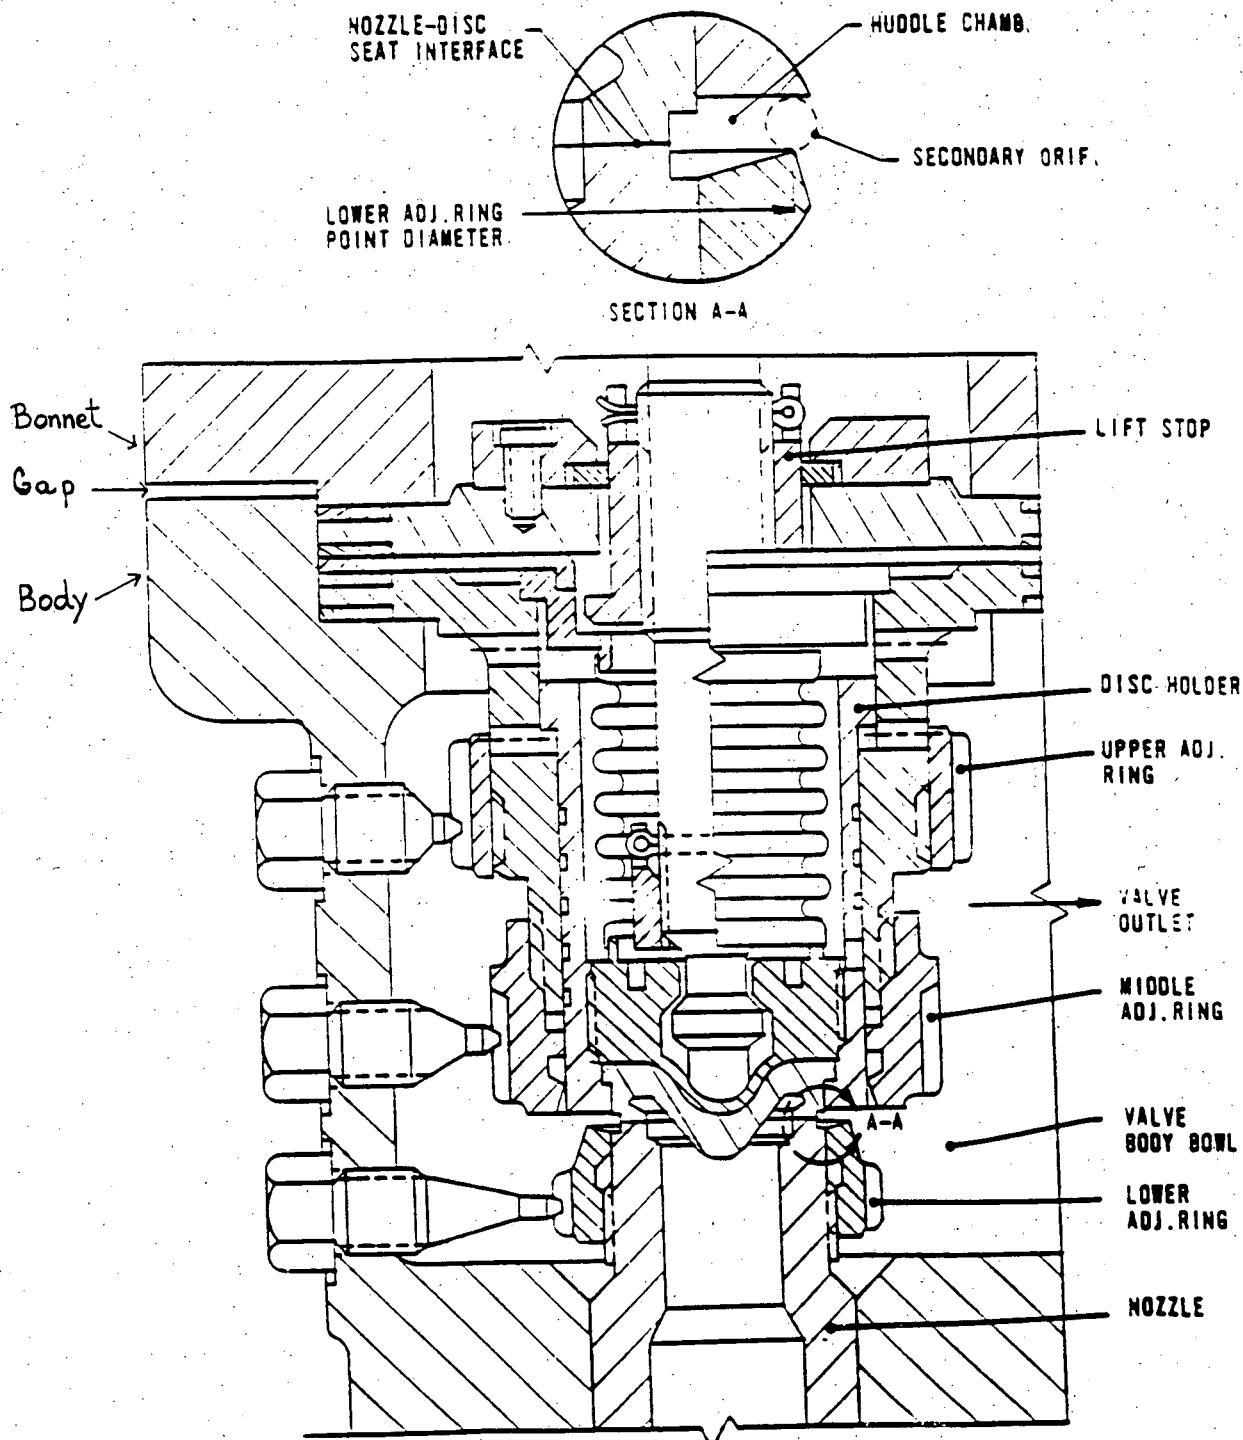
FIGURE 1
VALVE OPENING

If valves are leaking during the steam setpoint verification test, the valves' huddle chamber (see Figure 1) could become pressurized, effectively increasing the valve seat area. With this larger area, a lower pressure could then produce sufficient force to lift the disc. If the leak was later repaired as was done with the jack and lap process, this would result in a higher actual setpoint if retesting on steam is not performed.

The jack and lap process is a partial disassembly of the valve while maintaining spring pressure. This process is used to polish the valve seats, often in preparation for a final gaseous nitrogen leakage test. This disassembly process obviously can introduce some small error into the as-tested setpoint since it is very difficult to reassemble the valve exactly as it was found.

To improve the jack and lap process, the procedure was changed to require reestablishment of the bonnet-to-body gap (see Figure 1) as well as a subsequent steam setpoint verification test.
