FACIL: 50-270 Oconee Nuclear Station, Unit 2, Duke Power Co.

SUBJECT: LER 92-004-00: on 921019, loss of offsite power, generator load rejection & trip from 100% power occurred, causing spurious breaker failure relay actuations. Caused by mgt deficiency. Switchyard restored to normal status. W/921118 ltr.

Subject: Oconee Nuclear Site
Docket Nos. 50-269, -270, -287
LER 270/92-04

TITLE (4) Loss of Off-site Power and Unit Trip Due to Management Deficiency, Less Than Adequate Corrective Action Program

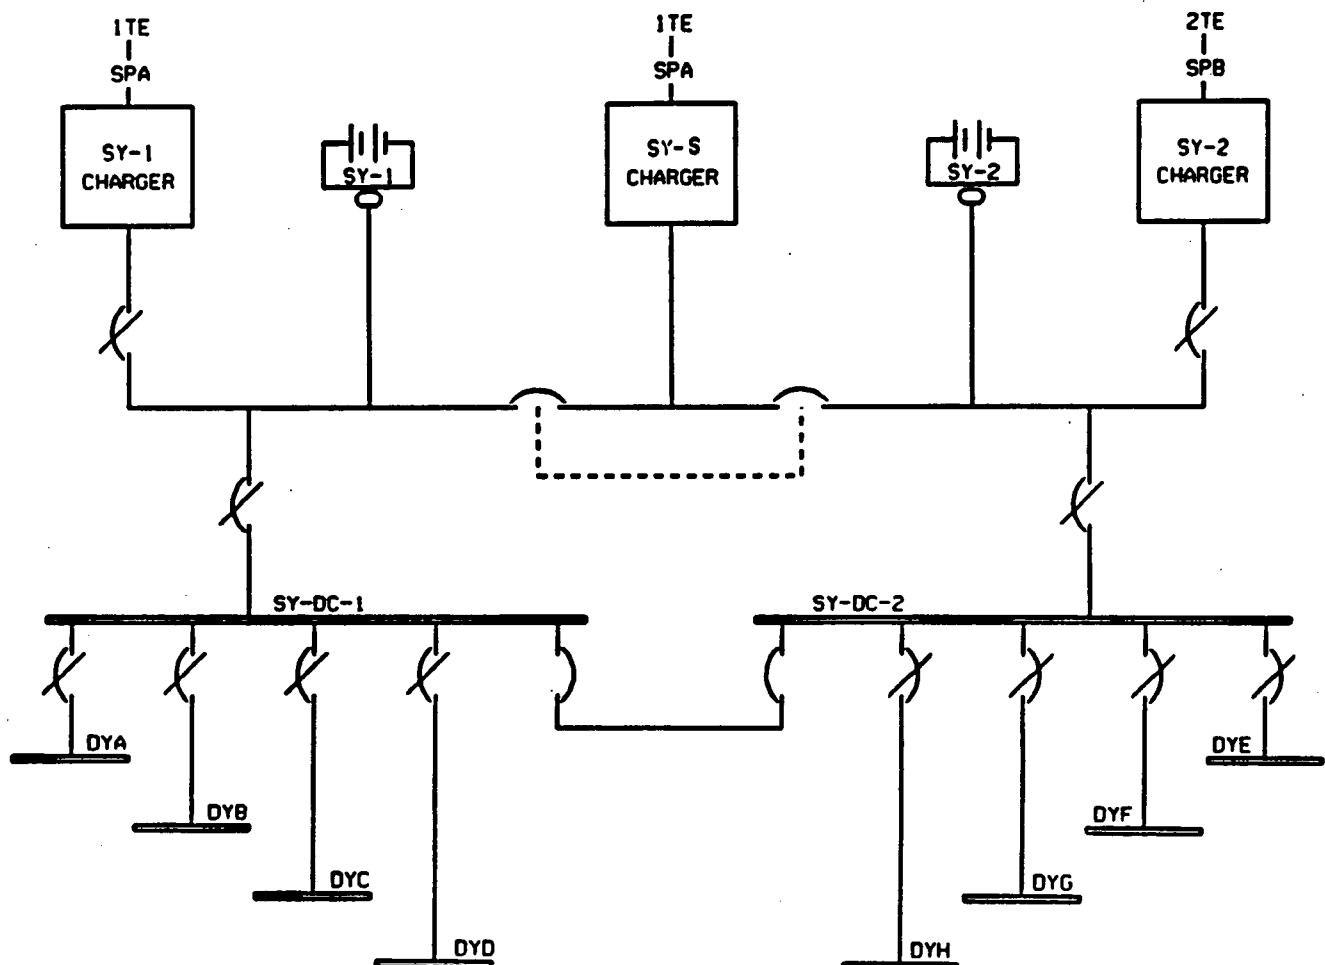
230KV SWITCHYARD DC POWER DISTRIBUTION

Subsequent investigation revealed that the SY-2 charger did not maintain bus voltage at approximately 130 VDC as expected. When tested using test instrumentation rather than the built-in output voltage meter, a series of rapid voltage swings occurred such that its voltage output exceeded 200 VDC. It was observed that the output voltage meter did not indicate the full magnitude of these swings as the seen by the test equipment. The vendor manual for the battery charger provides some specifications for current and voltage stability while connected to a battery, but no data is given for operation without a battery. No specific statement prohibits operation without a connected battery, but the setup instructions call for connecting a battery, and wording indicates that connection to a battery is assumed.

The observed voltage swings exceeded the ratings of several relays connected to the SY-2 bus, including the breaker failure relays for all PCBs in the SWYD. The investigation also revealed that, in 1980, the vendor of the breaker failure relays had sent out "Product Reliability Letters" stating that these relays could actuate spuriously if exposed to a 200 VDC differential for greater than 2 milliseconds. The letters also contained

Three specific factors combined to produce this event. First, the breaker failure relay zener diodes would pass a spurious signal when subjected to greater than 200 VDC for 2 milliseconds or longer. Second, the 230 KV Switchyard DC power system was being operated with the battery isolated from the SY-2 bus and with the battery charger as the only source of voltage. Third, the SY-2 battery charger, when operated in this configuration, produced an output voltage which varied from approximately 70 to over 200 VDC.

1. The modification procedure was revised to maintain SY-1 and SY-2 tied together and powered from SY-1 for the rest of the battery replacement.
2. The breaker failure relays in the switchyard were modified per vendor instructions. Similar breaker failure relays in the switchyard at Duke Power's McGuire Nuclear Station were also modified.
