FACIL:50-270 Oconee Nuclear Station, Unit 2, Duke Power Co.

SUBJECT: Special rept:on 930630, valve packaging event occurred due to equipment failure. Leakage cleaned up, area decontaminated, studs on valve 2HP-64 replaced & valve vendor contacted for assessment of problem relative to 10CFR21 considerations.

Subject: Oconee Nuclear Station
Docket Nos. 50-269, -270, -287
Special Report Concerning Manual
Start of Engineered Safeguards Pump

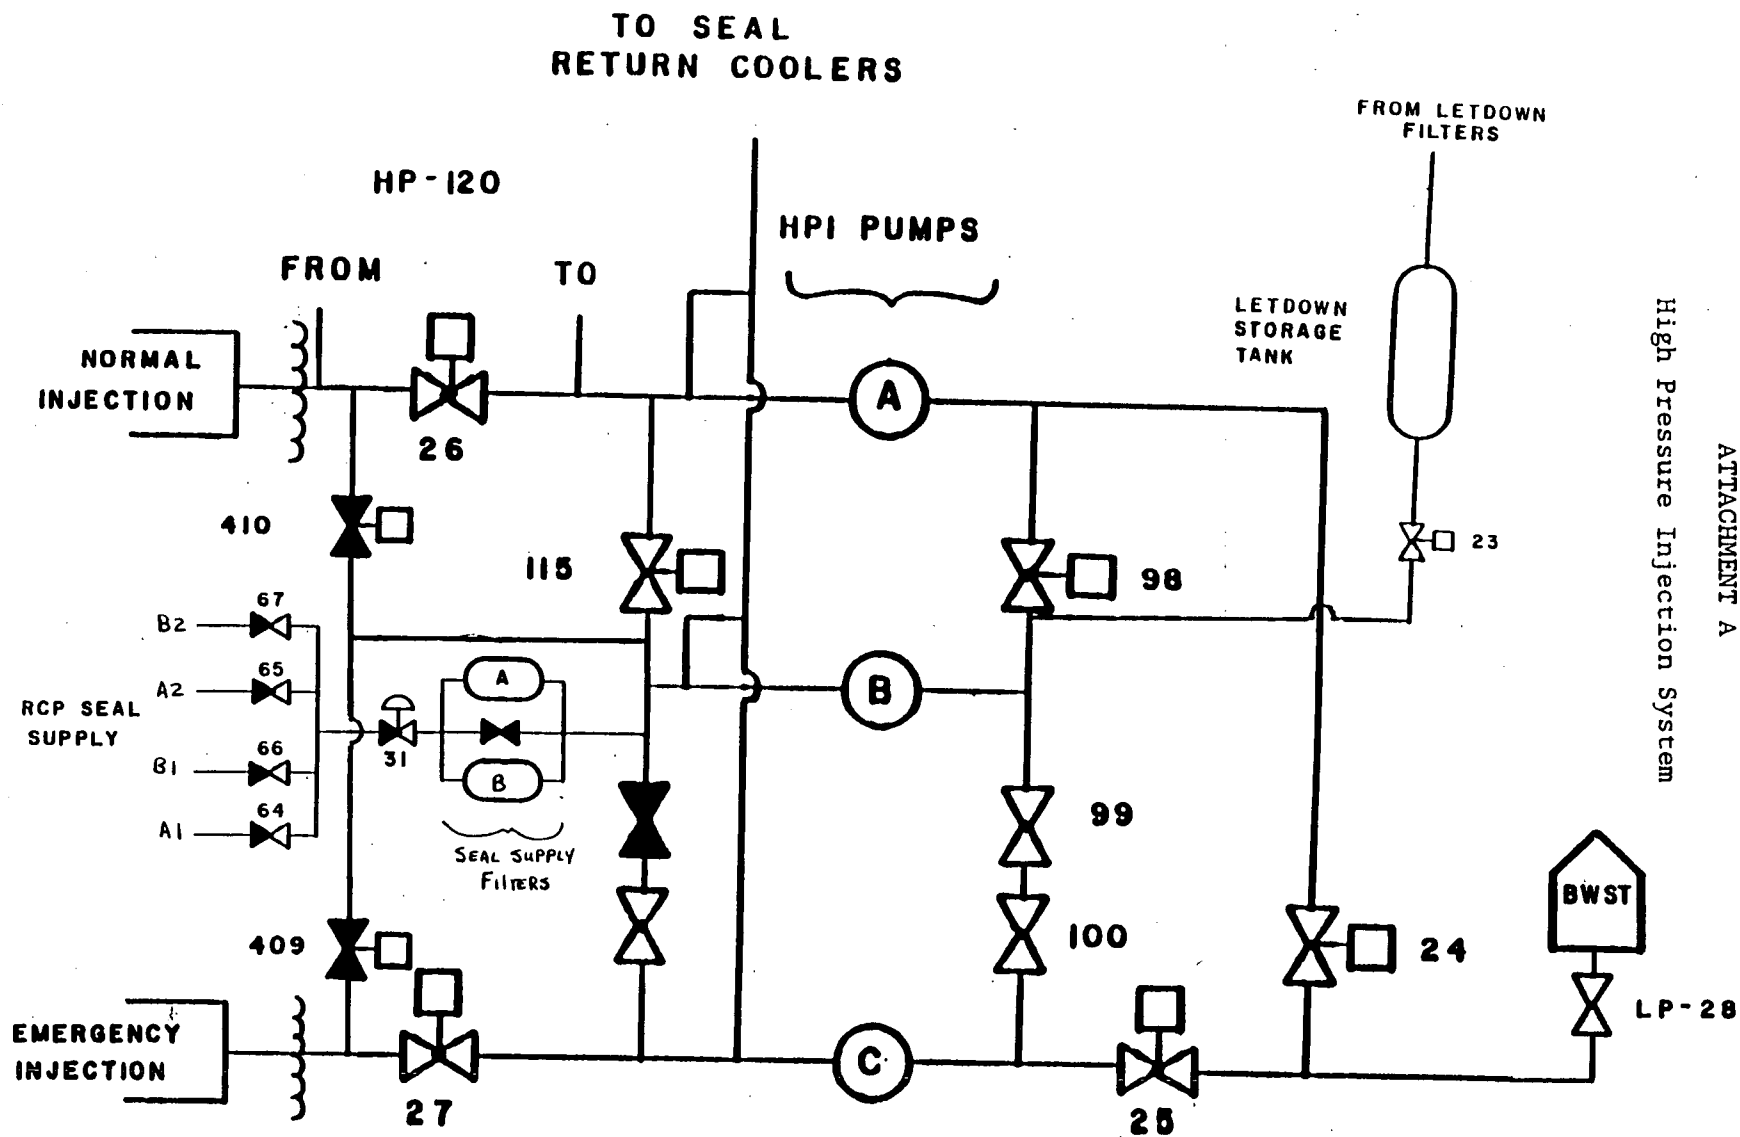
ATTACHMENT A

The High Pressure Injection (HPI) System [EIIIS:BQ] is a part of the Emergency Core Cooling System which mitigates the consequences of loss of coolant accidents. The HPI System prevents uncovering of the core for smaller break sizes, where high Reactor Coolant System (RCS) [EIIIS:AB] pressure is maintained, and delays the uncovering of the core for intermediate break sizes. The HPI System, during emergency operation, supplies borated water to the RCS from the Borated Water Storage Tank (BWST). The HPI System has three parallel HPI pumps that have the capability to take suction from the BWST and to discharge through two redundant injection flow paths into the RCS. (See Attachment A)

The Operators took corrective action in accordance with AP/2/A/1700/14, Loss of Normal HPI Make-up and Letdown. At 1055 hours, the Operators started HPI pump 2A. At 1058 hours, valve 2HP-115, the HPI discharge header separation valve, was closed to isolate the seal injection header from the normal make-up line, which is also used for Emergency Core Cooling Flow. This made HPI pump 2B unavailable for Engineered Safeguards actuation and a 72 hour LCO was entered per TS 3.3.1. Then HPI pump 2B was secured at 1100 hours and 2HP-31, Seal Flow Control Valve, was closed. These actions isolated seal injection to all four RCPs and stopped the leak. (The effect on RCP seal operation is discussed below.) Operators also closed 2HP-138, Seal Flow Control Inlet Valve, and 2HP-283, Seal Supply to RCP 2A1 Outside Stop Check Valve, in order to further isolate 2HP-64 for maintenance. Operations personnel estimated that a total of approximately 550 gallons leaked from the HPI system to the Auxiliary Building during this event.

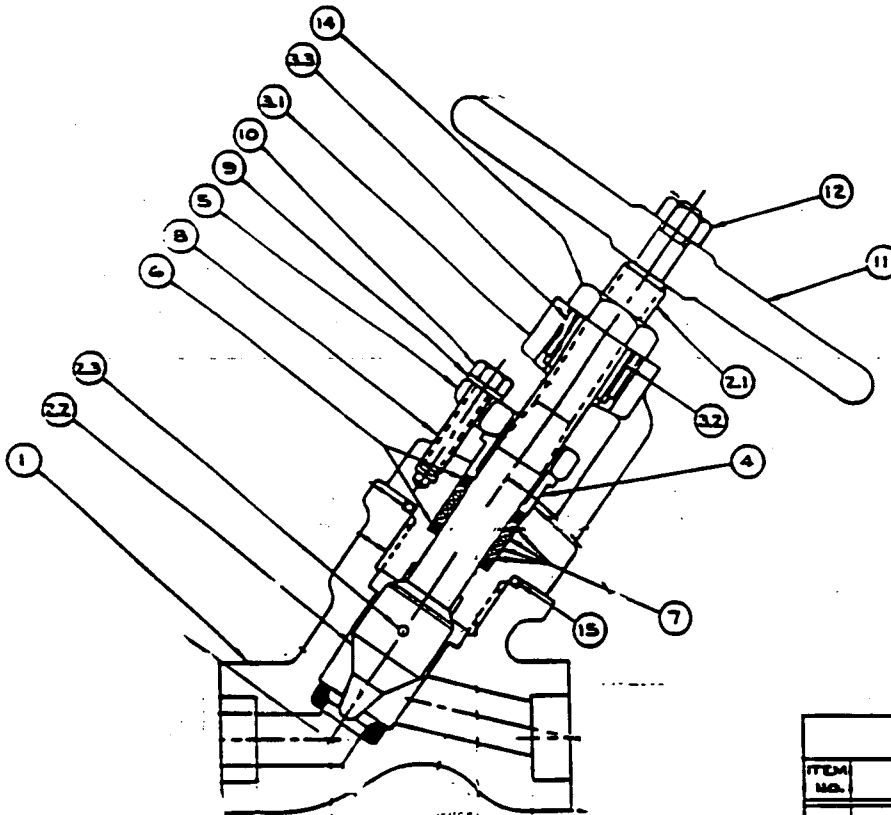
ATTACHMENT B

Valve 2HP-64 (see Attachment B) is a manual throttle valve used to regulate the seal supply flow to RCP 2A1. It is a 1/2 inch, stainless steel, packed y-globe throttle valve, manufactured by Kerotest and has been in service since March, 1988. The gland studs are 1/4 inch in diameter and are made of cadmium plated ASTM A193, Grade B7 material.

According to MT-A, he tightened the gland nuts in 1/2 turn increments, alternating between the two nuts. At approximately 1015 hours, after approximately 1 and 1/2 turns, one of the studs broke. (Subsequent examination showed that it sheared at the surface of the valve bonnet.) The gland and gland follower were pushed up the stem by system pressure until the gland was cocked at an angle, held by the single remaining stud and nut. The packing leak increased from minor seepage to a more noticeable level.

MT-A dressed out in paper anti-contamination clothing. He also went to the hot tool storage area to get additional tools and a 4 inch C-clamp. Upon his return to the valve, MT-A attempted to install the C-clamp on the valve stem. However, at approximately 1030 hours, while he was doing this, the second gland stud also broke, allowing the gland and gland follower to back out completely. System pressure ejected the packing, and High Pressure Injection (HPI) system water began spraying out of the valve.

The broken studs were sent to the Duke Power Applied Science Center laboratory for analysis. The laboratory examination confirmed that the studs composition and structure was consistent with ASTM A193, Grade B7 material with cadmium plating. The stud which broke first had a rust deposit indicating that failure had occurred in at least two steps. The laboratory examination found evidence of ductile failure at both the initiation and final fracture points, with propagation by mixed intergranular and ductile fracture. The second stud showed mixed microvoid and intergranular fracture. The laboratory report concluded that hydrogen had been absorbed into the metal, possibly during the cadmium plating process, causing hydrogen embrittlement.

The initiating cause of this event is equipment failure. Both gland studs broke during the attempt to tighten the valve packing. The Root Cause of the event is Design/Manufacturing Deficiency, (Material Deficiency, apparently resulting from the manufacturing process). Laboratory tests indicate that hydrogen, presumed to be introduced during the cadmium plating process, induced embrittlement which weakened the gland studs.

1. The studs on 2HP-64 were replaced, the valve repacked, and the system was returned to service.
2. Component Engineering inspected the packing gland studs on the other seal supply throttle valves for all three Oconee Units.

1. During the next appropriate outage of sufficient duration on each unit, the valve packing gland studs (or the entire valves) on all seal supply throttle valves will be replaced.
2. Site Engineering will contact the valve vendor for assessment of the defective stud problem relative to 10CFR21 considerations.
