LICENSEE EVENT REPORT (LER)

Oconee Nuclear Station, Unit 2

TITLE (4) Operation With Steam Generator Tube Indications In Excess Of Limits
Due To Manufacturing Error

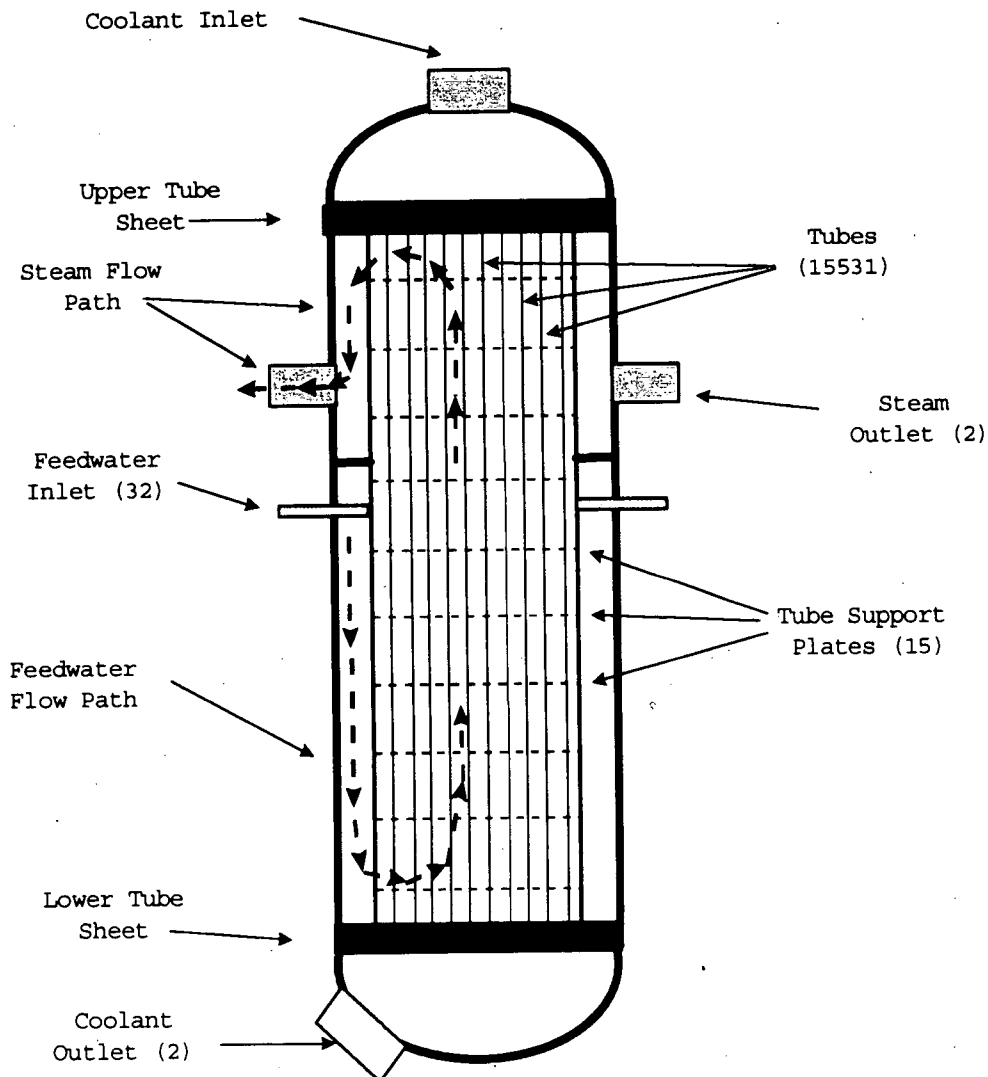
Attachment A**Oconee Unit 2A OTSG****Vertical Cross Section**

Oconee Nuclear Station uses the Babcock and Wilcox (B&W) Nuclear Steam Supply System [EIIS:AC], which includes two Once Through Steam Generators (OTSGs) [EIIS:SG], for primary to secondary heat transfer. The B&W OTSG is a vertical, straight tube heat exchanger. The OTSGs are 73 feet tall, and approximately 13 feet in diameter. Inside the OTSG shell, there is an upper tube sheet, 15 tube support plates, a lower tube sheet, and 15531 tubes per steam generator. See Attachment A.

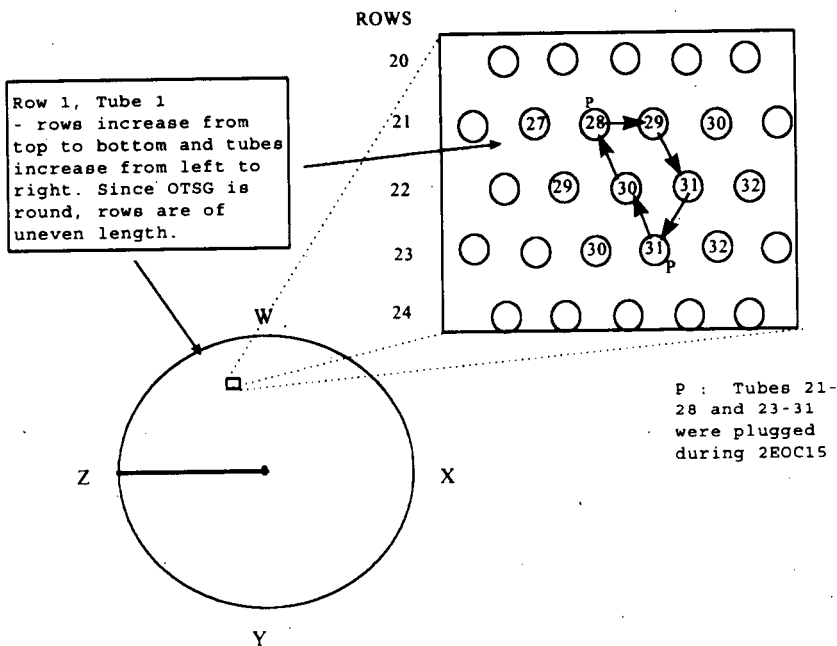
Attachment B

For identification purposes, tubes are designated by row and tube co-ordinates. The row numbers start on one edge of the tube sheet and tube numbers start at the beginning of each row and count up. See Attachment B. By design, the tubes go "straight" through the OTSG, such that a tube should penetrate the upper and lower tube sheets at the same co-ordinates. All tube inspections and repairs are accomplished using the assumption that these tube locations are as designed. Tube examinations are often executed by running different test probes from the upper and lower tube-sheets. Tube repair, by plugging, requires locating the tube end location from each tube-sheet and removing the tube from service by installing a plug at each end. For each activity, the positive identification of the tube by its co-ordinates on the respective tube-sheet is essential. There is not a requirement that the tube be verified to be in the same tube "hole" in each tube-sheet.

By inserting a probe in a given tube hole in the upper tube sheet (UTS) and verifying where it either exited the lower tube sheet (LTS) or encountered an obstruction, the investigation determined that five tubes exited the UTS in a different location (co-ordinate). These five tubes are "rotated" or mis-aligned at some point along their axial length in the OTSG, such that, for a given tube hole in the UTS, the tube does not match up to the corresponding tube hole in the LTS. See Attachment B. This type of error could only have occurred during original fabrication of the OTSG prior to shipment to Oconee.

The five affected tubes in the 2A OTSG are at UTS locations 21-28, 21-29, 22-30, 22-31, and 23-31. The relationship is that the tube in location 21-29 in the UTS comes out in location 22-31 in the LTS. Location 22-31 in the UTS is 23-31 in the LTS, 23-31 in the UTS is 22-30 in the LTS, 22-30 in the UTS is 21-28 in the LTS, and 21-28 in the UTS is 21-29 in the LTS.

Arrows indicate tube exit location
in Lower Tubesheet

After this in-situ testing, the five mis-aligned tubes were plugged to remove them from service.
