| United States Nuclear Regulatory Commission Official Hearing Exhibit In the Matter of: CROW BUTTE RESOURCES, INC. (License Renewal for the In Situ Leach Facility, Crawford, Nebraska) | |

Previously Recorded Sites

25DW00-243 (2368-S016)

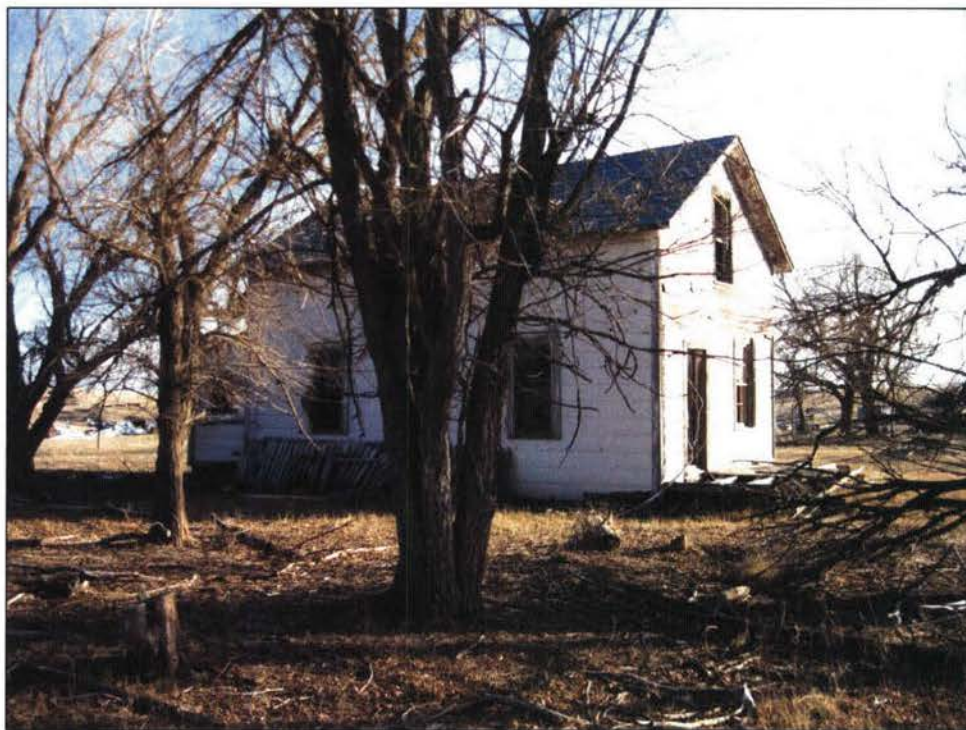
Site 25DW00-243 is a historic homestead located in Section 7 T50W R29N, east and west of Hollibaugh Road (**Figures 130 and 153**). The Nebraska State Historic Preservation Office, in cooperation with the Nebraska State Historical Society, completed a historic building inventory of Dawes County in 2005 that identified the main farmhouse (Feature F2) as DW00-243, an abandoned house built circa 1890.

Figure 130. 25DW00-243, overview, facing southeast. Photograph taken by Ashley Howder on 12/05/101.

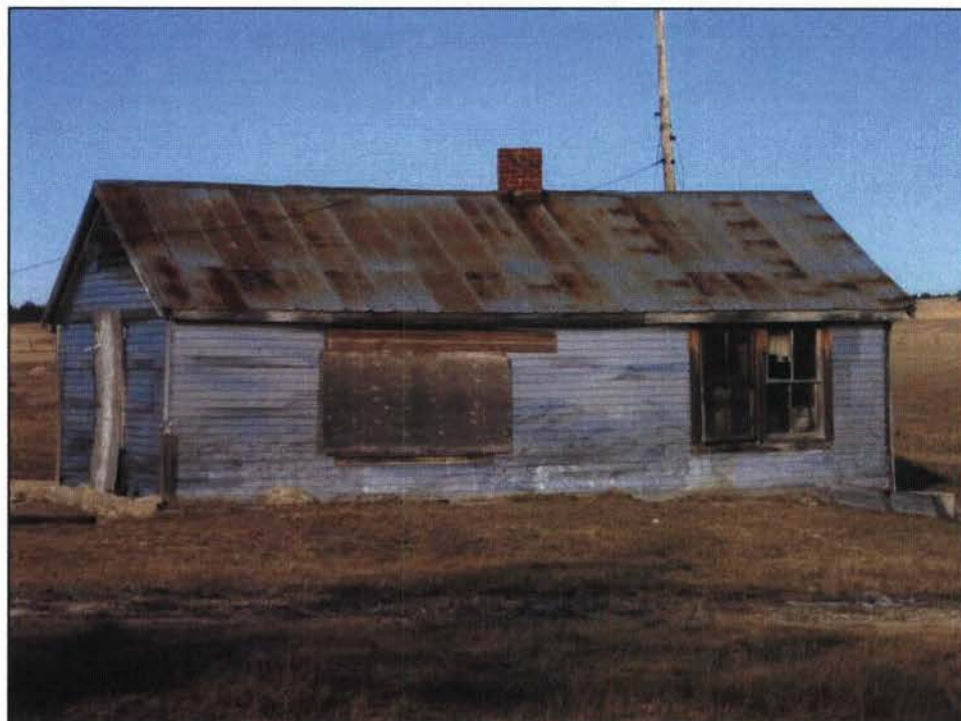
One small house (Feature F1) has a rectangular floor plan measuring 16 feet by 32 feet (**Figure 131**). Feature F1 has a metal roof, metal siding, a brick chimney, two rooms, a white enamel washing machine, and interior shelving. This small structure appears to have functioned as a house and a laundry shed. There are pieces of concrete from a foundation that surround the base of the house for landscaping purposes as opposed to supporting the structure. At the time of abandonment, the structure had electricity as evidenced by electrical outlets and light fixtures remaining in the structure.

Figure 131. 25DW00-243, house (Feature F1), facing northeast. Photograph taken by Ashley Howder, on 12/05/2010.

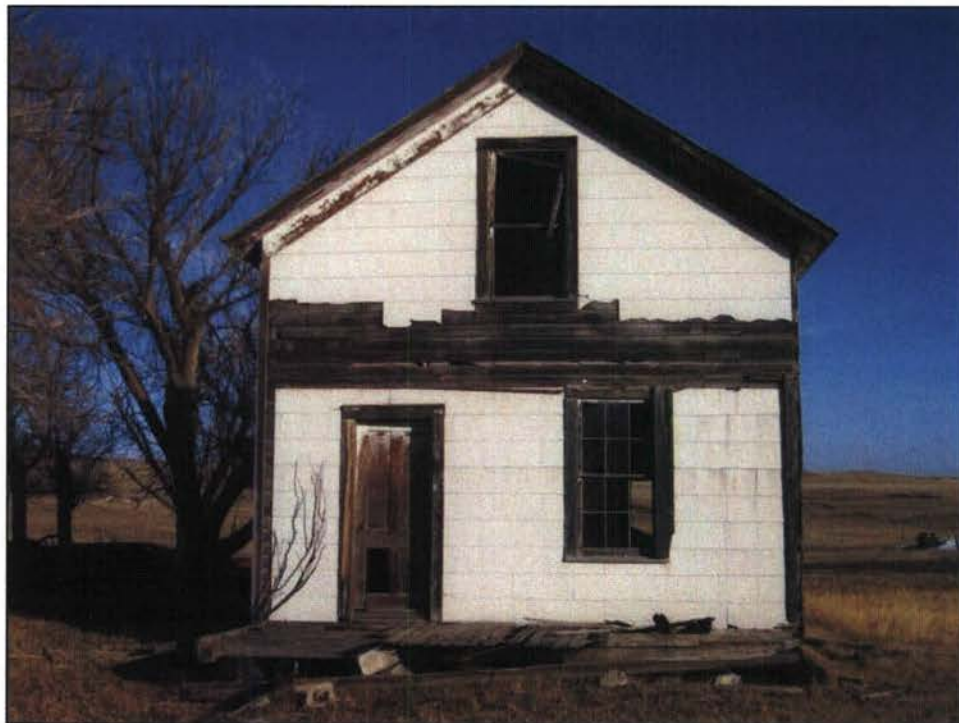
The main farmhouse (Feature F2) is located on the east side of Hollibaugh Road and is a one and a half story front gable house with 6/6 windows, a four panel door, 4+ rooms, and an addition on the back or east side of structure (**Figure 132 and 133**). The farmhouse (Feature F2) has a rectangular floor plan that measures 36 feet by 18 feet, has composite and white horizontal wood siding, wide fascia board, and a rolled asphalt roof. The front door is accessed by way of a small wooden front porch that is in poor condition on the west face of the house and opens into a living room. Inside the main room is a curved stair case leading to the upper story (**Figure 132**). The upper story appears to have a finished interior. There is a lumber stamp reading "6-61" on the upper northwest corner of the south face of the house (**Figure 134**). At the time of abandonment, the house had electricity as evidenced by light fixtures and electrical appliances remaining in the structure. There are two outbuildings in the direct vicinity of the main farmhouse, a wood frame house that has been converted into a washing shed (Feature F1) 210 feet northeast and one side gable storage shed (Feature F3) 70 feet southwest. One 1953 Willys Overland pickup truck and several wagons are parked behind, or on the east side, the house (**Figure 135**).

Figure 132. 25DW00-243, house (Feature F2), facing east. Photograph taken by Ashley Howder, on 12/05/2010.

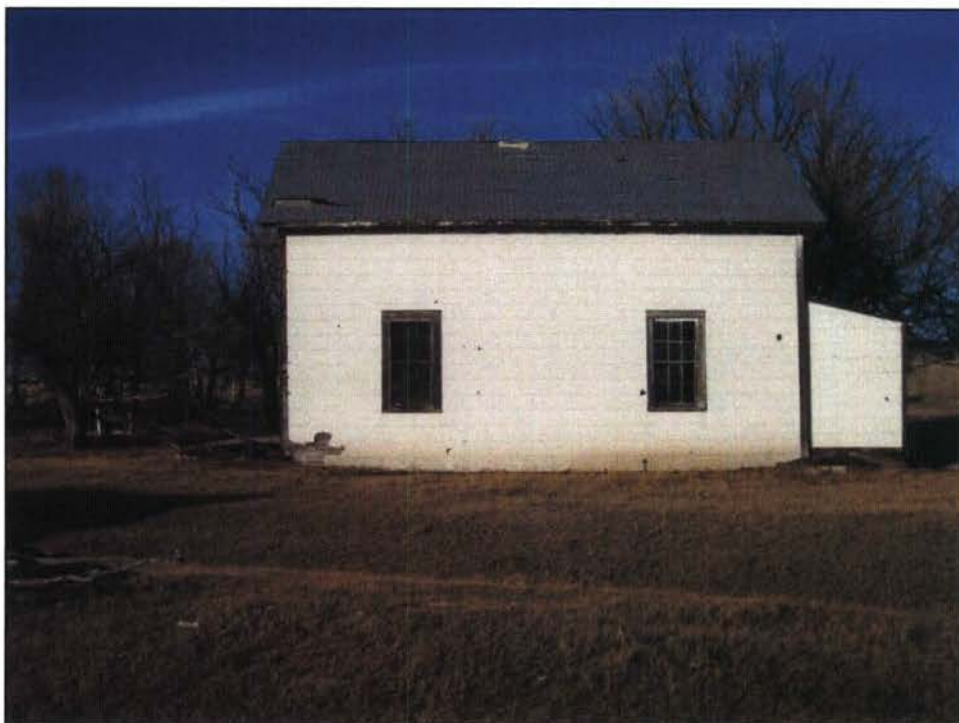
Figure 133. 25DW00-243, south face of main house (Feature F2) showing shed roof addition, 6/6 windows, siding, and asphalt roof, facing north. Photograph taken by Ashley Howder, on 12/05/2010.

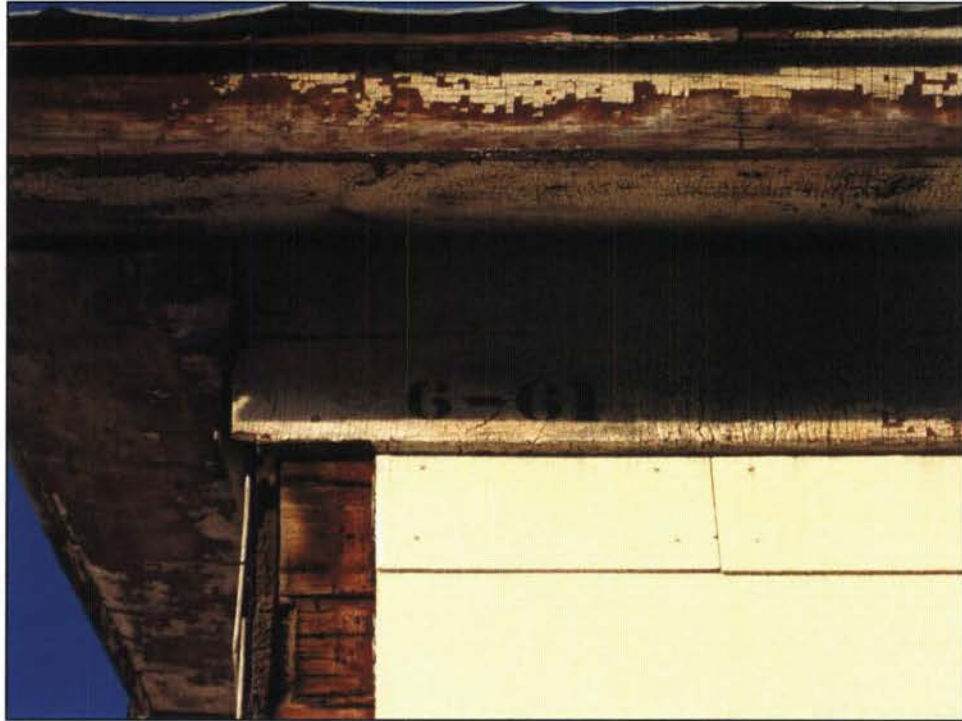
Figure 134. 25DW00-243, south face of main house (Feature F2) showing lumber stamp "6-61", facing north. Photograph taken by Ashley Howder, on 12/05/2010.

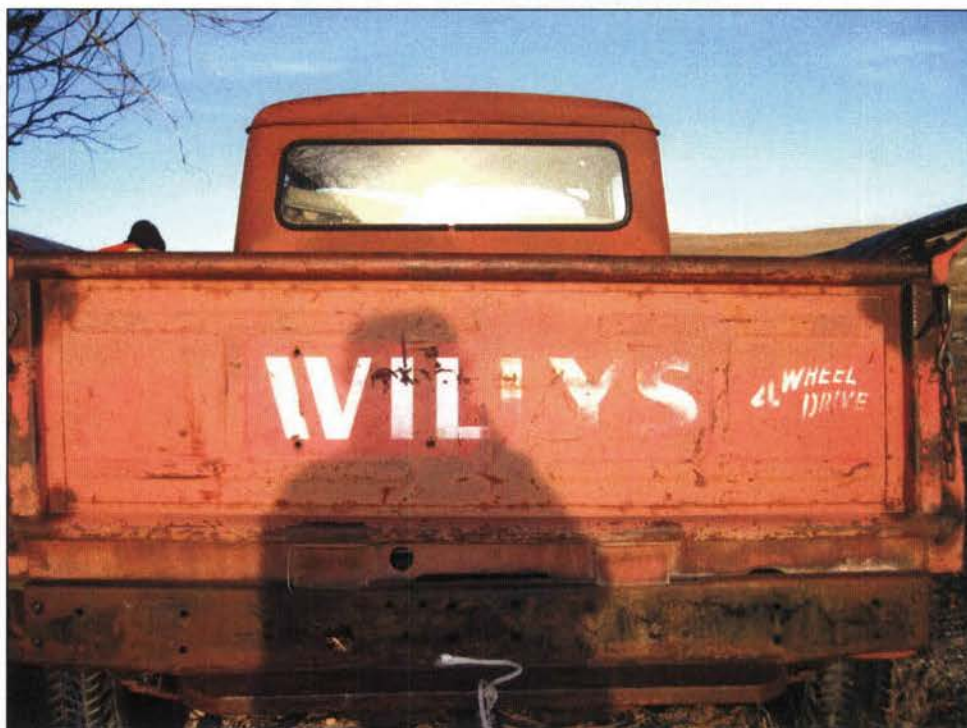
Figure 135. 25DW00-243, 1953 Willys Overland pickup truck, facing northeast. Photograph taken by Ashley Howder, on 12/05/2010.

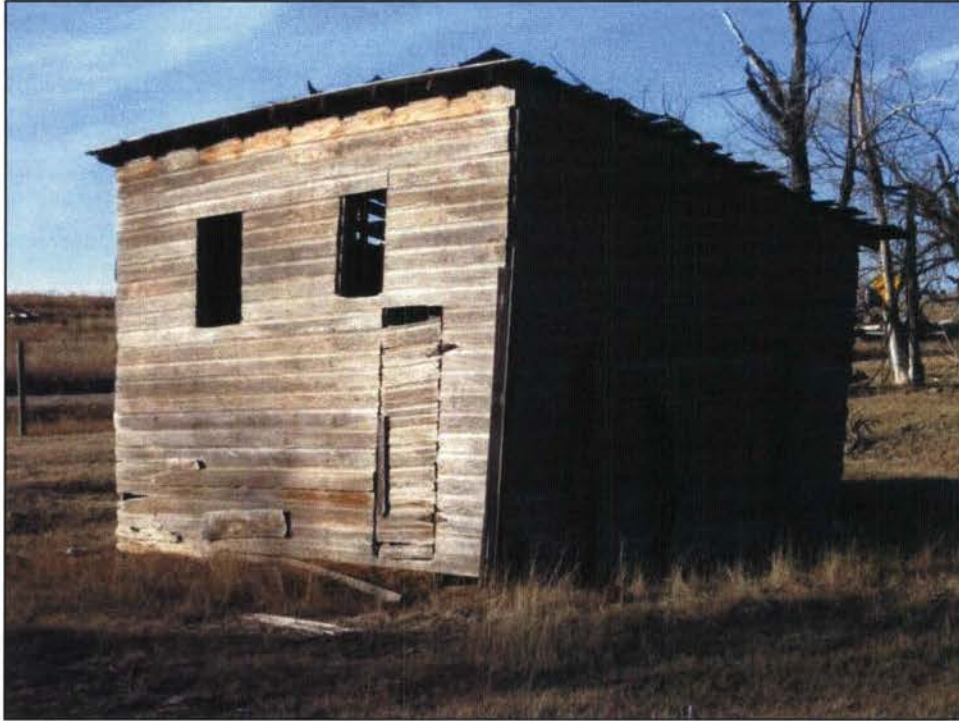
The side gable storage shed (Feature F3) has a rectangular floor plan measuring 10 feet by 16 feet (**Figure 136**). Feature F3 has a wood frame construction, unpainted horizontal siding, a narrow door, and two small upper windows on the southern face. The side gable shed is adjacent and north of the orchard. The orchard

Figure 136. 25DW00-243, side gable shed (Feature 3) near main farm house, facing northwest. Photograph taken by Ashley Howder, on 12/05/2010.

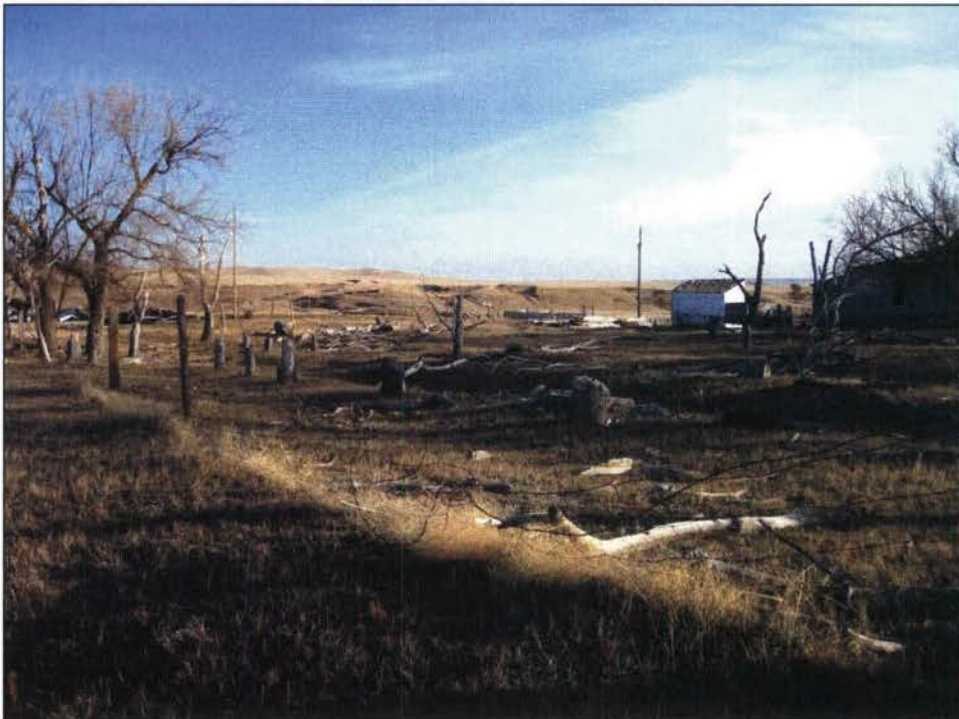
is rectangular in shape and measures 141 feet by 118 feet, and was planted directly north of the second farmhouse (Feature F4) (**Figure 137**).

Figure 137. 25DW00-243, orchard, facing southeast. Photograph taken by Ashley Howder, on 12/05/2010.

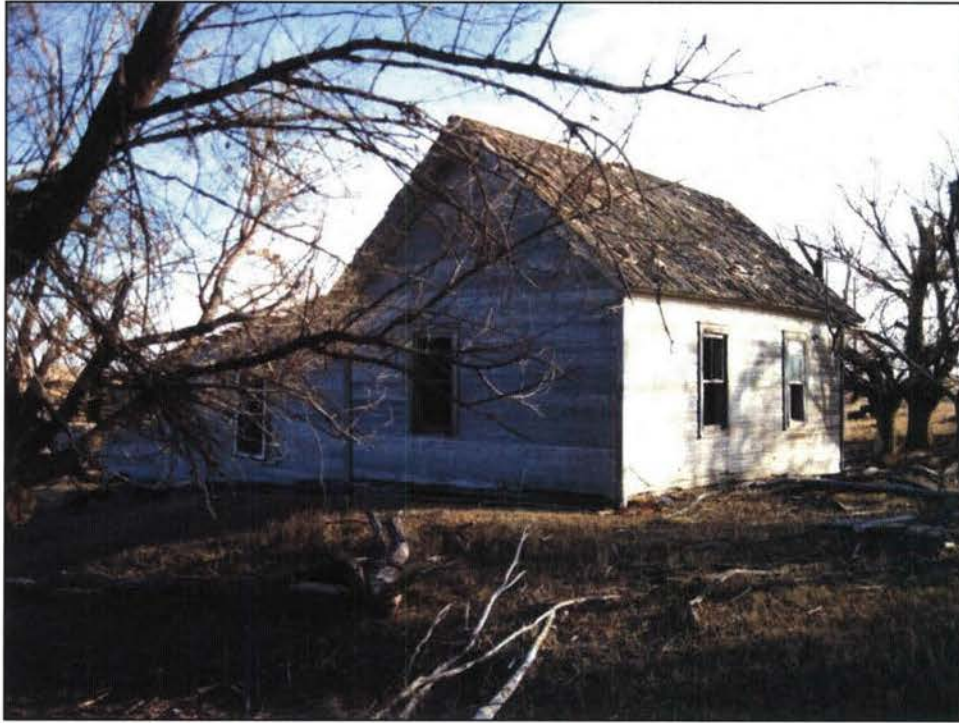
The second farmhouse (Feature F4) is an unpainted, one story, side gable house in considerably poorer condition than the main farmhouse (**Figure 138**). The original floor plan was relatively square, measuring 25 feet by 32 feet. The front of the house (e.g. the eave line and door) faces the east toward the unpaved driveway and away from Hollibaugh Road (**Figure 139**). A sizeable side gable porch measuring 8 feet by 24 feet has been added to the front of the house, and is structurally unstable thus preventing entry. The horizontal wooden siding and wooden shingles are unpainted. The house contains 3+ rooms and a dirt crawl space used for storage (**Figure 140**). The crawl space is filled with abandoned furniture, including one chair, shelves, drawers, and a table. At the time of abandonment, the structure had electricity as evidenced by electrical outlets and light fixtures remaining in the structure. A wood paneled flatbed trailer is parked in the dirt road directly behind the house. One foundation and standing chicken coop gate (Feature F7) is located 62 feet northeast. There is one white side gable shed (Feature F5) 102 feet southeast of the farmhouse (Feature F4).

Figure 138. 25DW00-243, farmhouse (Feature F4) showing the north and west faces of the structure, facing southeast. Photograph taken by Ashley Howder, on 12/05/2010.

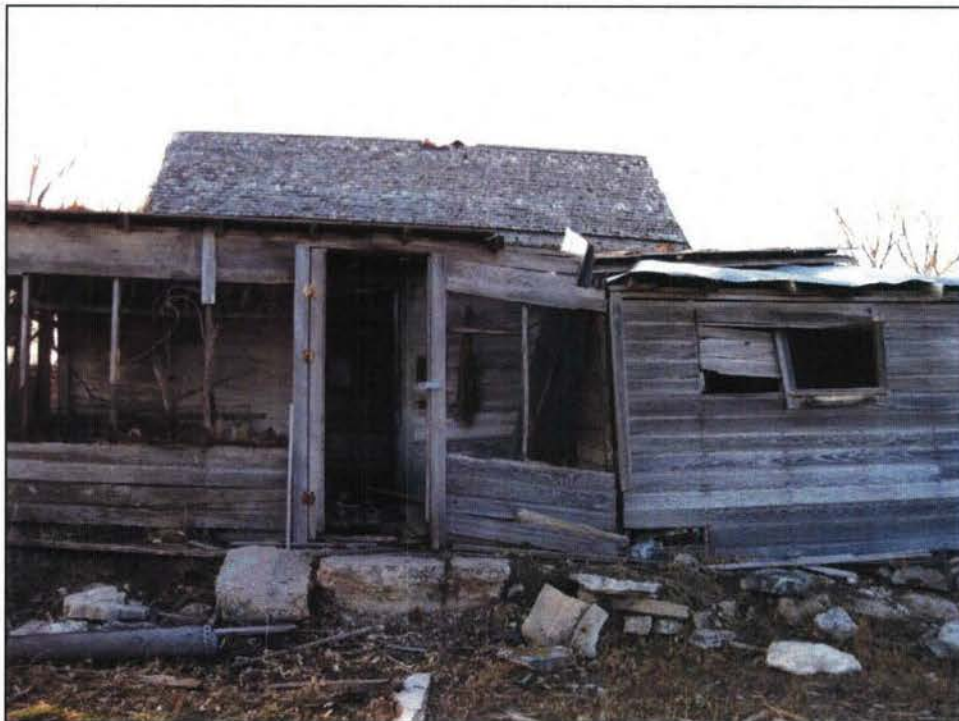
Figure 139. 25DW00-243, farmhouse (Feature F4) showing front porch, facing northwest. Photograph taken by Ashley Howder, on 12/05/2010.

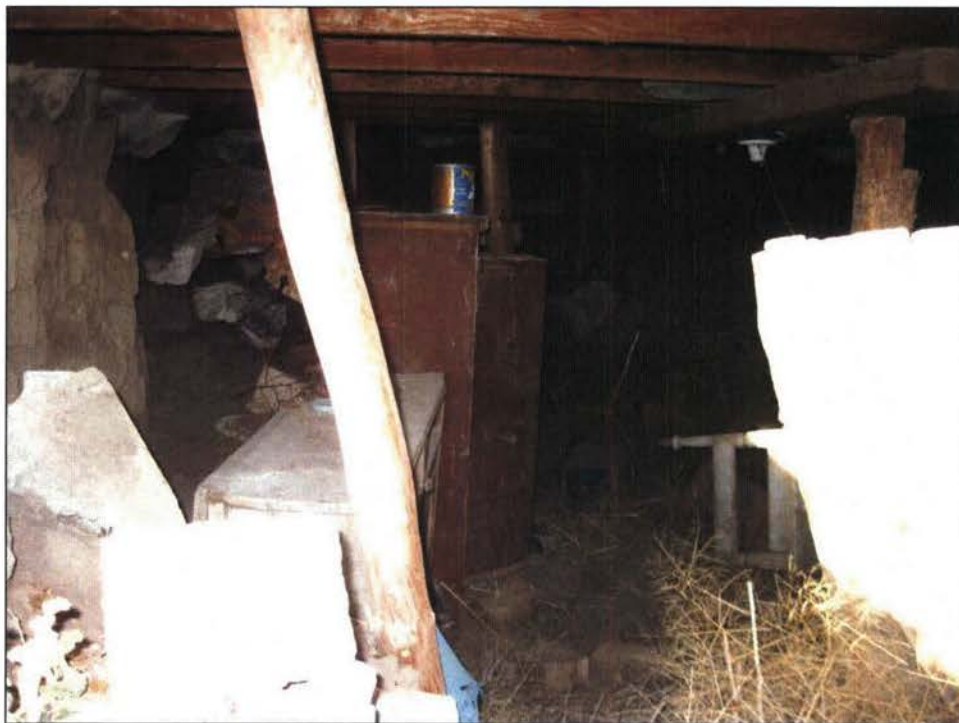
Figure 140. 25DW00-243, crawl space beneath farmhouse (Feature F4), facing south. Photograph taken by Ashley Howder, on 12/05/2010.

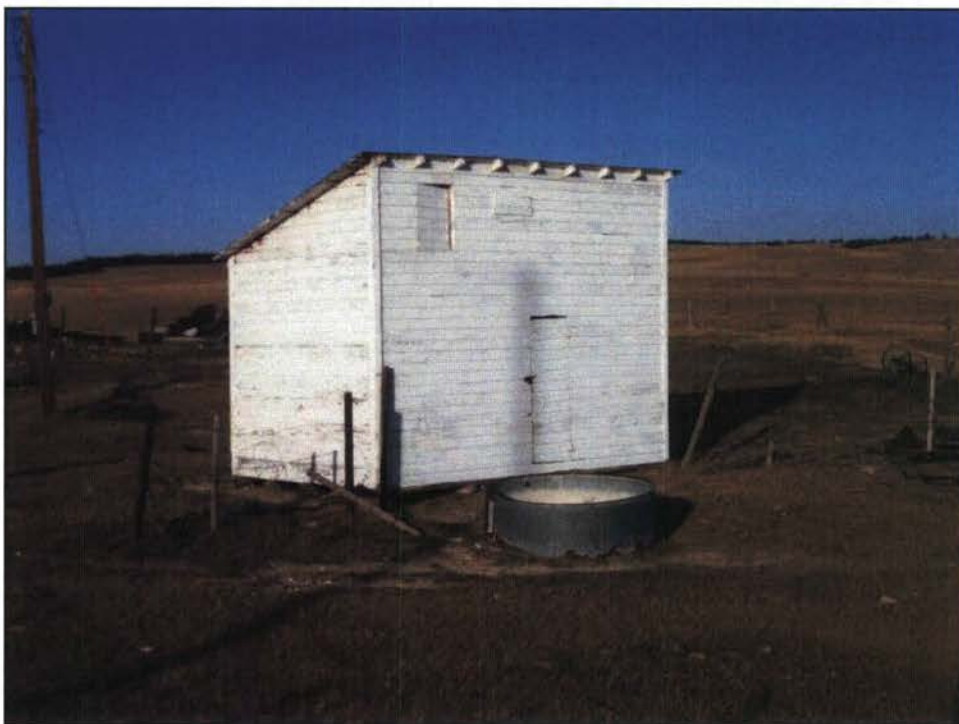
The white side gable shed (Feature F5) has a rectangular floor plan and measures 16 feet by 10 feet (**Figure 141**). The shed (Feature F5) has white painted horizontal wood siding, a wood plank roof, and a small door and small window on the south face of the structure. There is a small metal stock tank directly adjacent to the south face of the shed. The structure (Feature F5) may have been used for storage or as a livestock shelter. There is one red livestock shed (Feature F6) 189 feet east of the white side gable shed (Feature F5).

Figure 141. 25DW00-243, white side gable shed (Feature F5), facing northeast. Photograph taken by Ashley Howder, on 12/05/2010.

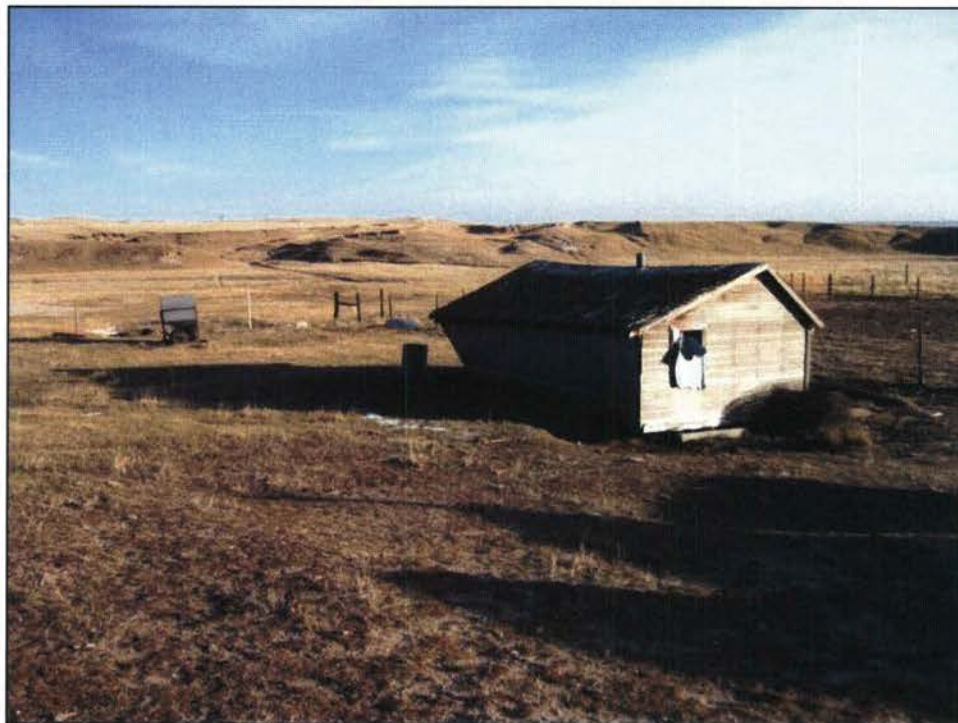
One animal shed (Feature F6) located 189 feet east of the white side gable shed is located within a network of fenced animal enclosures (**Figure 142**). The animal shed (Feature F6) has a rectangular floor plan, measures 20 feet by 12 feet, a wood frame construction, and was originally painted cherry red. The shed (Feature F6) has a wide, wood plank door on the east face of the structure. There are four squat windows on the south face of the structure and one window on the west face.

Figure 142. 25DW00-243, animal shed (Feature F6) with fencing in background, facing southeast. Photograph taken by Ashley Howder, on 12/05/2010.

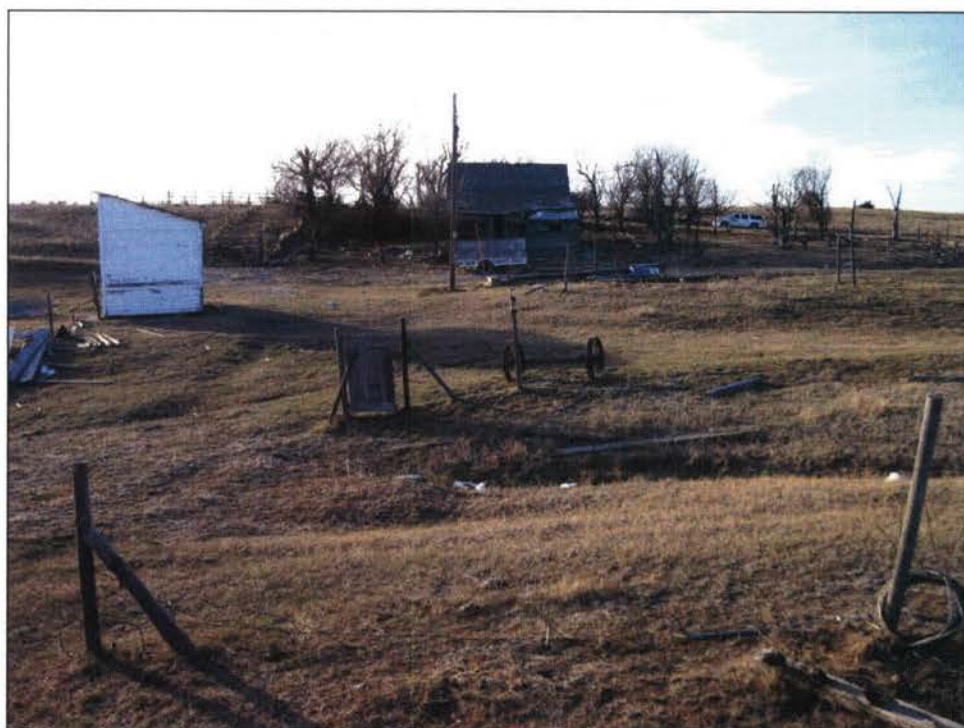
One remnant foundation (Feature F7) located 30 feet north of a standing chicken coop gate is located east of farmhouse (Feature F4) and measures approximately 23 feet by 23 feet (**Figure 143**). Foundation (Feature F7) appears razed and is in poor condition.

Figure 143. 25DW00-243, chicken coop gate and foundation (Feature F7) with Feature F5 and Feature F4 in the background, facing west. Photograph taken by Ashley Howder, on 12/05/2010.
