**TECHNICAL EVALUATION REPORT
CHRISTENSEN RANCH MINE UNITS 2 THROUGH 6 RESTORATION REPORT
URANIUM ONE USA, INC., WILLOW CREEK ISR FACILITY**

DATE: October 23, 2012
DOCKET NO.: 040-08502
LICENSEE: Uranium One USA, Inc.
SITE: Willow Creek Christensen Ranch, Wyoming
PROJECT MANAGER: Ron C. Linton
TECHNICAL REVIEWERS: John L. Saxton, Elise A. Striz

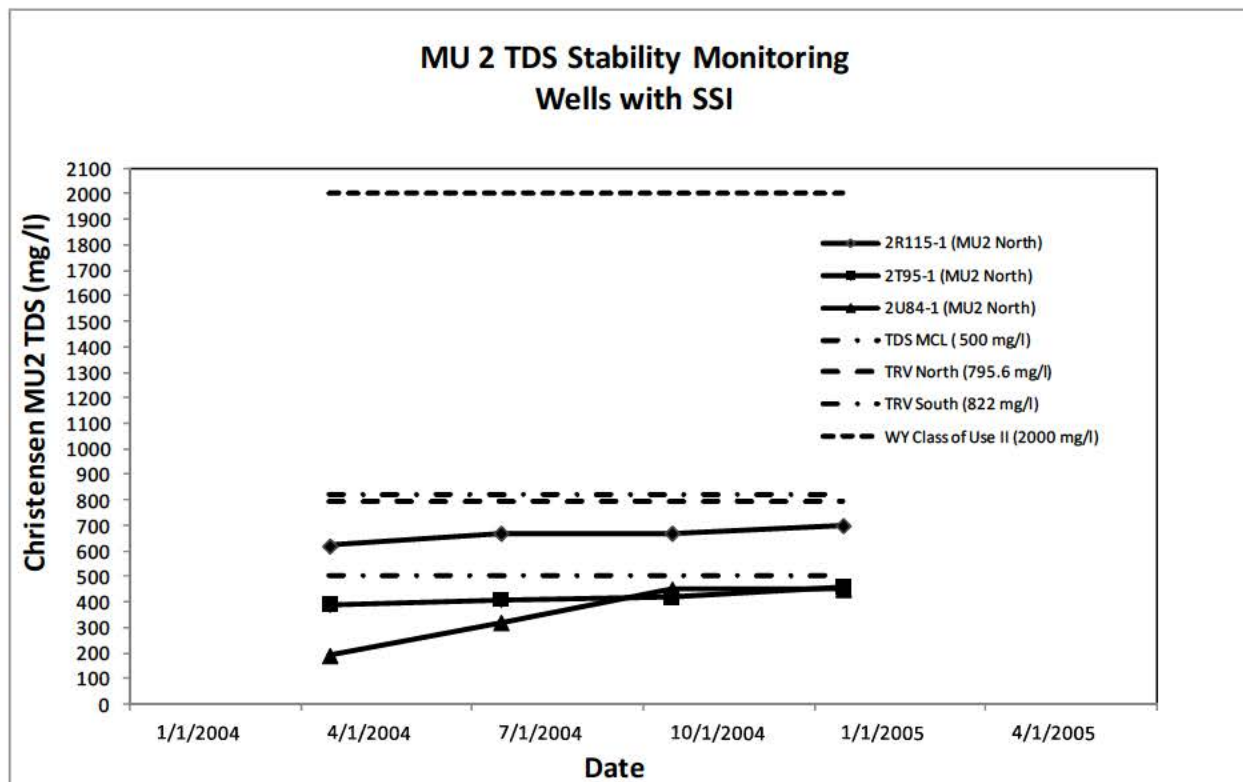
Figure 3a. MU2 North and South TDS Stability Monitoring Trend Analysis

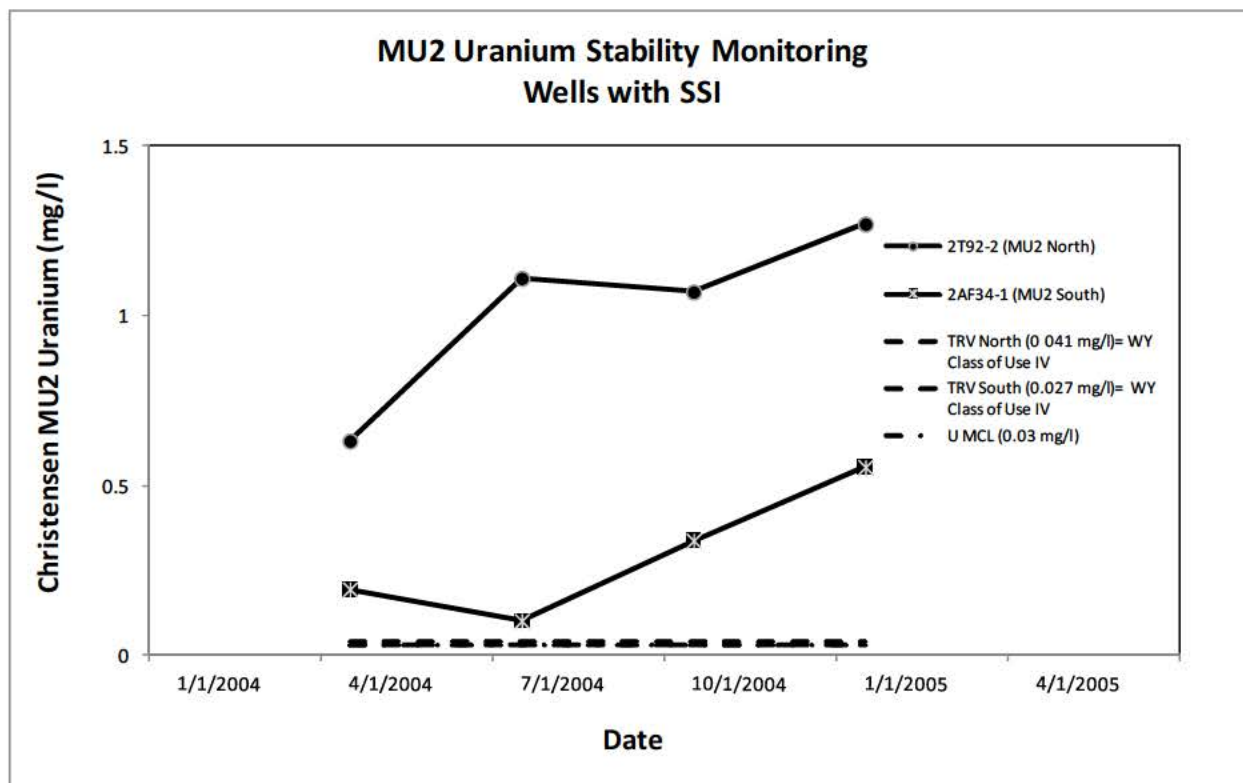
Based on the staff's stability analysis, a SSI trend was noted in the stability data for the following wells:

Figure 3b. MU2 North and South Uranium Stability Monitoring Trend Analysis

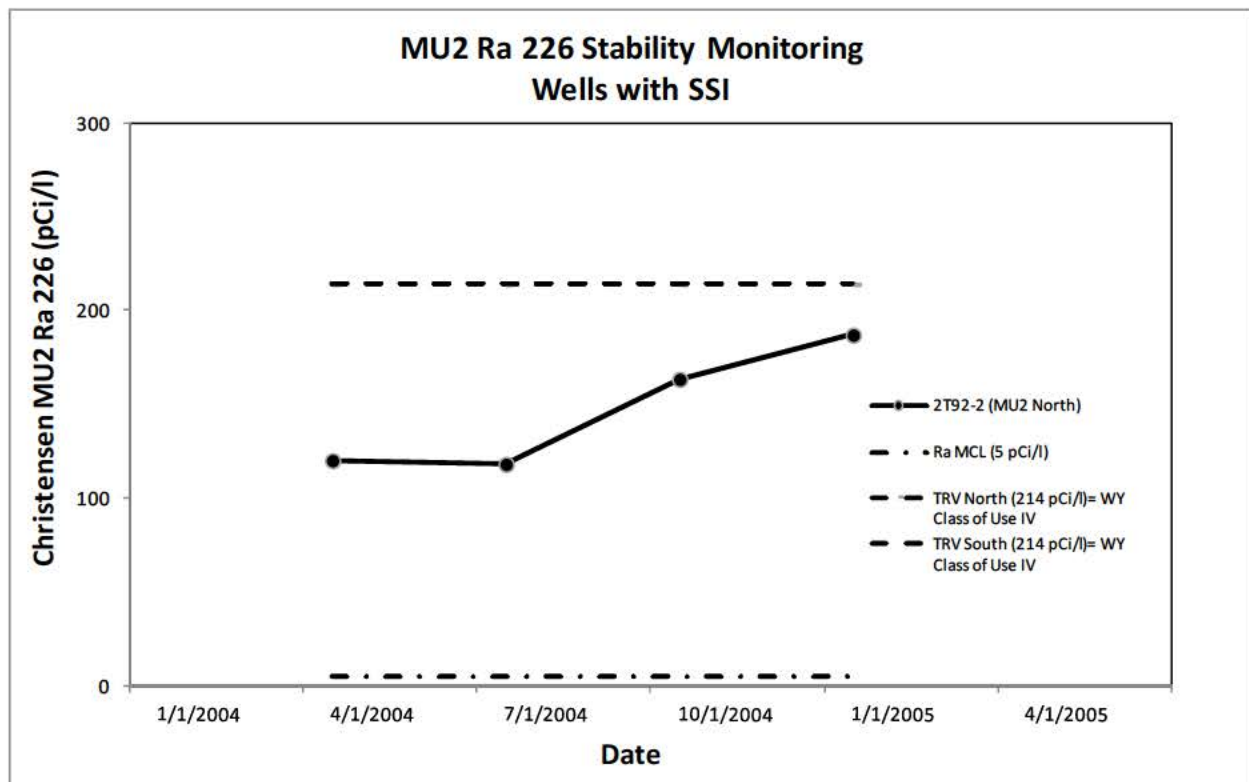
Figure 3c. MU2 North and South Radium-226 Stability Monitoring Trend Analysis

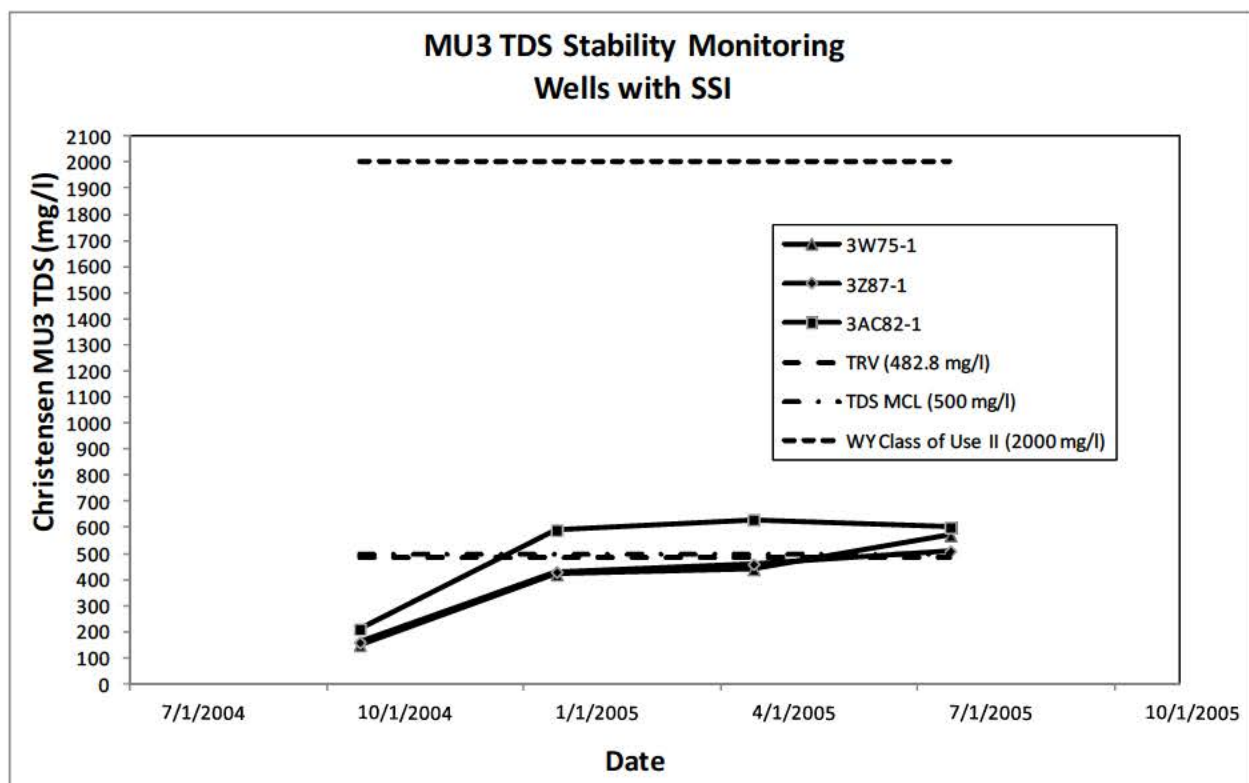
The SSI trends for wells in MU-3 w/o expansion and MU-3 w/ expansion (module 4A) for TDS, uranium and radium-226 are shown in Figures 4a, b, and c respectively. Based on the stability analysis, a SSI trend was noted in the stability data for the following wells in MU-3 w/o expansion:

Figure 4a. MU3 TDS Stability Monitoring Trend Analysis

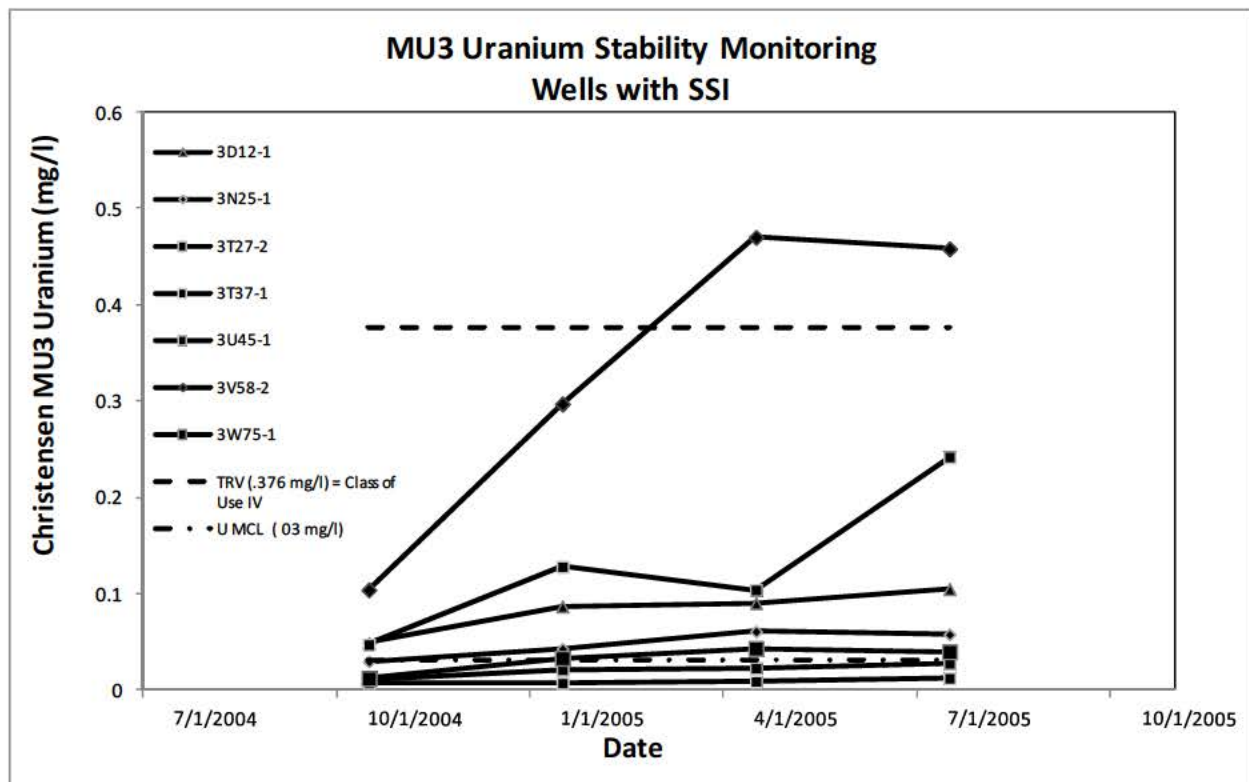
Figure 4b. MU3 Uranium Stability Monitoring Trend Analysis

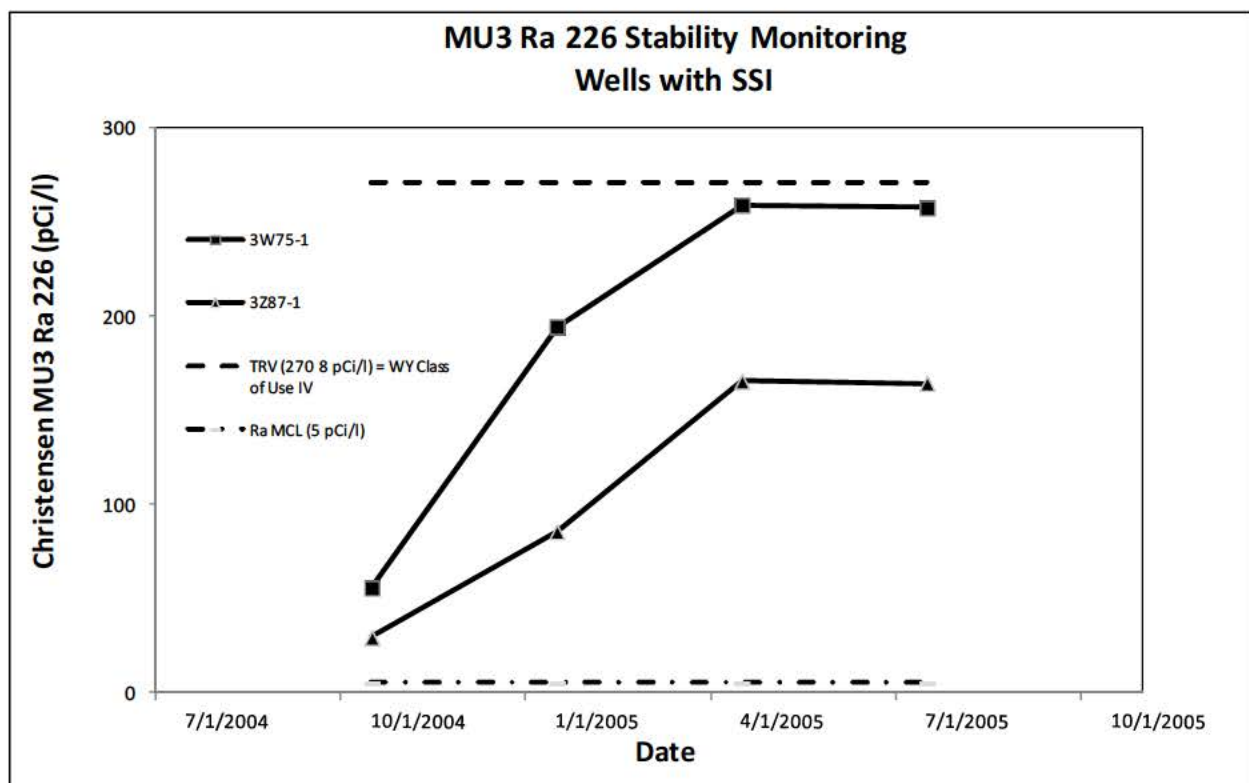
Figure 4c. MU3 Radium-226 Stability Monitoring Trend Analysis
