Subject: 10 CFR 71.95 Report on Energy Solutions 8-120B Casks

Potential Failure to Comply with Certificate of Compliance Conditions for the 8-120B Cask Vent Port Pre-Shipment Leak Test

**Failure to Observe Certificate of Compliance Conditions
for the 8-120B Vent Port Pre-Shipment Leak Test**

Details of the 8-120B Vent Port Leak Rate Test Setup

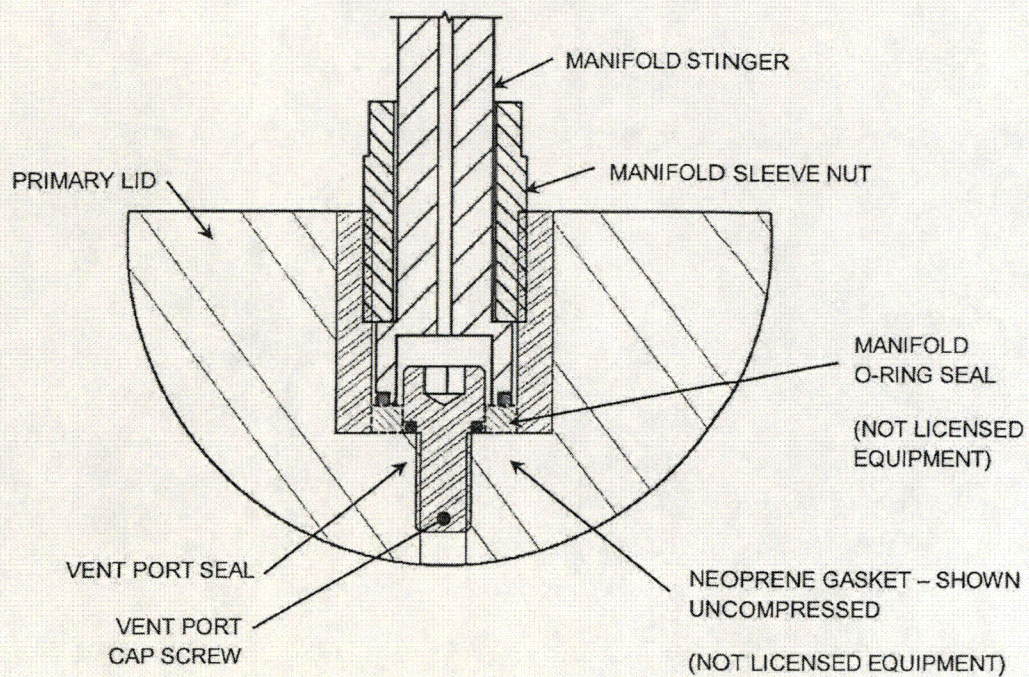
New 8-120B lids went into service in September 2013. It was found that the manifold sometimes had problems sealing with the vent port on these new lids. EnergySolutions personnel found that adding an extra neoprene gasket helped to reduce the false test failures. Since the pre-shipment leak rate test is performed in a radiation environment, false failures are undesirable because they increase the personnel exposure. The personnel did not realize that the gaskets had the potential to reduce the test sensitivity.

The neoprene gasket can constrict on the head of the vent port plug cap screw when it is compressed by the bottom end of the test manifold stinger, which could reduce the sensitivity of the pre-shipment leak test. Consequently, the vent port pre-shipment leak tests performed using the neoprene gasket may not have provided the required test sensitivity of 1×10^{-3} ref-cm³/sec.

The pre-shipment leak test of the vent port is a pressure drop test performed using a dedicated test manifold. The test manifold is not a part of the licensed package. It includes a stinger (shown below), an O-ring seal that contacts the stinger and the bottom of the vent port hole, and a sleeve nut to compress the O-ring seal. The test manifold was designed so that it surrounds the vent port cap screw, leaving a small gap between itself and the vent port cap screw. The 8-120B cask fleet began to ship with a new lid design in September 2013, and operations staff noted more frequent difficulty getting the manifold to seal. It became desirable to find a better way to seal the bottom of the manifold in order to minimize operator exposure. They found that adding a neoprene gasket (also not part of the licensed package) under the base of the stinger as shown below helped reduce testing time and exposure.
