PART 21 REPORT - POTENTIAL FAILURE OF ELECTROMATIC RELIEF VALVE CUTOUT SWITCHES

September 10, 2015
MFN 15-042 R2

**Subject: Closure of Part 21 60-Day Interim Report Notification:
Potential Failure of Electromatic Relief Valve Cutout Switch**

Description of Evaluation

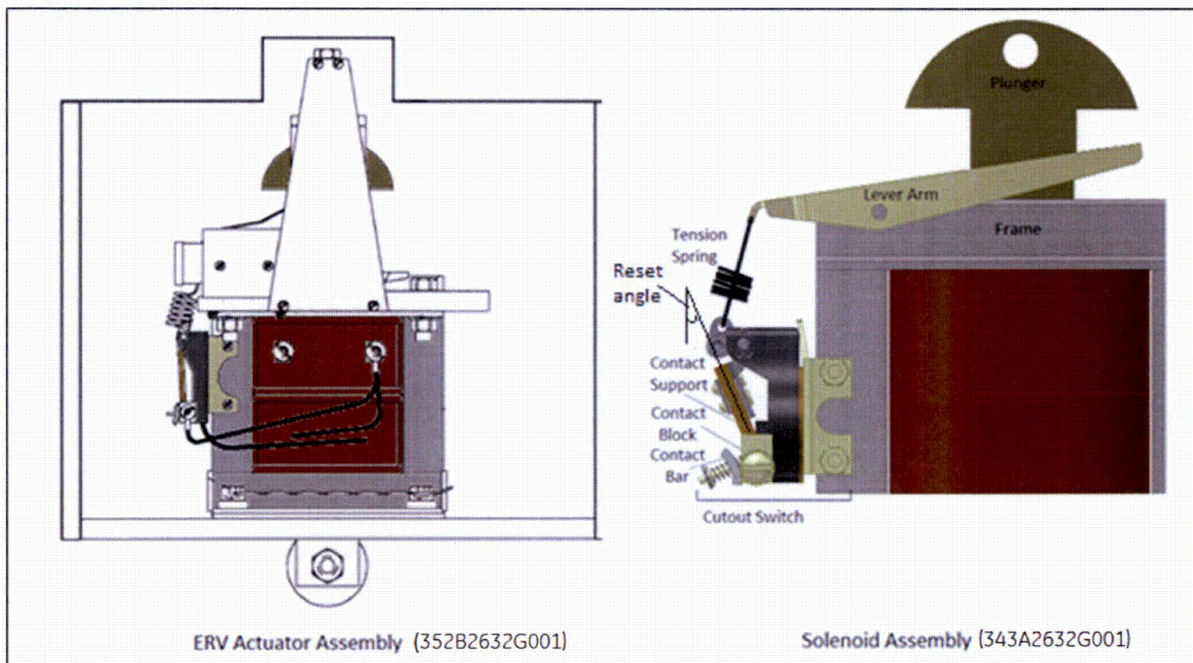
GEH provides various parts and components that are designed to actuate Electromatic Relief Valves (ERVs). The only manner in which these valves can be opened is from an electrical signal received by the actuator. The ERV Actuator Assembly contains the Solenoid Assembly which contains the cutout switch assembly as shown in Figure 1.

The cutout switch bypasses the secondary holding coil in order to develop the magnetic field energy to engage the plunger. When the plunger is fully seated the cut out switch is open allowing current flow thru the secondary coil providing additional inductance to be introduced into the circuit. Upon the actuation of the solenoid the plunger lowers and impacts the back end of the plunger lever arm. The lever arm pivots, raising the front end of the arm which is connected to the tension spring. This causes the contact support to rotate (clockwise in Figure 2) creating a gap between the contact blocks and the contact bar. The gap between the contact bar and the contact blocks removes the bypass of the secondary coil. The purpose of the secondary coil is to prevent burnup of the primary coil. When the electrical signal is removed the plunger lifts allowing the plunger lever arm to lift which releases the tension on the tension spring and allowing the torsion spring to close the contacts, resetting the actuator. The resetting force is provided by a torsion spring by F2 which may be seen in Figure 1. If the secondary coil is not bypassed before the actuation signal is received the actuator will fail to provide the force necessary to actuate its valve.

Figure 1 Actuator and Solenoid Assembly in the reset position

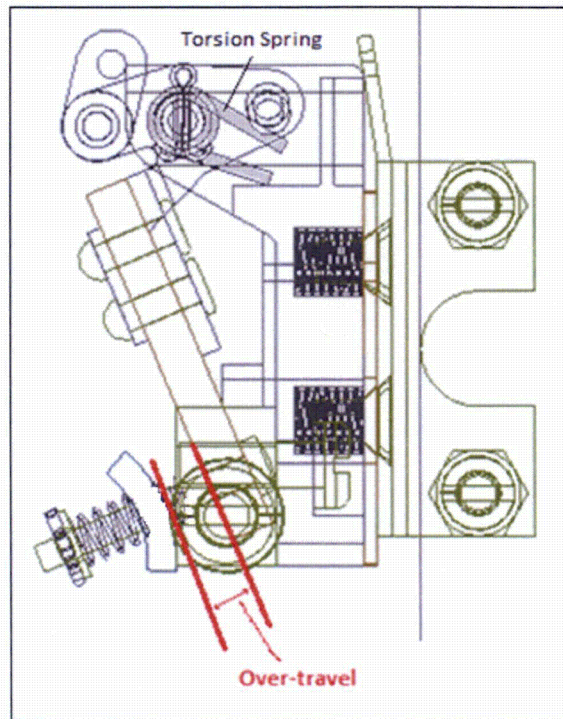
Figure 2 Over travel of cutout switch

Following the observed failures, an investigation was initiated to determine the cause of the failures, and to determine whether the condition applied to components previously supplied to and accepted by licensees. The investigation concluded that the ERV actuator assemblies failed to change state because of the failure of the cutout switch to fully close and provide the appropriate current path. When ERV Unit #5 failed, a 0.003 inch gap was present between the contact bar and one of the contact blocks. When ERV Unit #8 failed, a 0.001 inch gap was present between the contact bar and one of the contact blocks. For both ERV Unit #5 and ERV Unit #8 contact existed between the contact bar and one of the blocks but a gap existed between the contact bar and the other contact block.

Multiple contributing factors were discovered which could have led to the presence of the gaps. The most significant of these factors is a change in lever arm positioning causing increased forces in the tension spring which prevent proper closure of the cutout switch. Design changes to reduce wear caused by vibration on the actuators changed lever arm position and also allowed for additional dimensional tolerance which tended to increase force in the tension spring. Additionally, insufficient clearances between the lever arm hinge pin and the associated

bushing may have contributed to increased frictional forces in the part, becoming a second contributing factor.

Proper contact in the cutout switch is dependent on the reset angle. For discussion purposes the term reset angle refers to the angle of the contact support after the plunger lifts and the part resets. The solenoid assembly in Figure 2 is in the reset position therefore the contact support is in the reset angle. Unreliable performance occurs when the reset angle for a given part does not consistently ensure adequate contact. Conversely, reliability is achieved when the reset angle always ensures sufficient contact between the contact bar and the contact blocks.

If positive over travel has not been previously confirmed during maintenance activities, perform inspection at the next available opportunity to verify that the condition does not exist.

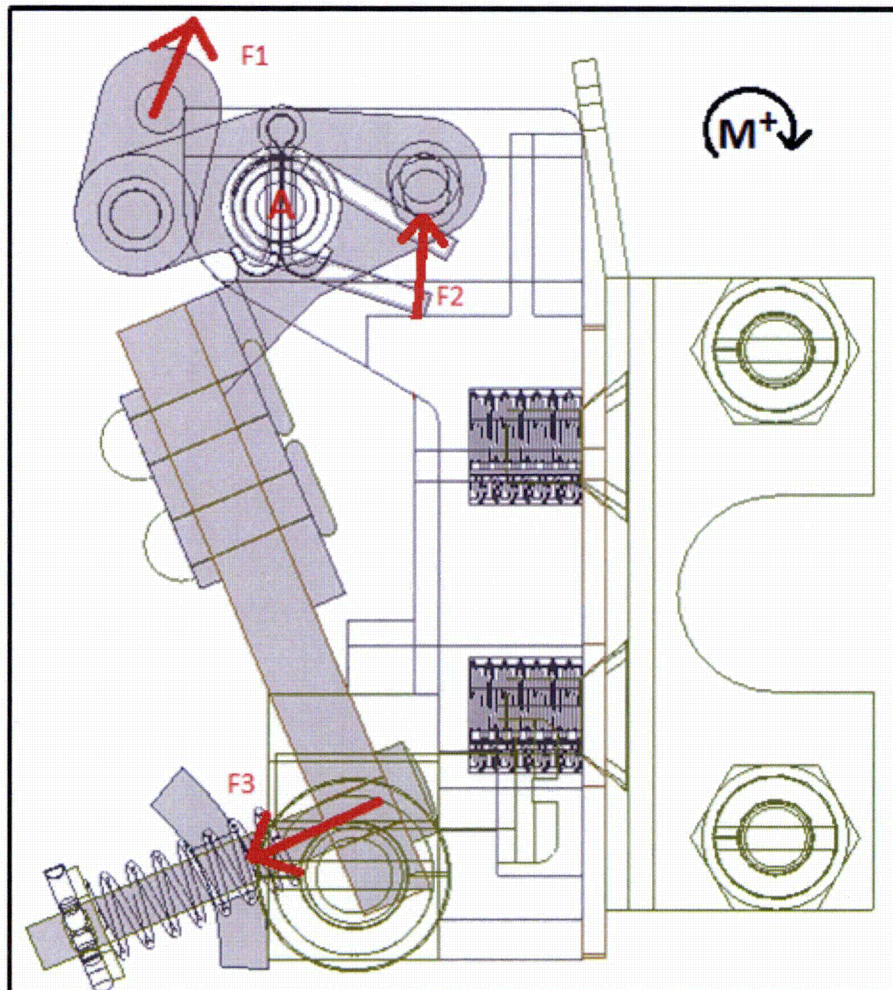
Figure 3

When a part resets there are four moments that determine the reset angle. Three of these are caused by the forces shown in Figure 3. The fourth is caused by friction. For a given part the moments caused by forces F1, F2, and, F3 are only dependent on the angle of the contact support. Therefore any variance in the reset angle is due to variation of the moment due to friction in the part. The amount of over travel, as shown in Figure 2, is a good indication of the susceptibility of an assembly to unreliable operation. Positive over travel ensures proper contact is made despite frictional variation.

Friction is present when the assembly is reset, not allowing the contact support to proceed entirely to its neutral, zero friction reset angle. As energy is added to the system sufficient to

overcome the frictional moment, the contact bar will tend to drift towards its zero friction angle. This means an assembly that doesn't consistently make contact when initially reset would be expected to do so as energy is added, as by normal system vibration. ERV Units #5 and #8, which were previously observed to exhibit inconsistent operation, have been manually agitated during bench testing at GEH. These assemblies were found to function consistently in the presence of this agitation. This agitation was applied during bench testing which consisted of repeated instances of assembly actuation followed by mechanical agitation. Additional testing was performed to mimic vibrations and impact energies experienced on site. While this testing confirmed that added energy tended to increase reliability when a gap between the contact bar and the contact blocks was present, it was unable to model plant conditions with sufficient accuracy to draw application specific conclusions based on the results. The primary reason for this inability was lack of available plant data to describe agitation energies in all the situations where the ERVs would need to be functional.
