SUBJECT: Special rept: on 901017, use of alternate power source makes standby shutdown facility technically inoperable.

Subject: Oconee Nuclear Station
Docket Nos. 50-269, -270, -287
Special Report Concerning Use of Alternate
Power Source Makes Standby Shutdown Facility
Technically Inoperable Due to Defective Procedure

TITLE (4) Use of Alternate Power Source Makes Standby Shutdown Facility Technically Inoperable Due to Defective Procedure

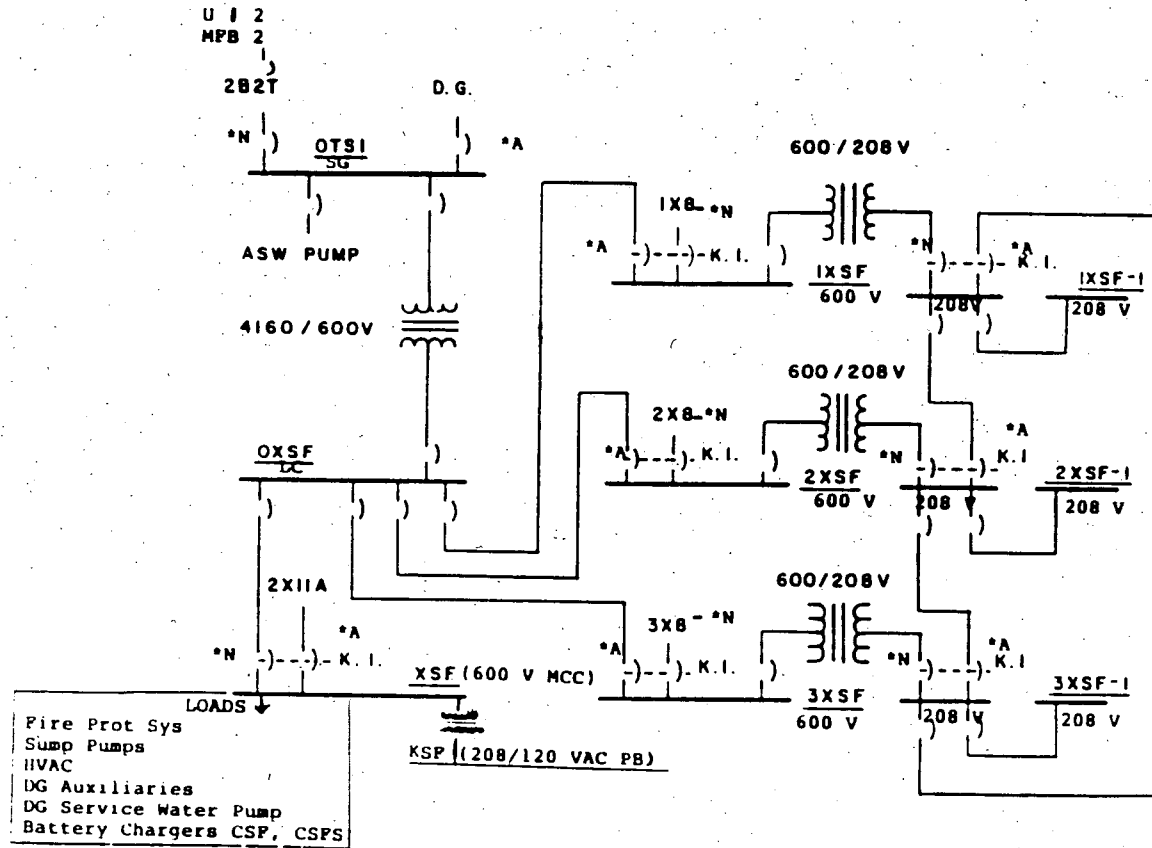
ATTACHMENT 1

The 600V Motor Control Center XSF receives normal power from the 600V Load Center OXSF. It also has an alternate feed from the 600V Load Center 2X11A (located in the station) that is used whenever power from Load Center OXSF is not available. (See attachment 1). A Kirk-Key Interlock scheme is employed on these two incoming breakers [EIIS:BRK] that prevents them from being closed at the same time.
