Subject: Oconee Nuclear Station
Docket Nos. 50-269, -270, -287
LER 269/91-03

Oconee Nuclear Station, Unit 1

Technical Inoperability of Oconee Backup Electrical Power Sources Results From
Deficiently Designed Circuit Breaker Arrangement of Keowee Hydro Auxiliary Loads

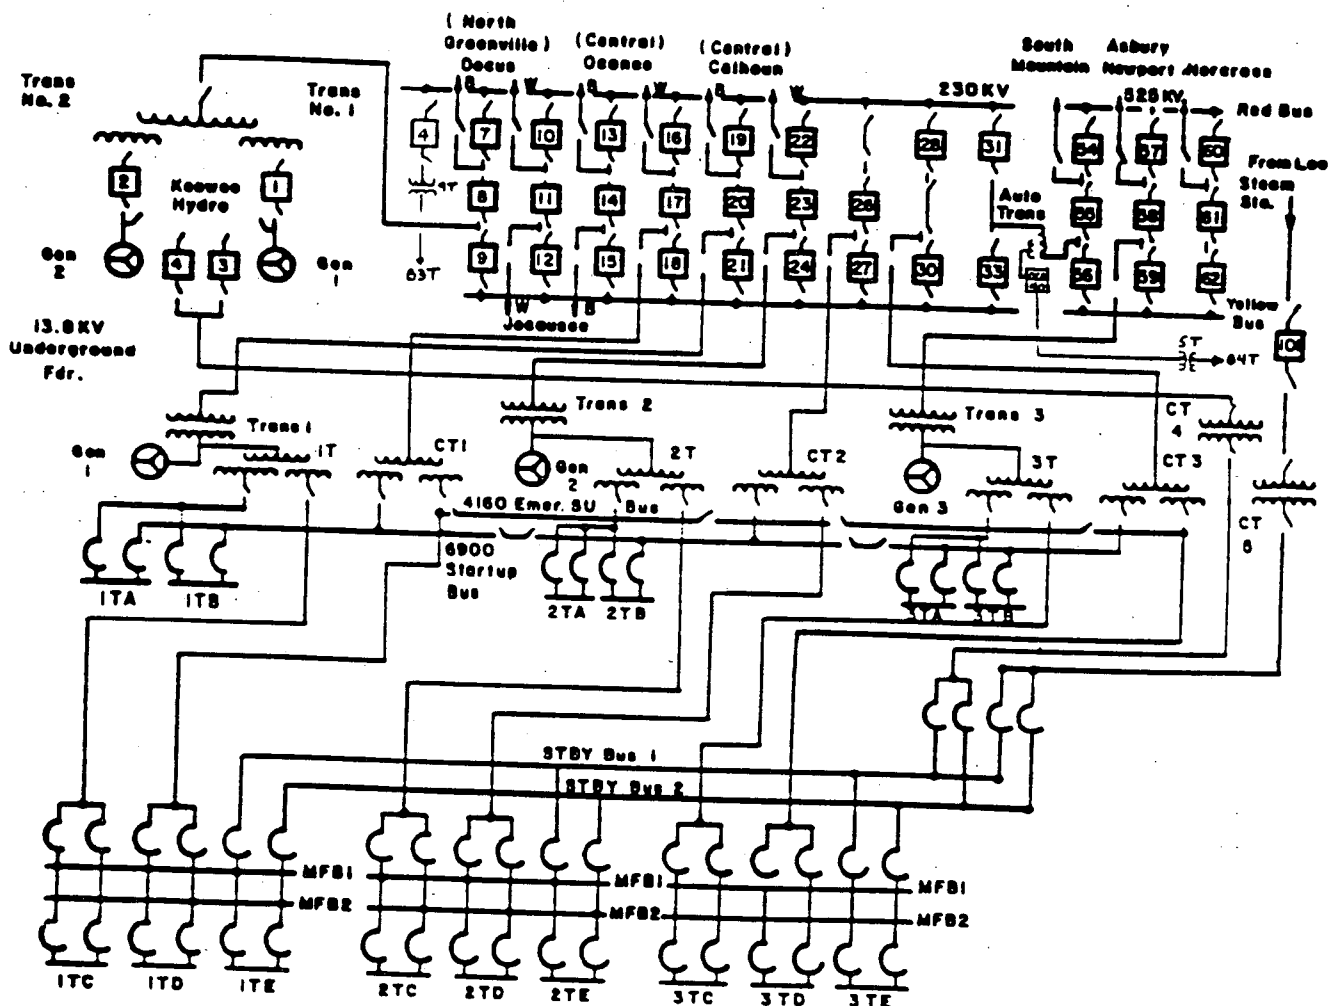
ATTACHMENT 1

Each unit at Oconee Nuclear Station has several sources of electrical power available to supply essential station equipment (see Attachment 1). The sources are listed below in the order of preferred choice:

1. The 230 kilovolt (KV) transmission network [EIIS:SK] through the Oconee units' normal (1,2,3T) or startup (CT-1,2,3) transformer [EIIS:EA].
2. One of two Keowee Hydro units [EIIS:EK] (located on the Oconee site) through the 230 KV circuit.
3. The other Keowee Hydro unit through an underground circuit and transformer CT-4 [EIIS:EK].
4. A dedicated 100 kv line from gas turbines at Lee Steam Station (located 30 miles from Oconee Nuclear Station) through transformer CT-5.
5. The startup transformer of another Oconee unit.
6. The CT-5 transformer from the Central Switchyard.
