SUBJECT: LER 91-004-00:on 910506,tech inoperability of emergency
 electrical power path occurred due to incorrect relay trip
 setpoints.Caused by inappropriate action.Emergency power
 path through CT-4 proven operable.W/910605 ltr.

Subject: Oconee Nuclear Station
Docket Nos. 50-269, -270, -287
LER 269/91-04

LICENSEE EVENT REPORT (LER)

FACILITY NAME (1) Oconee Nuclear Station, Unit 1										DOCKET NUMBER (2) 0 5 0 0 0 2 6 9										PAGE (3) 1 OF 1																			
TITLE (4) Technical Inoperability of an Emergency Electrical Power Path Due to Incorrect Relay Trip Setpoints Results From Inappropriate Action																																							
EVENT DATE (5) MONTH DAY YEAR 0 5 0 6 9 1 9 1									LER NUMBER (6) YEAR SEQUENTIAL NUMBER REVISION NUMBER - 0 0 4 - 0 0									REPORT DATE (7) MONTH DAY YEAR 0 6 0 5 9 1									OTHER FACILITIES INVOLVED (8) FACILITY NAMES DOCKET NUMBER(S) Oconee, Unit 2 0 5 0 0 0 2 7 0 Oconee, Unit 3 0 5 0 0 0 2 8 7												
OPERATING MODE (9) N			THIS REPORT IS SUBMITTED PURSUANT TO THE REQUIREMENTS OF 10 CFR §: (Check one or more of the following) (11)																																				
POWER LEVEL (10) 1 0 0			20.402(b)									20.406(c)

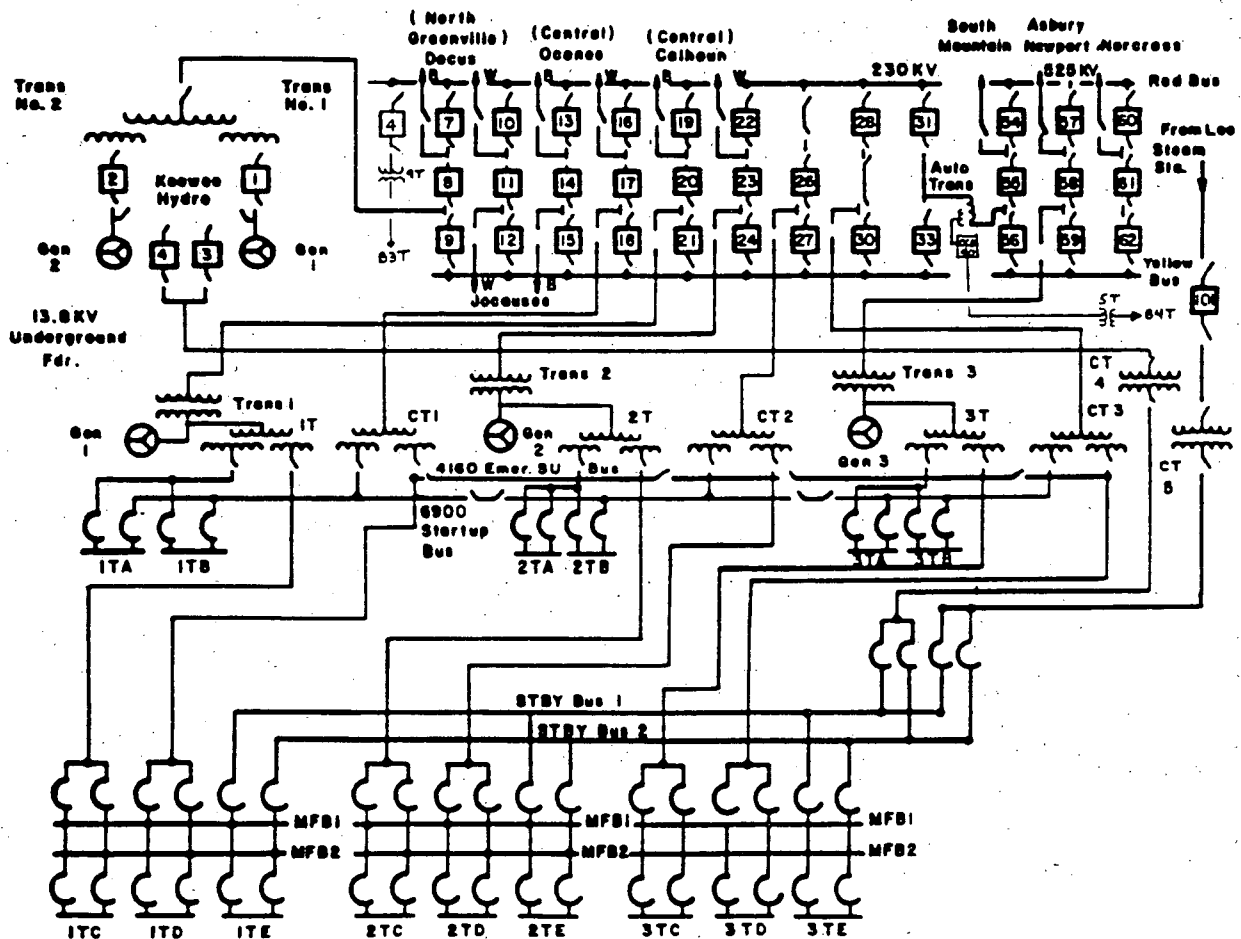
ATTACHMENT 1

The 230 KV switchyard is divided into a safety related yellow bus and a non-safety related red bus (See Attachment 1). These buses are separated by three power circuit breakers (PCBs) [EIIS:EA]. Incoming lines and feeder loads are always separated from the buses by at least one PCB.

OCONEE OVERHEAD NORMAL AND EMERGENCY ELECTRICAL POWER DISTRIBUTION

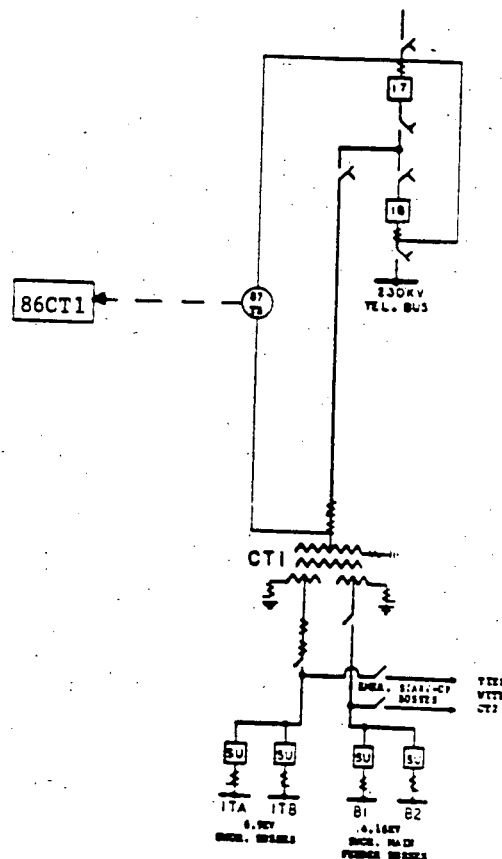
ATTACHMENT 2

An evaluation was performed to determine if the incorrect setpoints made the CT-1 transformer inoperable. It was found that, with the incorrect setpoints, a fault on non-safety related equipment (for instance, the 230 KV red bus) could inadvertently actuate the 87TB relays which would initiate a lockout of the CT-1 transformer. At 1800, Design Engineering Supervisor A notified Oconee Operations Shift Supervisor A and the Operations Support Manager that CT-1 was technically inoperable. A Limiting Condition for Operation (LCO) was entered for Unit 1 under Technical Specification 3.7.2.i.2. Unit 1 was operating at 100 percent full power. The underground power path was proven operable, as required by Technical Specifications. A review of other safety related type-87 differential relays continued.

CT-1 TRANSFORMER PROTECTIVE ZONE

Electrical fault protection for PCB's 17 and 18 and for the line connecting them to Transformer CT1 is provided by the Start-up Transformer Bus Differential Relays 87TB X-Y-Z.

Current is supplied to these relays from current transformers on the Red Bus side of PCB 17, on the Yellow Bus side of PCB 19, and in the 230 KV bushings of CT1.

When the comparison of these currents shows a fault in the protected area, Relays 87TB will pick up and initiate the Transformer CT1 Lockout Relay 86CT1.

1. Trip setpoints for 87TB -X, -Y, -Z relays, protecting the transmission line from the CT-1 transformer to the 230 KV switchyard were reset to manufacturer's recommendations.
2. Trip setpoints for 87BY -X, -Y, -Z relays, protecting the 230 KV yellow bus, were reset to manufacturer's recommendations.

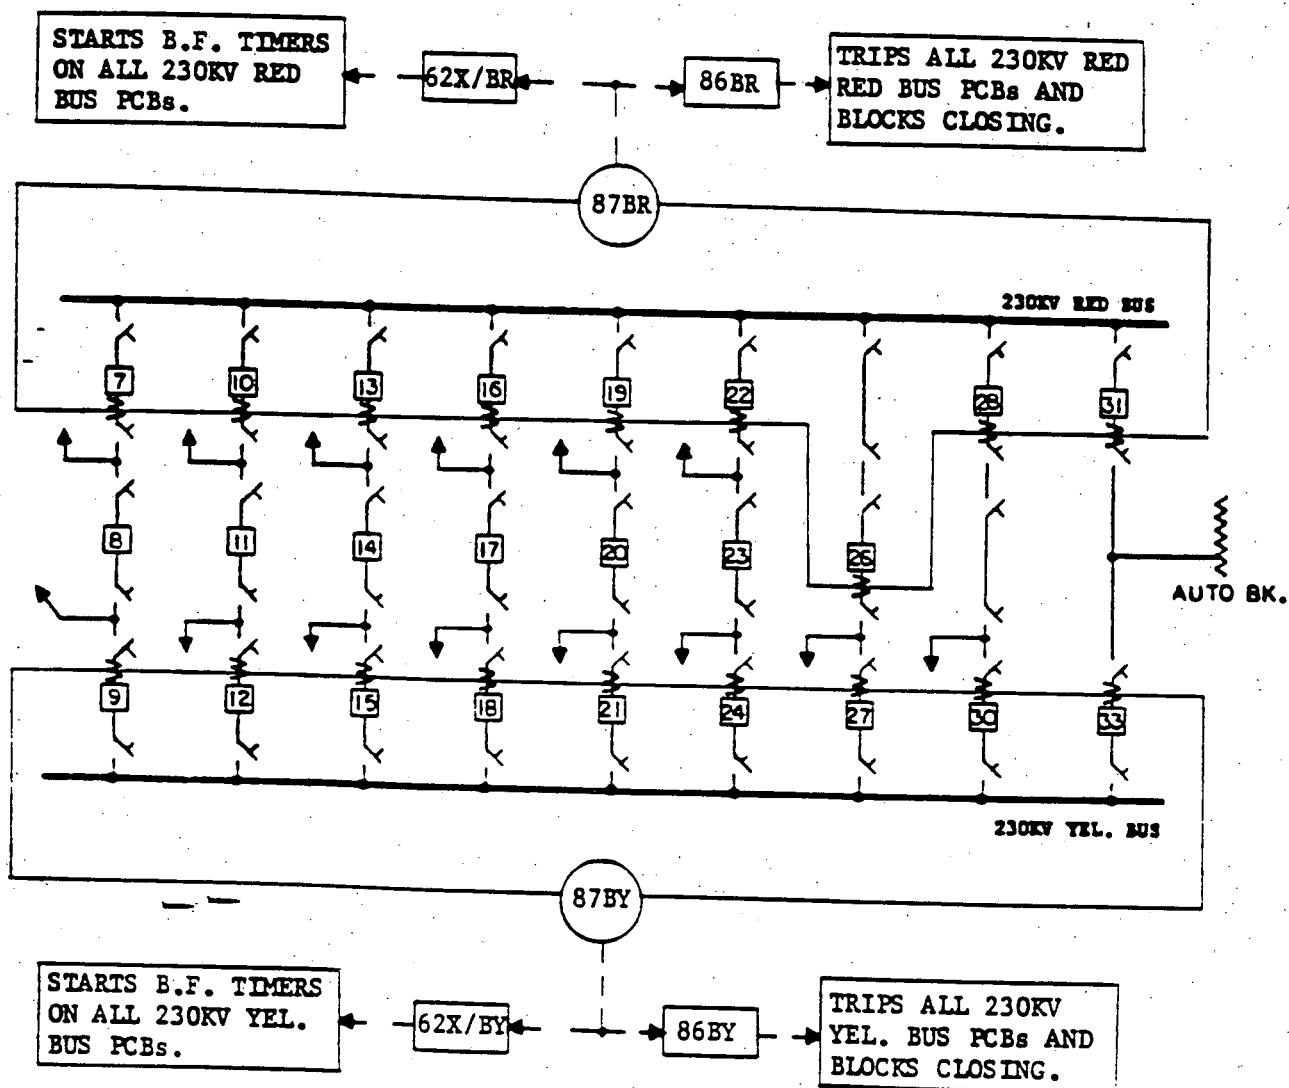
ATTACHMENT 3

switchyard. However, analysis showed that an adjacent fault on non-safety related equipment would not inadvertently trip these relays. Differential voltage relays 87BY-X,-Y,-Z, which provide fault protection for the 230 KV switchyard yellow bus (see Attachment 3), were also found to have incorrect setpoints associated with their 87H components. Analysis showed that an adjacent fault on non-safety related equipment could inadvertently isolate the entire yellow bus. This made the overhead emergency power path to the startup transformers on all three units technically inoperable.

YELLOW BUS PROTECTIVE ZONE

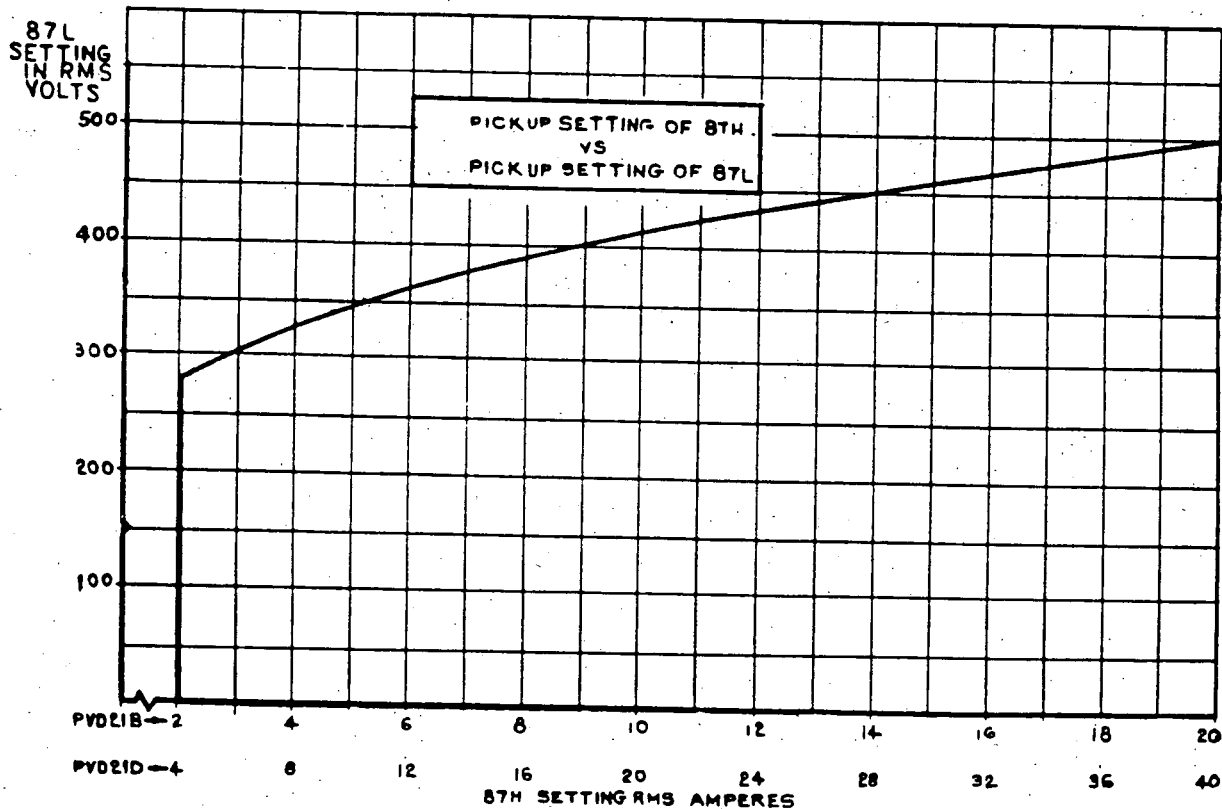
ATTACHMENT 4

The General Electric manual (GEK-45405) for the PVD21D relays contains a graphical method for determining the 87H setpoints. The 87L setpoint is first obtained from a relay circuit formula. It is used to determine from a graph (see Attachment 4) the appropriate 87H setpoint. The graph has two scales on the x-axis, one for PVD21B relays and one for PVD21D relays. The incorrect relay setpoints corresponded to the setpoints which would have been obtained by using the PVD21B scale. This was true for all 87-type differential voltage relays in the 230 KV switchyard. Transmission Department Engineer A stated that he failed to notice the second scale.

87H DIFFERENTIAL RELAY OVERCURRENT SETPOINT GRAPH
(from General Electric manual GEK-45405)
