## REGULATORY INFORMATION DISTRIBUTION SYSTEM (RIDS)

SUBJECT: LER 91-010-00: on 910918, determined that operating limit curve for letdown storage tank pressure versus level inadequate. Caused by design deficiency. Operating limit curve revised & addl instructions provided. W/911021 ltr.

Subject: Oconee Nuclear Station  
Docket Nos. 50-269, -270, -287  
LER 269/91-10

**TITLE(4)** High Pressure Injection System Technically Inoperable For Some Single Failure LOCA Scenarios Due to Design Deficiency

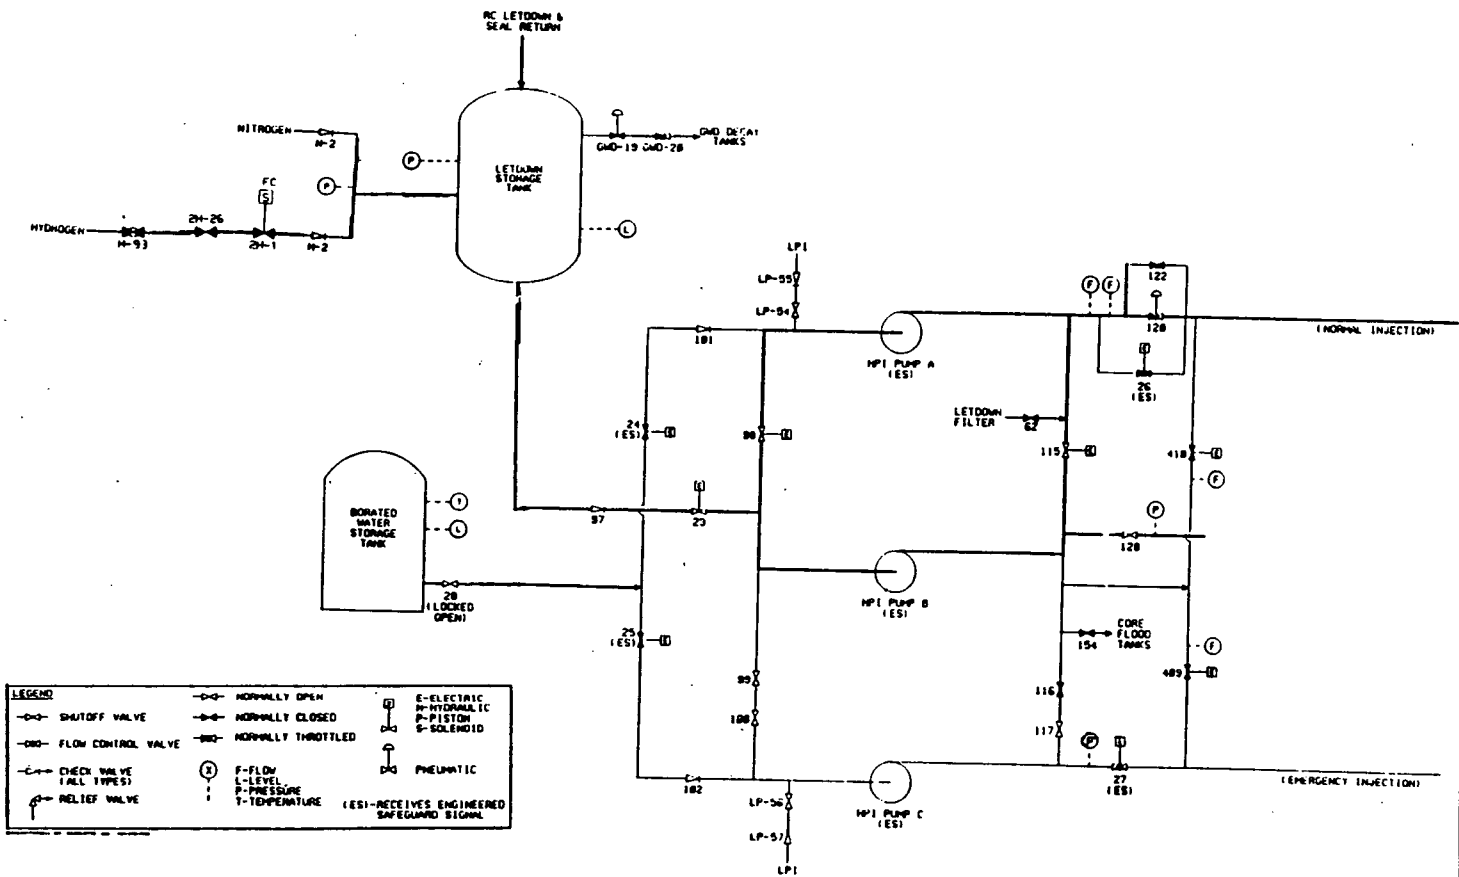
## Attachment 1

The HPI System is also a part of the Emergency Core Cooling System (ECCS) which mitigates the consequences of loss of coolant accidents (LOCA). The HPI System prevents uncovering of the core for smaller break sizes, where high RCS pressure is maintained, and delays the uncovering of the core for intermediate break sizes. The HPI System, during emergency operation, supplies borated water to the RCS from the Borated Water Storage Tank (BWST). The HPI System has three parallel HPI pumps that have the capability to take suction from the BWST and to discharge through two redundant flow paths into the RCS, utilizing four injection nozzles (two per flow path). The injection nozzles are located on each of the reactor inlet pipes downstream of the Reactor Coolant Pumps. (See Attachment 1)

The suction lines from the LDST to the HPI pumps are normally isolated from the BWST supply lines by check valves [EIIS:V] (HP-101 and HP-102) and motor operated valves (HP-24 and HP-25). In the event of an Engineered Safeguards [EIIS:JE] actuation, the motor operated valves will open, and the pressure due to elevation head in the BWST will overcome the pressure due to LDST level and hydrogen pressure, opening check valves HP-101 and HP-102, closing HP-97 (LDST outlet header check valve), and providing flow from the BWST to the HPI pumps. As BWST level drops, the available pressure from the LDST could exceed the available pressure from the BWST, allowing flow from the LDST as a check valve opens. If allowed to continue, the hydrogen gas in the LDST could expand, filling the suction piping, until HPI pump suction could be lost, resulting in damage to one or more pumps. Therefore, the required total system flow might not be met and core damage could result. The procedural operating limit curve for LDST hydrogen pressure and volume is intended to assure that LDST pressure does not exceed available BWST pressure, even as BWST level is drawn down during a LOCA.

On September 19, 1991, at 1225 hours, it was concluded that the current procedure limits were adequate for most scenarios, but a scenario existed where a single failure might result in total failure of the HPI system. This scenario assumes a small break LOCA with a concurrent single failure of either HP-24 or HP-25, the two Borated Water Storage Tank (BWST) to HPI suction isolation valves. This failure would cause all of the required HPI injection flow to pass through one suction supply line, which would lead to higher pressure losses and therefore lower pressure in the suction supply header, resulting in entrainment of hydrogen from the LDST and eventual pump damage.

1. The operating procedure was revised to incorporate the new LDST Pressure Versus Level curve prepared by Design Engineering.
2. Revised Emergency Procedure to include requirement to immediately line up in Piggyback if a single failure of HP-24 or HP-25 occurred during/after a small break LOCA.

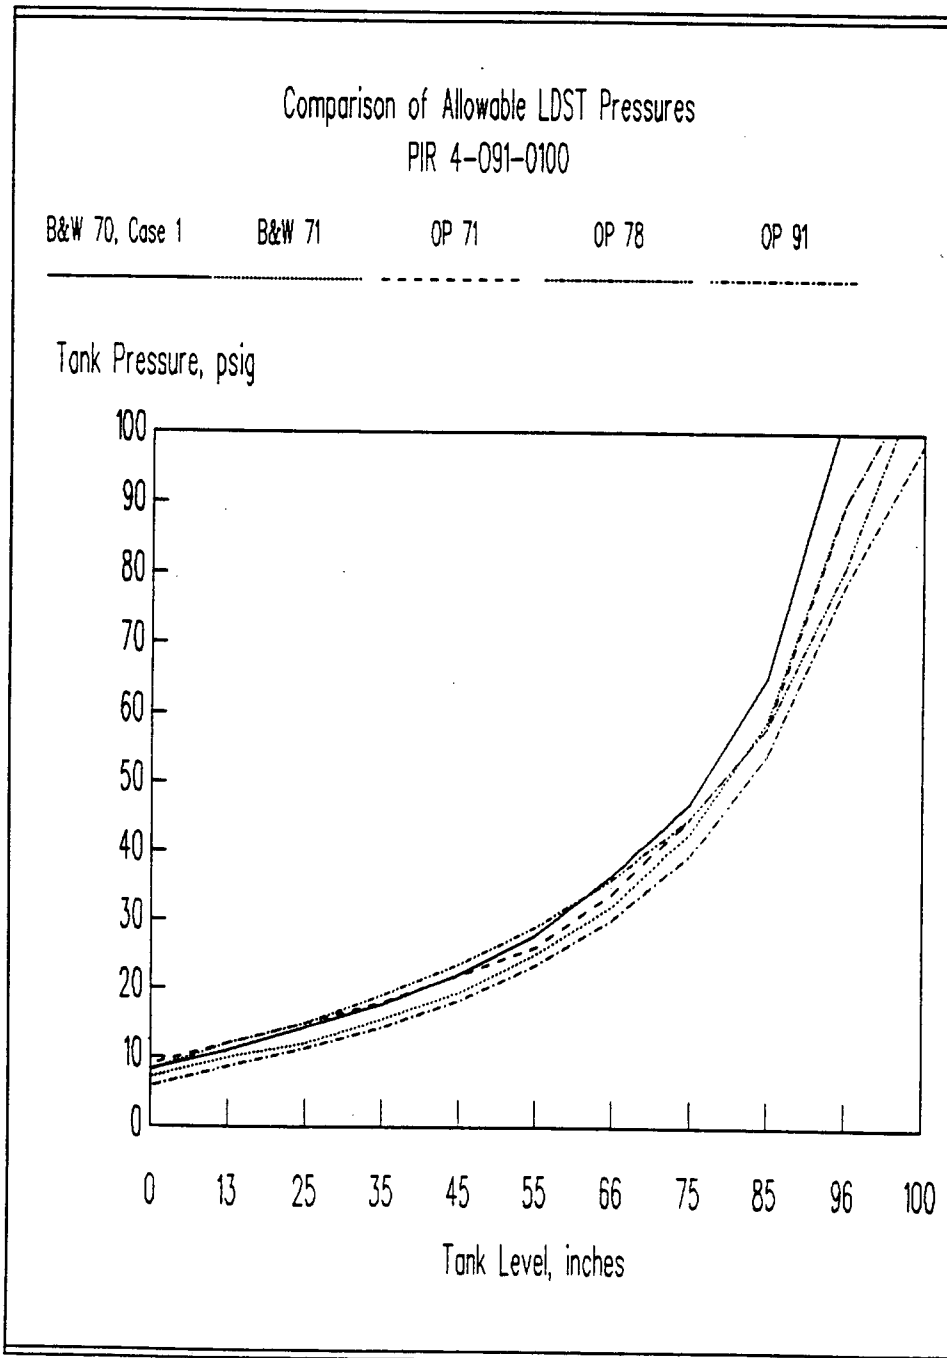
On September 19, 1991, at 1225 hours, while reviewing an alarm setpoint change, Design Engineering determined that the operating limit curve for Letdown Storage Tank (LDST) Pressure versus Level was inadequate. Use of this curve could permit operation outside the design basis for the emergency injection function of the High Pressure Injection (HPI) system. It was determined that, under certain small break LOCA scenarios, a single failure could result in hydrogen gas from the LDST expanding into the suction piping of the HPI pumps, causing the pumps to be damaged. This deficiency has existed on all three Oconee units since initial startup. At the time of discovery, Unit 1 was shutdown for refueling and Units 2 and 3 were both at 100 % full power. Corrective actions were to revise the operating limit curve and to provide additional instructions for operator action. The root cause was Design Deficiency.

A Duke Power curve was drawn and included in station operating procedures on 9/30/71. It is virtually equal to the B&W 1970 Case 1 curve for levels less than 55 inches and more conservative at higher levels. Subsequently the curve was redrawn several times as part of general procedure upgrades. No procedure change documentation mentions any intentional changes to the curves, but there are minor differences between the various versions. The 1978 version was less conservative than the 1971 version, especially between 25 to 75 inches, which includes the normal operating range.

Figure 1 LDST Pressure vs Level

As immediate corrective action DE provided new curves for use in the affected operating procedures. The new curves are slightly more restrictive so as to provide an additional safety margin to assure that hydrogen gas in the LDST will not expand into the HPI pump suction piping for any scenarios which do not involve single failure of a valve in the path from the BWST. Additionally, new instructions were provided to the operators for an alternative mitigating action if the single failure scenario does occur. Under the new guidance, operators will have at least thirty minutes to realign the HPI and Low Pressure Injection (LPI) [EII:BP] systems into "Piggyback" mode if a failure of either HP-24 or 25 is observed after an accident. The flow path would then be from the BWST through the LPI pumps to the HPI pump suction. This path would allow the LPI pumps to supply enough additional head pressure to assure that the hydrogen could not expand into the suction piping. This information was provided verbally to the Operations personnel on shift at the time. Procedure changes to incorporate the revised curves were approved later in the day of September 19, 1991.

1. Evaluate revision of operating procedure for another, more restrictive, curve which would not require any operator action.
2. Establish Station Directive guidance related to preparation and review of safety significant curves used in station procedures to better assure accuracy. Existing curves will be reviewed when changed or when the procedure is reissued.
