SUBJECT: Special Rept 1-091-0101, on 910920, LPI sys inadvertently overpressurized, causing of loss approx 12,400 gallons of RCS inventory to liquid waste disposal sys. Caused by mgt deficiency. Procedures revised & training conducted.

Subject: Oconee Nuclear Station
Docket Nos. 50-269, -270, -287
Special Report Concerning
Low Pressure Injection System

| TITLE(4) Low Pressure Injection System Overpressurized Due to Management Deficiency | | | | | | | | | | | | | | | | |

Special Report

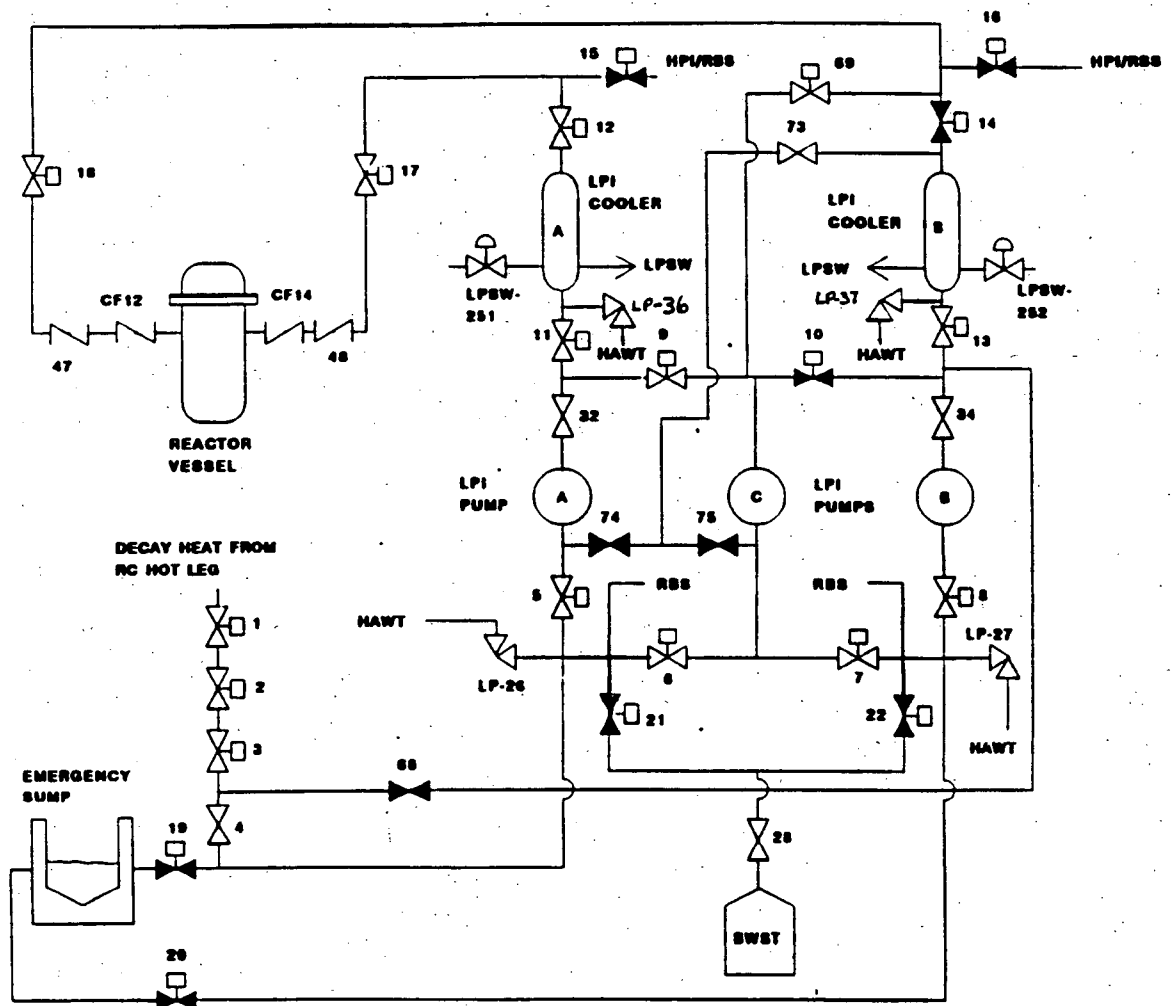
ATTACHMENT 1

LOW PRESSURE INJECTION SYSTEM

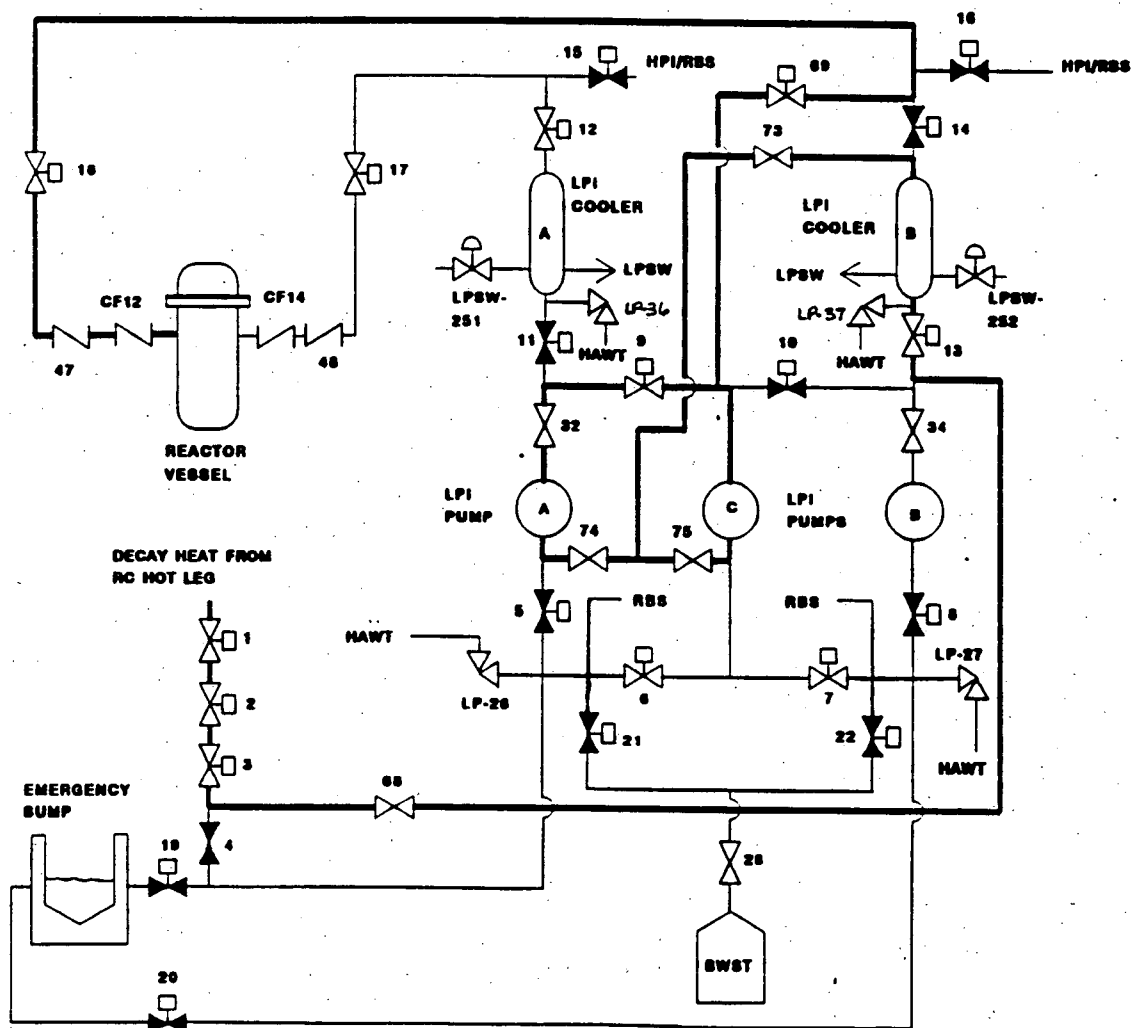
ATTACHMENT 2

LOW PRESSURE INJECTION SYSTEM
SWITCHOVER MODE
