SUBJECT: LER 92-004-00: on 920508, unit 1 reactor tripped from 14% full power to low discharge pressure on MFP. Caused by mgt deficiency. Operators trained on hotwell level oscillations & task specific procedure developed. W/920608 ltr.

Subject: Oconee Nuclear Site
Docket Nos. 50-269, -270, -287
LER 269/92-04

FACILITY NAME (1) Oconee Nuclear Station, Unit 1										DOCKET NUMBER (2) 0 5 0 0 0 2 6 9 1				PAGE (3) OF 0 7		
TITLE (4) Reactor Trip Results From Low Main Feedwater Pump Discharge Pressure Due to Management Deficiency																
EVENT DATE (5)			LER NUMBER (6)			REPORT DATE (7)			OTHER FACILITIES INVOLVED (8)							
MONTH	DAY	YEAR	YEAR	SEQUENTIAL NUMBER	REVISION NUMBER	MONTH	DAY	YEAR	FACILITY NAMES				DOCKET NUMBER(S)			
0 5	0 8	9 2	9 2	0 0 4	0 0	0 6	0 8	9 2					0 5 0 0 0			
OPERATING MODE (9)		THIS REPORT IS SUBMITTED PURSUANT TO THE REQUIREMENTS OF 10 CFR §: (Check one or more of the following) (11)														
N		20.402(b)				20.405(c)				<input checked="" type="checkbox"/> 50.73(a)(2)(iv)				73.71(b)		
POWER LEVEL (10)		20.405(a)(1)(i)				50.36(c)(1)				50.73(a)(2)(v)				73.71(c)		
1 4		20.405(a)(1)(ii)				50.36(c)(2)				50.73(a)(2)(vii)				OTHER (Specify in

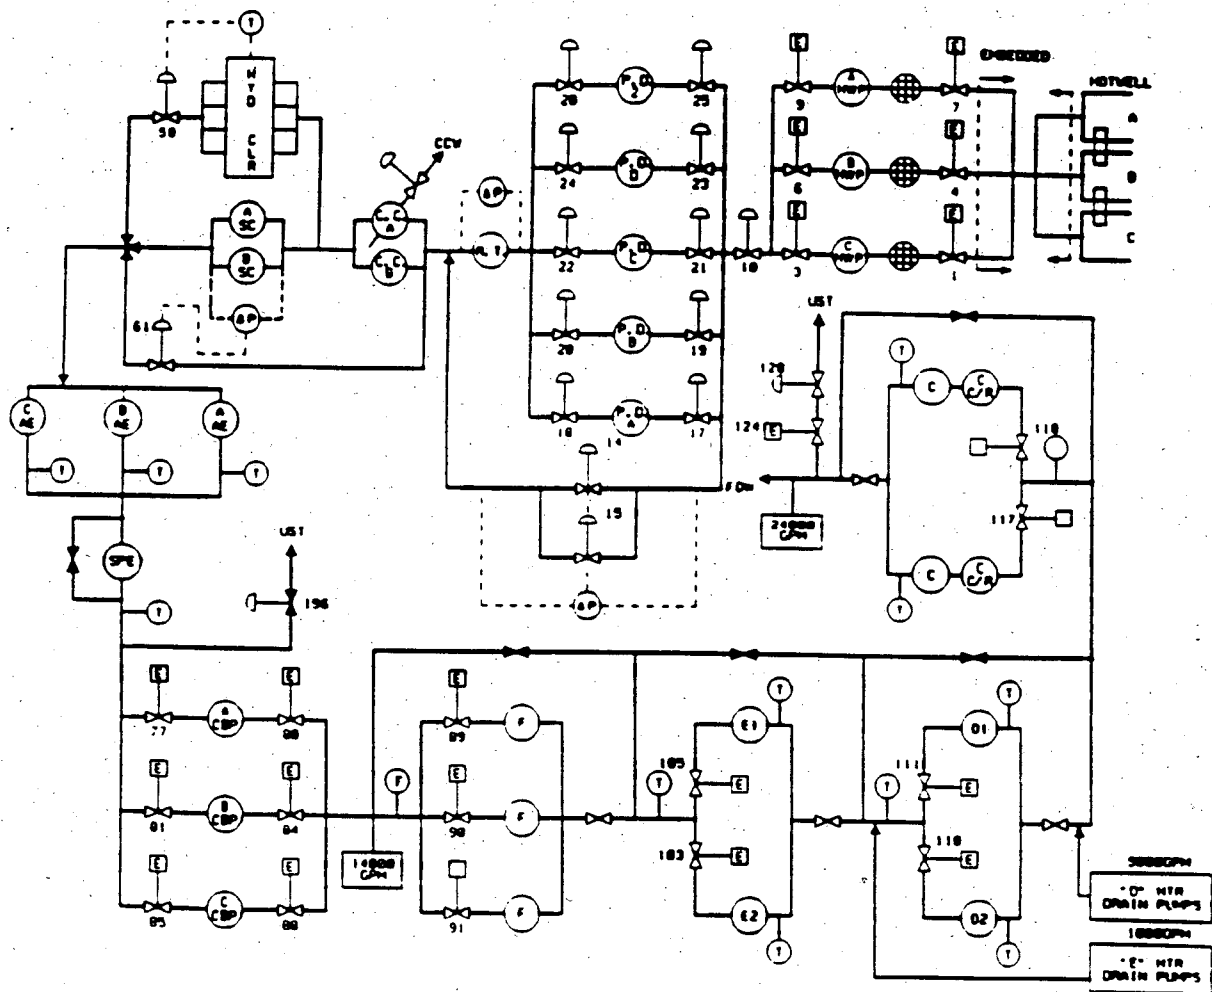
ATTACHMENT 1

The Condensate System [EIIS:SD] originates at the condenser hotwell. The Hotwell Pumps and Condensate Booster Pumps increase system pressure to that required for the Main Feedwater Pump (MFDWP) net positive suction head. The Upper Surge Tank provides a surge volume for the Condensate System. (See Attachment 1)

At 0340 hours, the CR SRO, Shift Manager, and Shift Supervisor decided on a method to reduce hotwell level, which only involved opening two valves in the Condensate System. This included opening 1C-124 (Condensate Recirc to Upper Surge Tank) and then opening 1C-128 (Condensate Recirc Control) to divert condensate to the Upper Surge Tank and then to the Condensate Storage Tank. After completing this lineup it would be transferred to another unit. The CR SRO stated that he had reduced hotwell level using this method on other occasions. The CR SRO stated that actions in the Alarm Response Manual would not solve the high level, because the Alarm Response procedure (1SA6/C-12) did not address the unit's specific operating condition.

At approximately 0342 hours, the CR SRO told CRO to verify that 1C-128 (Condensate Recirc Control) was in the closed position. After verifying 1C-128 closed, the CR SRO instructed the RO to open 1C-124. Upon opening 1C-124, 1B MFDWP discharge pressure decreased to approximately 800 psig, causing Reactor Protective System Channels A, B, C, and D Feedwater Pump Anticipatory Trip to initiate a Reactor and Main Turbine Trip at 0342:16 hours. The CRO immediately closed 1C-124.
