SUBJECT: LER 92-005-00: on 920508, unit tripped from 14% full power & emergency feedwater actuated. Caused by equipment failure & defective procedure. Solenoid valve replaced & post-trip review directive revised. W/920709 ltr.

Subject: Oconee Nuclear Site
Docket Nos. 50-269, -270, -287
LER 269/92-05

FACILITY NAME (1) Oconee Nuclear Station, Unit 1										DOCKET NUMBER (2) 0 5 0 0 0 2 6 9				PAGE (3) 1 OF 0 8		
TITLE (4) Equipment Failure and Defective Procedure Result In Operation In Violation of Technical Specification																
EVENT DATE (5)			LER NUMBER (6)				REPORT DATE (7)			OTHER FACILITIES INVOLVED (8)						
MONTH	DAY	YEAR	YEAR	SEQUENTIAL NUMBER	REVISION NUMBER	MONTH	DAY	YEAR	FACILITY NAMES				DOCKET NUMBER(S)			
0 5	1 0	9 2	9 2	0 0 5	0 0 0	0 7	0 9	9 2					0 5 0 0 0			
OPERATING MODE (9) N			THIS REPORT IS SUBMITTED PURSUANT TO THE REQUIREMENTS OF 10 CFR §: (Check one or more of the following) (11).													
POWER LEVEL (10) - 0 -			20.402(b)				20.406(c)				50.73(a)(2)(iv)				73.71(b)

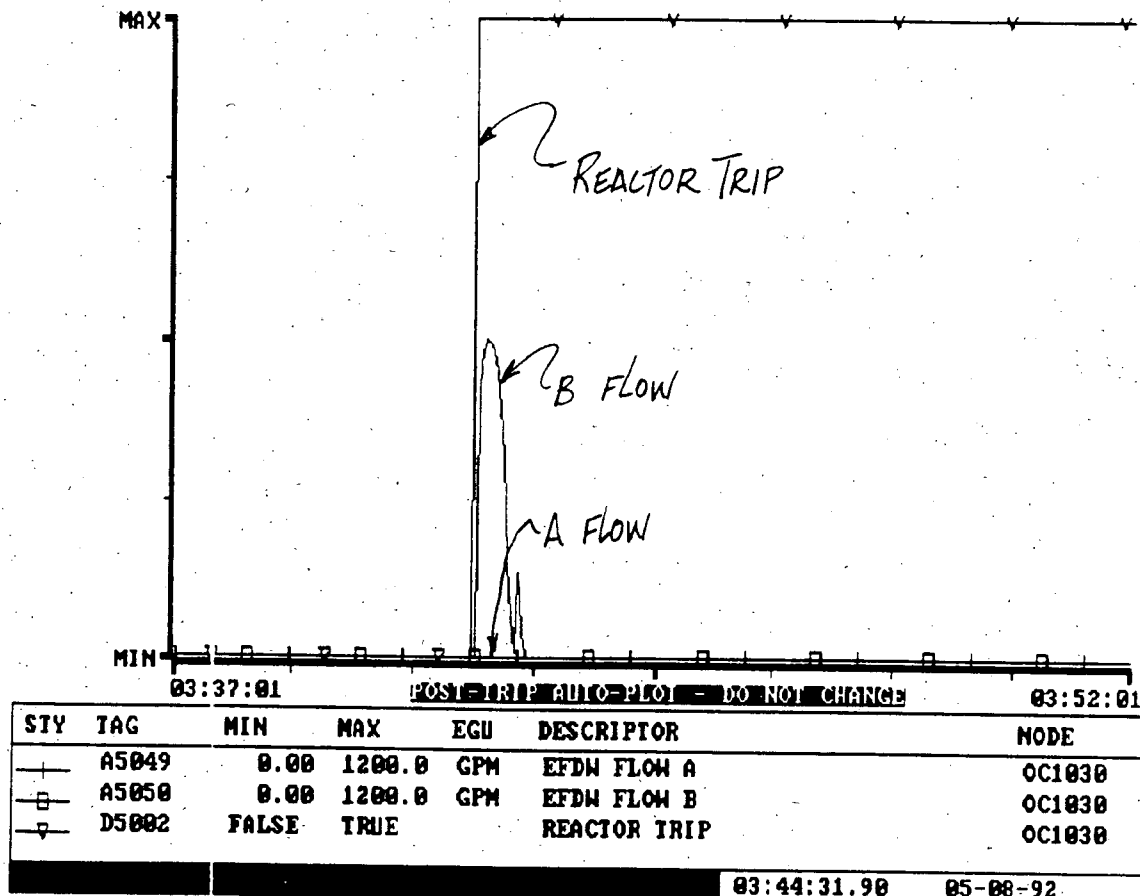
ATTACHMENT A

The transient monitor plot (See Attachment A) for Emergency Feedwater (EFDW) flow that was submitted as part of the Reactor Transient Analysis was plotted on a 15 minute time line. The MDEFDWPs were on for approximately 43 seconds. The amount of time the EFDW controls called for 1FDW-315 and 1FDW-316 to be open was only 15-30 seconds. Unless the flow parameter had been observed by the Control Room Operator during this time frame, it would not have been detected. The personnel performing Post Trip Review and Transient Analysis stated that they did not place sufficient emphasis on the EFDW flow aspect since the B MFDW pump remained on during the event and both Motor Driven EFDW pumps started. They also observed that steam generator levels tracked together to approximately 18 inches immediately following the reactor trip and progressed to the level where EFDW maintains (30 inches).

The Post Trip Review Checklist did not explicitly require documentation that flow had been established in both SG trains. The transient monitor plot showing EFDW train A and B flow was not clear in showing that both EFDW trains had exhibited flow.

1. Enhance the Post Trip Review process as necessary, specifically addressing the verification of Emergency Feedwater Flow.
