SUBJECT: LER 92-008-00: on 920717, discovered that closing circuit fuse in ACB-8 breaker blow, causing inoperability of Keowee Unit 2. Caused by failure of positive 10 amp 1B feeding breaker. Fuses removed & replaced by DT10 fuses. W/920817 ltr.

Subject: Oconee Nuclear Site
Docket Nos. 50-269, -270, -287
LER 269/92-08

FACILITY NAME (1) Oconee Nuclear Station, Unit 1										DOCKET NUMBER (2) 0 5 0 0 0 2 6 9				PAGE (3) 1 OF 1 0			
TITLE (4) Equipment Failure And Inappropriate Action Result In The Concurrent Inoperability Of Both Onsite Emergency Power Sources And A Technical Specification Violation																	
EVENT DATE (5)			LER NUMBER (6)				REPORT DATE (7)			OTHER FACILITIES INVOLVED (8)							
MONTH	DAY	YEAR	YEAR	SEQUENTIAL NUMBER	REVISION NUMBER	MONTH	DAY	YEAR	FACILITY NAMES				DOCKET NUMBER(S)				
									Oconee, Unit 2				0 5 0 0 0 2 7 0				
0 7	1 7	9 2	9 2	0 0 8	0 0	0 8	1 7	9 2	Oconee, Unit 3				0 5 0 0 0 2 8 7				
OPERATING MODE (9)		THIS REPORT IS SUBMITTED PURSUANT TO THE REQUIREMENTS OF 10 CFR §. (Check one or more of the following) (11)															
N		20.402(b)				20.405(c)				50.73(a)(2)(iv)				73.71(b)			
POWER LEVEL (10)		20.405(a)(1)(i)				50.36(e)(1)

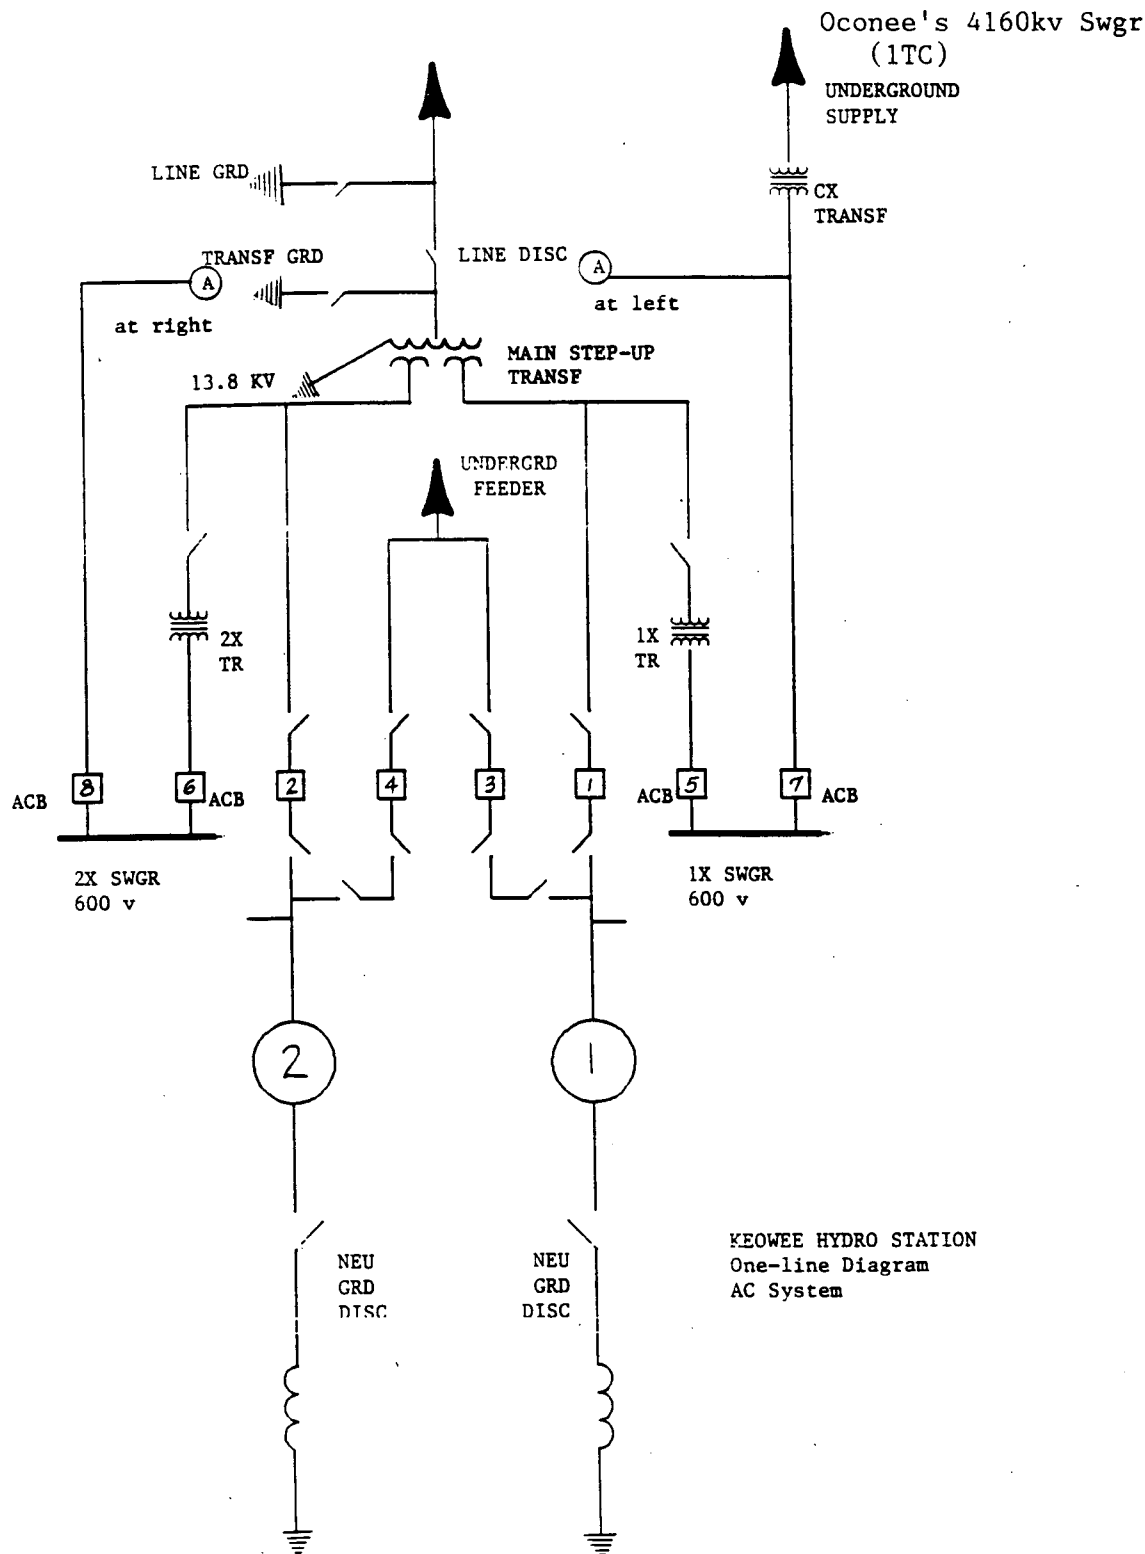
ATTACHMENT 1

The Keowee 600 VAC Switchgears 1X and 2X with their normal and alternate feeder breakers will provide power to the Keowee auxiliary loads. (See Attachment 1) Keowee's Auxiliary Switchgear 1X and 2X receive their normal, non-emergency power from the 230 KV switchyard back charging Keowee's Main Step-up Transformer through ACB-5 and ACB-6. An alternate power source is provided to 1X and 2X Switchgear from one of Oconee Unit 1's 4160 VAC Switchgear (1TC) through Keowee's CX Transformer and the Alternate Feeder Breakers ACB-7 and ACB-8, respectively. With only one Keowee Unit available and tied to the underground and a Loss of Offsite Power occurs, the only available Keowee Auxiliary power source is through CX. Therefore, a loss of CX or ACB-7 or 8 makes the associated Keowee Unit tied to the underground technically inoperable.
