SUBJECT: LER 92-010-00: on 920819, determined that under postulated LOCA, coincident w/LOP, fault on nonsafety load could trip upstream Keowee auxiliary load ctr breaker. Caused by design defect. Breakers modified. W/920916 ltr.

Subject: Oconee Nuclear Site
Docket Nos. 50-269, -270, -287
LER 269/92-10

FACILITY NAME (1) Oconee Nuclear Station, All Units												DOCKET NUMBER (2) 0 5 0 0 0 2 6 9				PAGE (3) 1 OF 0 9			
TITLE (4) Design Deficiency Results In Technical Inoperability Of Oconee Emergency Electrical Power Sources																			
EVENT DATE (5)			LER NUMBER (6)			REPORT DATE (7)			OTHER FACILITIES INVOLVED (8)										
MONTH	DAY	YEAR	YEAR	SEQUENTIAL NUMBER	REVISION NUMBER	MONTH	DAY	YEAR	FACILITY NAMES						DOCKET NUMBER(S)				
									Oconee, Unit 2						0 5 0 0 0 2 7 0				
0	8	1	9	2	9	2	0	1	0	0	0	9	1	6	9	2	Oconee, Unit 3	0 5 0 0 0 2 8 7	
OPERATING MODE (9)		THIS REPORT IS SUBMITTED PURSUANT TO THE REQUIREMENTS OF 10 CFR §: (Check one or more of the following) (11)																	
N		20.402(b)			20.405(c)			50.73(a)(2)(iv)			73.71(b)								
POWER LEVEL (10)		20.405(a)(1)(i)			50.36(a)(1)			50.73(a)(2)(v)(D)			73.71(c)								
11010		20.405(a)(1)(ii)			50.36(a)(

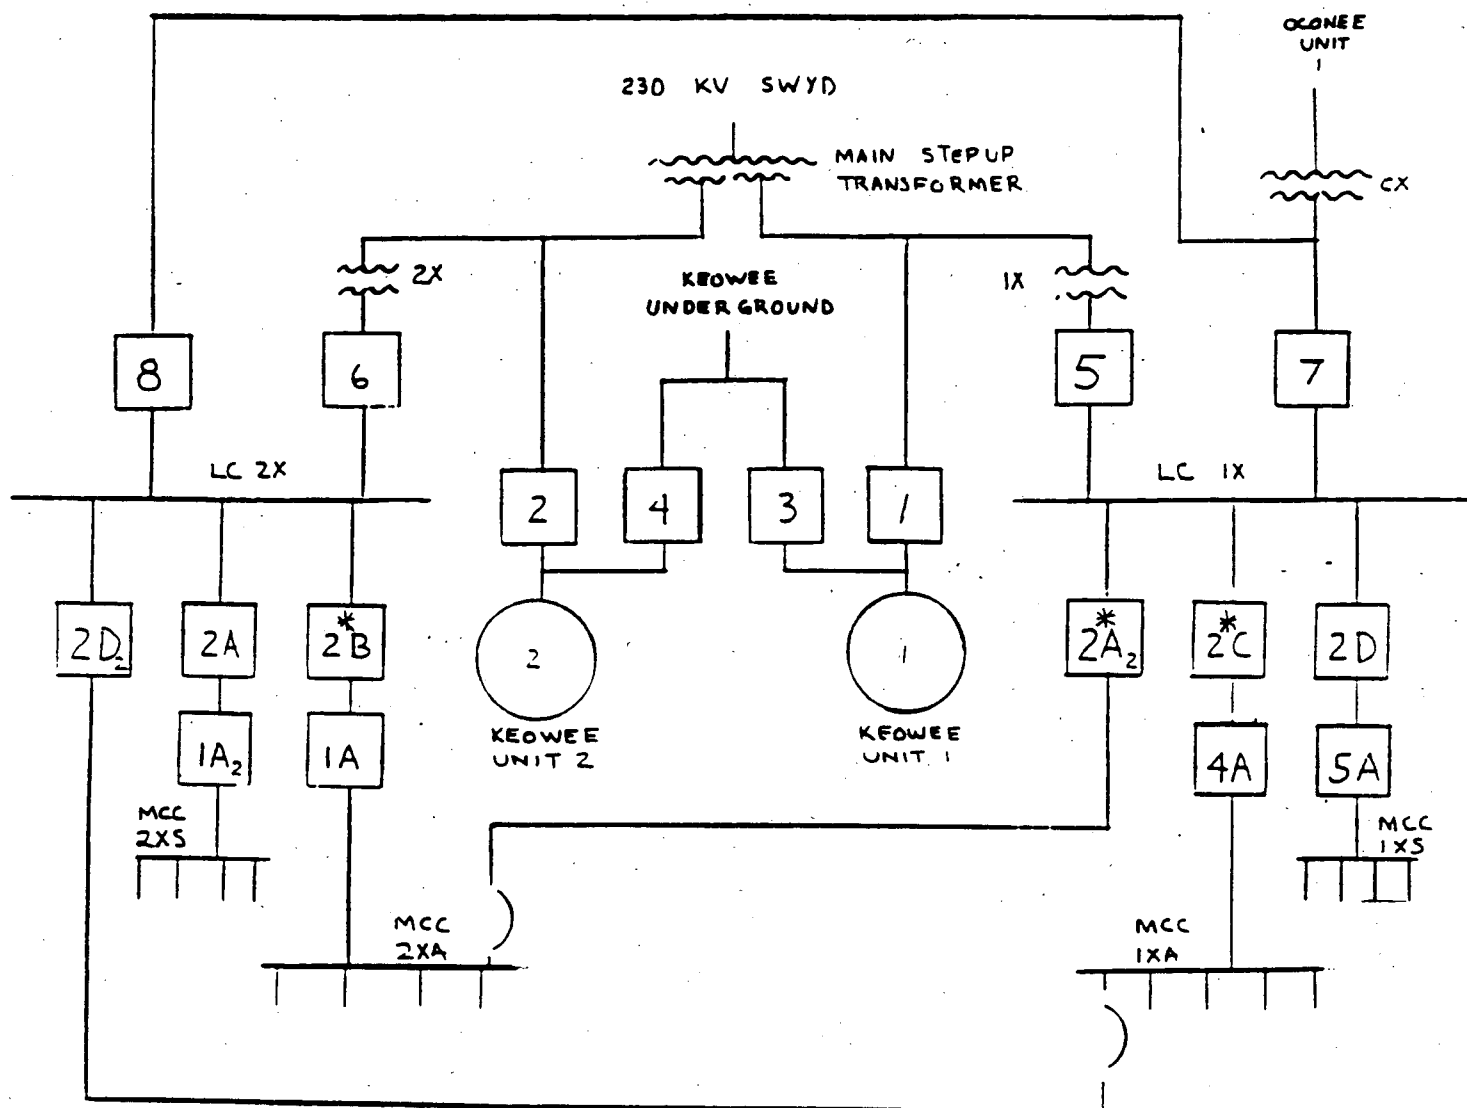
ATTACHMENT 1

The operability of the Keowee Hydro units depends on the ability to supply power to its own essential safety related auxiliary loads (see Attachment 1). These loads are normally supplied from the 230 KV transmission network or Keowee generator output via the Keowee main transformer and transformers 1X and 2X [EIIS:EC]. The CX transformer, powered from Oconee Unit 1, is required for the unit aligned to the underground path to be operable. The auxiliary transformers (1X, 2X or CX) supply the 1X and 2X load centers [EIIS:EC] which, in turn, supply motor control centers 1XA, 2XA, 1XS, and 2XS. 1XA and 2XA supply safety related loads at the Keowee Hydro station and also some non-safety related loads.

The existence of a breaker coordination problem made both Keowee units technically inoperable. After a Loss of Offsite Power (LOOP), if a fault were to occur on a non-safety related load powered from 1XA or 2XA, the discriminator circuit may isolate the load center before the individual load can be isolated. Under these conditions, the Keowee units would start when required. The amount of time that they would run prior to tripping due to low governor oil pressure depends on the initial governor oil pressure, the amount of load supplied by the unit, and the rate at which load is increased. The Keowee operators have local indication of the loss of the load center and various alarms due to the loss of motor control center loads. It is possible that the loss of Keowee auxiliary power might be diagnosed and corrected prior to the Keowee unit trip.

KEOWEE HYDROELECTRIC STATION AUXILIARY POWER SYSTEM

*BREAKERS AFFECTED BY DISCRIMINATOR

- 1) A modification was performed to jumper out the discriminator circuitry. After the installation of the modification, the LCO was exited.
