SUBJECT: LER 92-011-00: on 920827, failure of Keowee Hydro (KH) underground feeder air circuit breaker (ACB) could cause KH overhead feeder ACB to close, resulting in EP loss. Caused by design deficiency. KH units declared inoperable. W/920924 ltr.

Subject: Oconee Nuclear Site
Docket Nos. 50-269, -270, -287
LER 269/92-11

Oconee Nuclear Station, Unit 1

Potential Single Failure During A LOCA/LOOP Event May Result In The Loss
Of Emergency Power Due To Design Deficiency

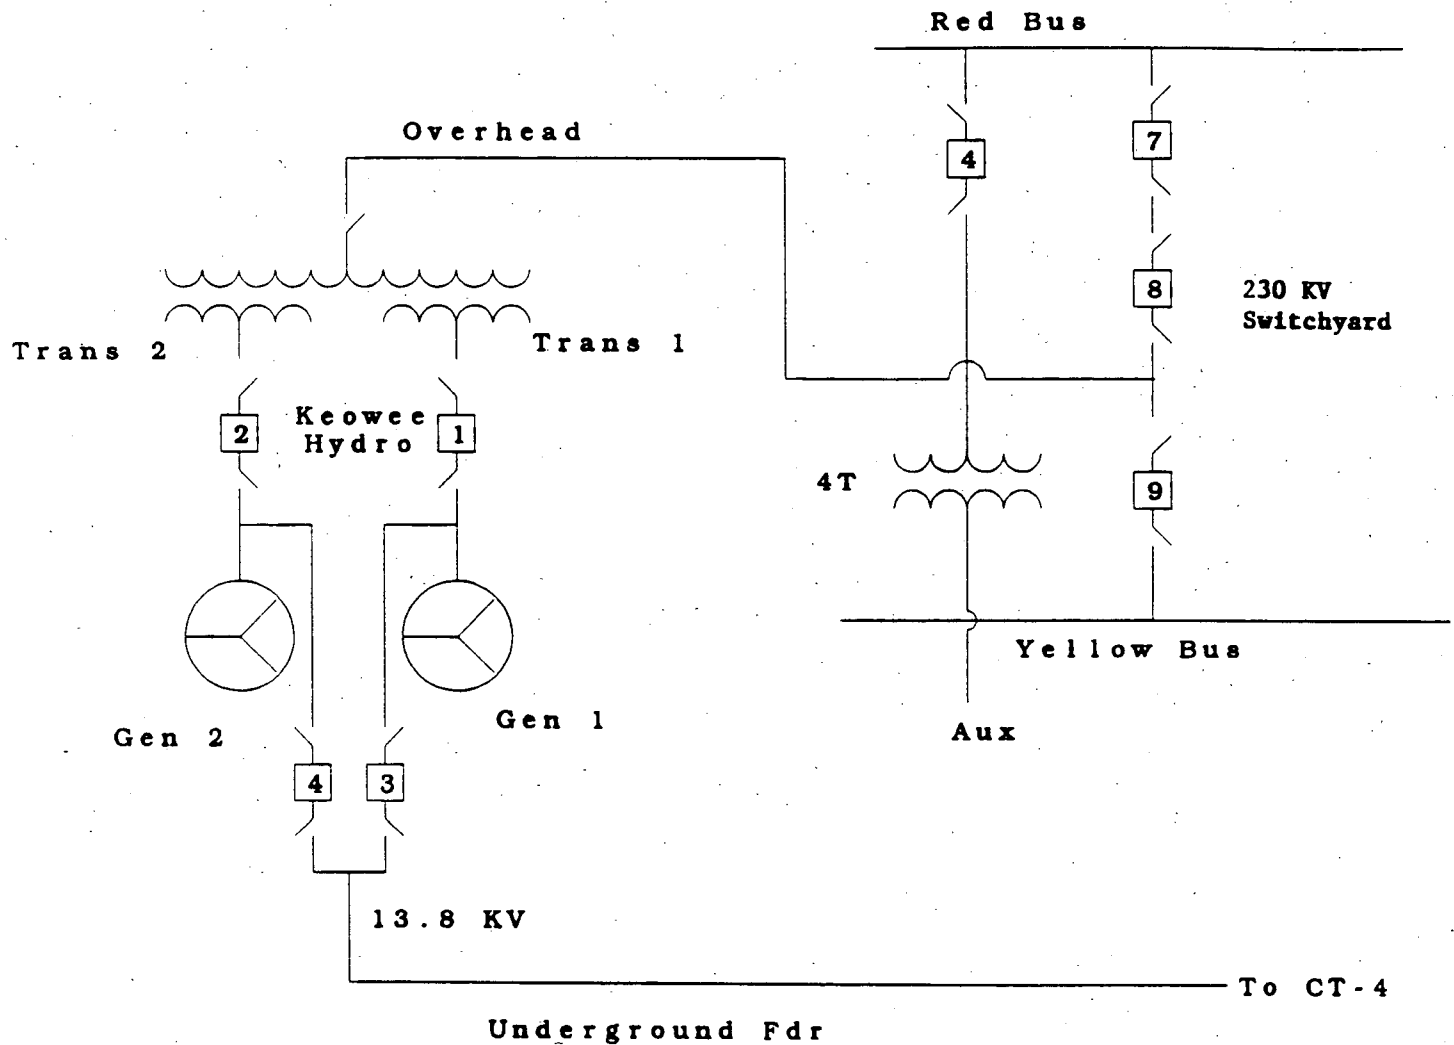
ATTACHMENT 1

The second path is an underground cable feeder to the Oconee transformer CT-4 [EIIS:XFMR] which supplies the redundant standby power buses. The underground feeder is arranged with double air circuit breakers (ACB-3 & ACB-4) so that it, too, can be connected to either KH unit (See Attachment 1). This underground feeder is connected, at all times, to one KH generator [EIIS:GEN] on a predetermined basis and is energized along with CT-4 whenever the associated KH unit is in service. The underground feeder and associated transformer (CT-4) are sized to carry full engineered safeguards loads of one Oconee unit plus the auxiliary loads required for safe shutdown of the other two Oconee units.

The event described in this report involved a LOCA/LOOP Design Basis Event with the unit tied to the underground experiencing a single failure of its underground feeder ACB, causing it to trip, allowing the overhead ACB's to close, thus tying both KH units together. Therefore, this event is considered recurring. Since this problem originated with the initial design of the KH units, the corrective actions for subsequently identified problems could not be expected to have prevented this situation.

The postulated event described in this report requires a single failure which causes a Keowee Hydro (KH) underground feeder Air Circuit Breaker (ACB) to trip due to a fault. This would allow the overhead ACB's to close simultaneously, tying the two KH units together. This could result in the potential damage of both KH units, rendering them inoperable. This event could result in the loss of all automatic emergency power sources for Oconee Nuclear Station.

- 1) The appropriate overhead Air Circuit Breaker (ACB) 1 or 2 was opened by locking an existing key switch interlock and is to remain open until completion of a modification.

- 1) Modify the ACB's control circuitry to preclude the postulated failure as described in this report.
- 2) Complete the single failure analysis of KH Units' power system.
