SUBJECT: LER 92-019-00: on 921210, determined that postulated fault could cause loss of emergency power sys due to design deficiency. C/A included mods to Keowee control circuitry to preclude postulated failure. W/930111 ltr.

Subject: Oconee Nuclear Site  
Docket Nos. 50-269, -270, -287  
LER 269/92-19

FACILITY NAME (1)  
**Oconee Nuclear Station, Unit One**DOCKET NUMBER (2)  
**05000 269**PAGE (3)  
**1 OF 08**TITLE (4) **Postulated Single Failure That Could Result In The Loss Of  
Emergency Power System As Result Of A Design Deficiency**

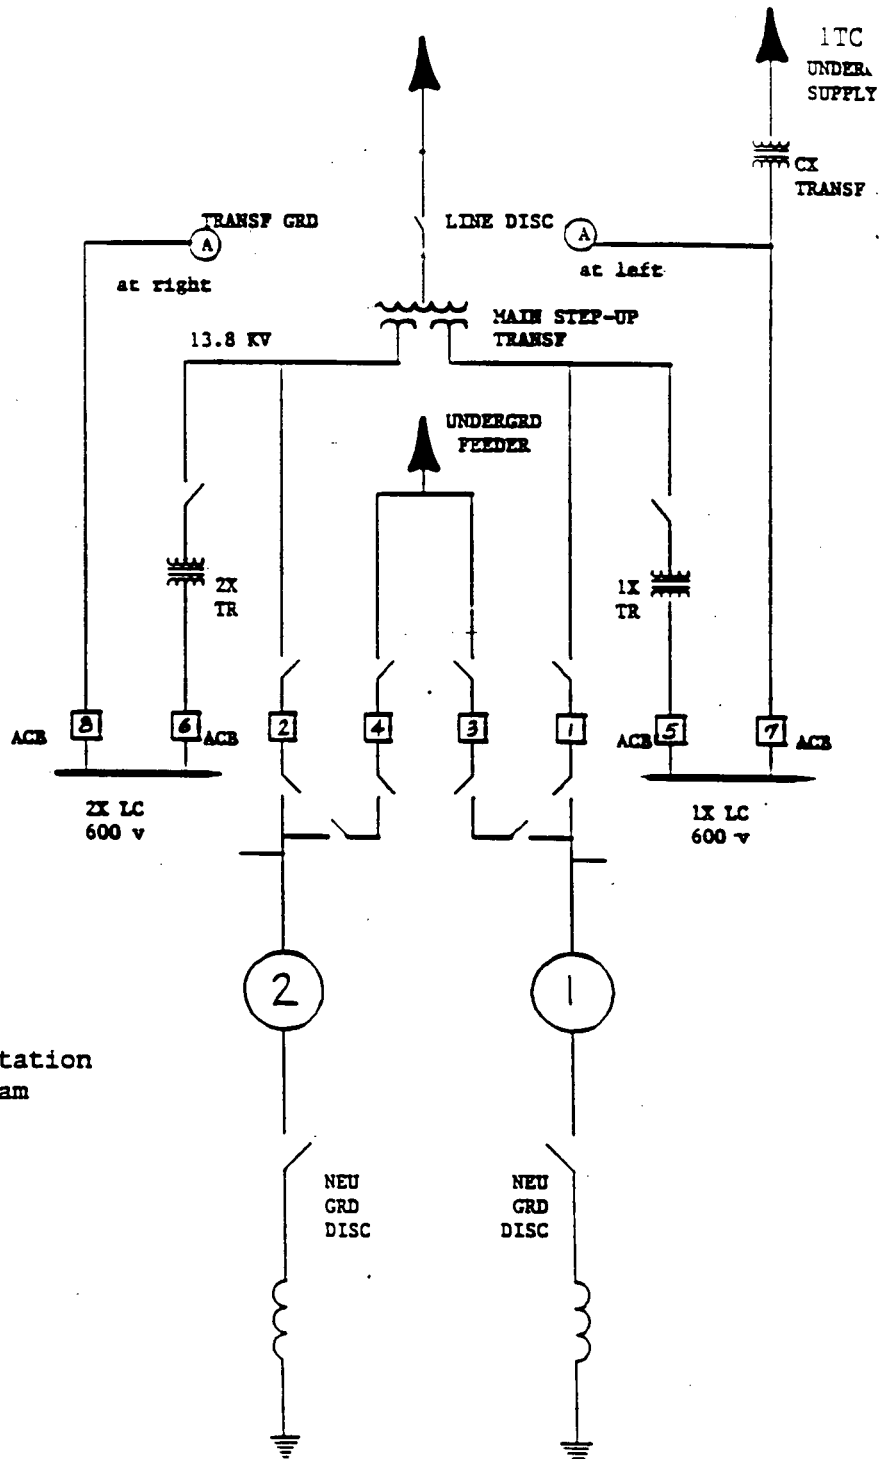
**ATTACHMENT 1**

Either Keowee Hydro Unit ( KHU ) can be tied to the underground or overhead power path. The normal lineup is to dedicate one KHU to the underground emergency power path by closing Air Circuit Breakers ( ACB ) -3 or 4 and to align the other KHU to the overhead power path through ACB-1 or 2 ( See Attachment 1 ).

A fault occurring in the area protected by the transformer differential relay and the Load Center supply breaker overcurrent protection device ( between Normal supply breaker and the Load Center ) on the unit aligned to the underground path, would result in a trip and lockout of the auxiliary Load Center's Normal and Alternate Feeder breakers, the overhead path breakers, and the Oconee Switchyard Tie breakers. A similar postulated fault on the unit aligned to overhead power path would affect the overhead unit only.

Keowee Hydro Station  
One-line Diagram  
AC system

- 1) Implement modifications to the Keowee breaker control circuitry to preclude the postulated failure as described in this report.
