SUBJECT: Forwards special rept re Unit 1 Reactor Bldg Tendon #7,
providing results of engineering review,performed to
justify continued svc of Units 1 & 2.

Subject: Duke Power Company
Oconee Nuclear Station, Unit 1
Docket No. 50-269
Reactor Containment Building
Tendon Surveillance #7

OCONEE UNIT 1
Seventh Tendon Surveillance
Technical Specification 3.6.7.2.c Special Report

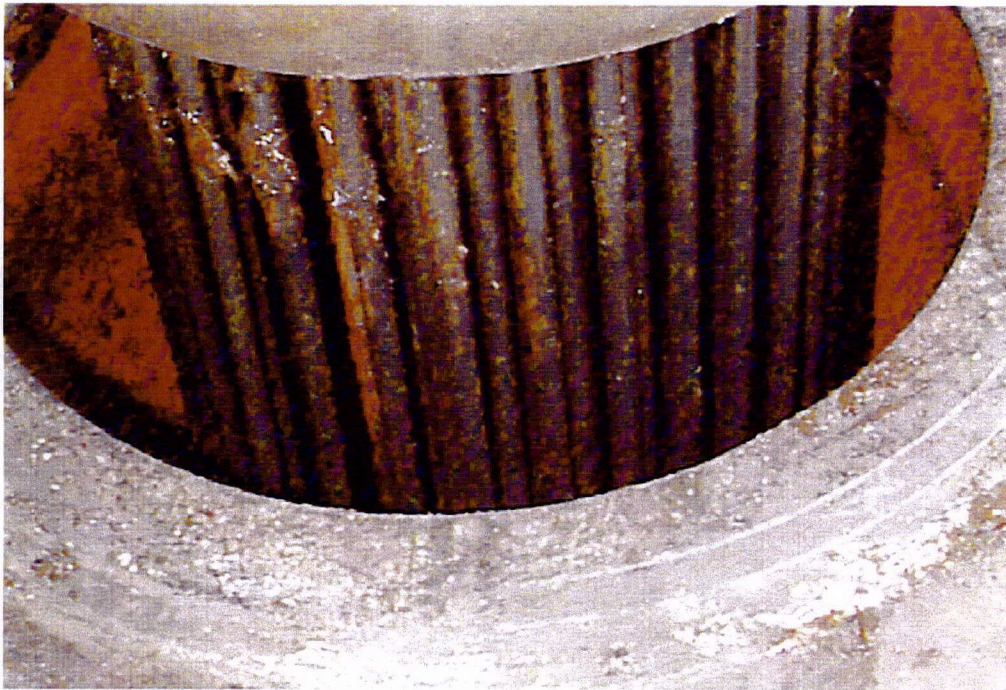
FIGURE 1
Surface Corrosion on Wires

The anchorage components, stressing washers, shims, and bearing plates, were examined for corrosion, corrosion level, and grease coverage. Tendons 23V14, 23V20 and 23V22 had good grease coverage, but some surface corrosion (with no pitting) was observed on the buttonheads and stressing washers. Some pitting was noted on the bearing plates, but was generally outside the cap. In addition, for tendon 23V16, pitting less than 0.003 inches deep was observed on the stressing washers and buttonheads, and some surface corrosion was noted on the wires. However, there was no significant reduction in wire cross sectional area. Photographs are

provided in Figures 1-3 to illustrate these conclusions. No corrosion was observed on the wires of any tendon on the field (lower) end, despite the presence of standing water in this part of the sheath. The water had no free surface for oxygen replenishment, and the oxygen originally contained in the water had apparently been scavenged by corrosion activity on other surfaces such as the tendon sheath. Table I provides a summary of corrosion levels and grease coverage on the bearing plate, shims, buttonheads, and stressing washer.

Note: Orange color on trumpet is primer. Wire left of center was observed to have most corrosion. Corrosion was present only on the side toward the viewer. Surface is rough, raised approximately 1/16" over adjacent surface.
