DUKE POWER COMPANY

Jocassee Development
Report on the August 25, 1979
Earthquake and its effect on the
Jocassee Structures

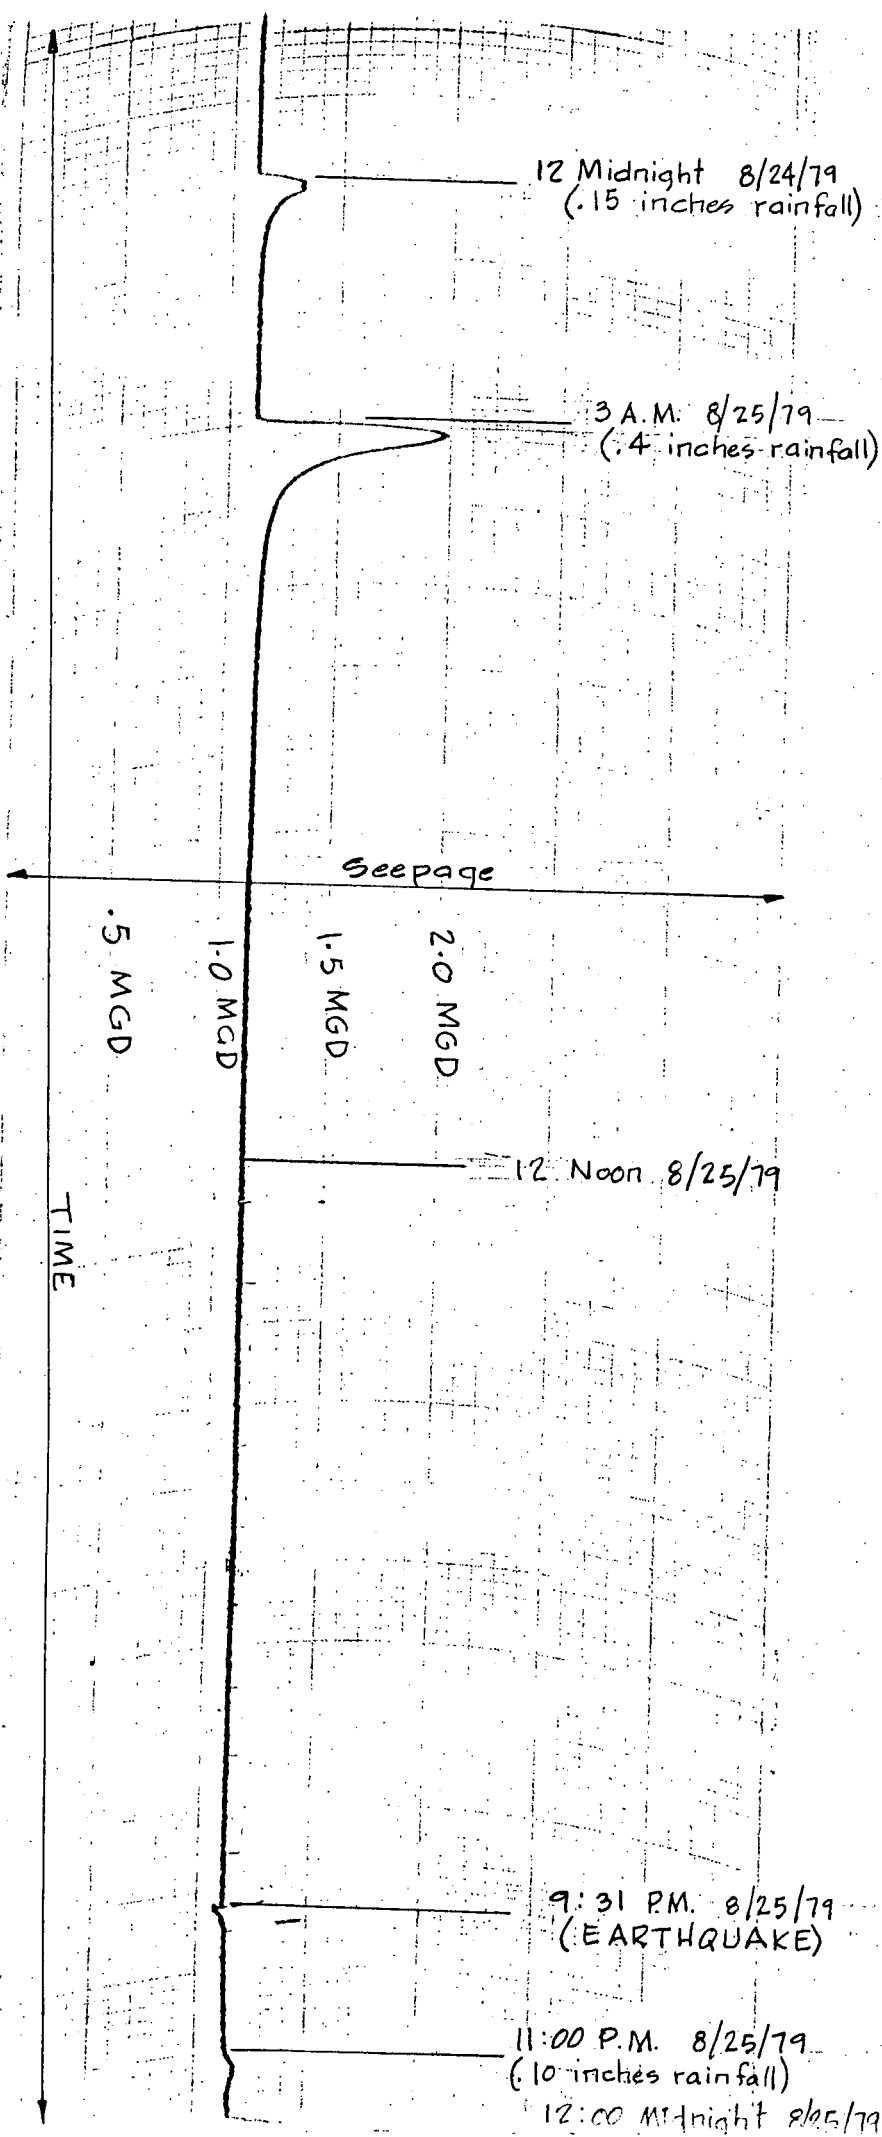
FIGURE A

A Parshall Flume is used to measure cumulative seepage on the west abutment. A recording chart is used to monitor the flow instantaneously. Attached as Figure A is a copy of the chart for the day of August 25, 1979 showing an almost indiscernable increase in the seepage following the seismic event.

West Abutment Seepage
Parshall Flume Tape
For 8/25/79

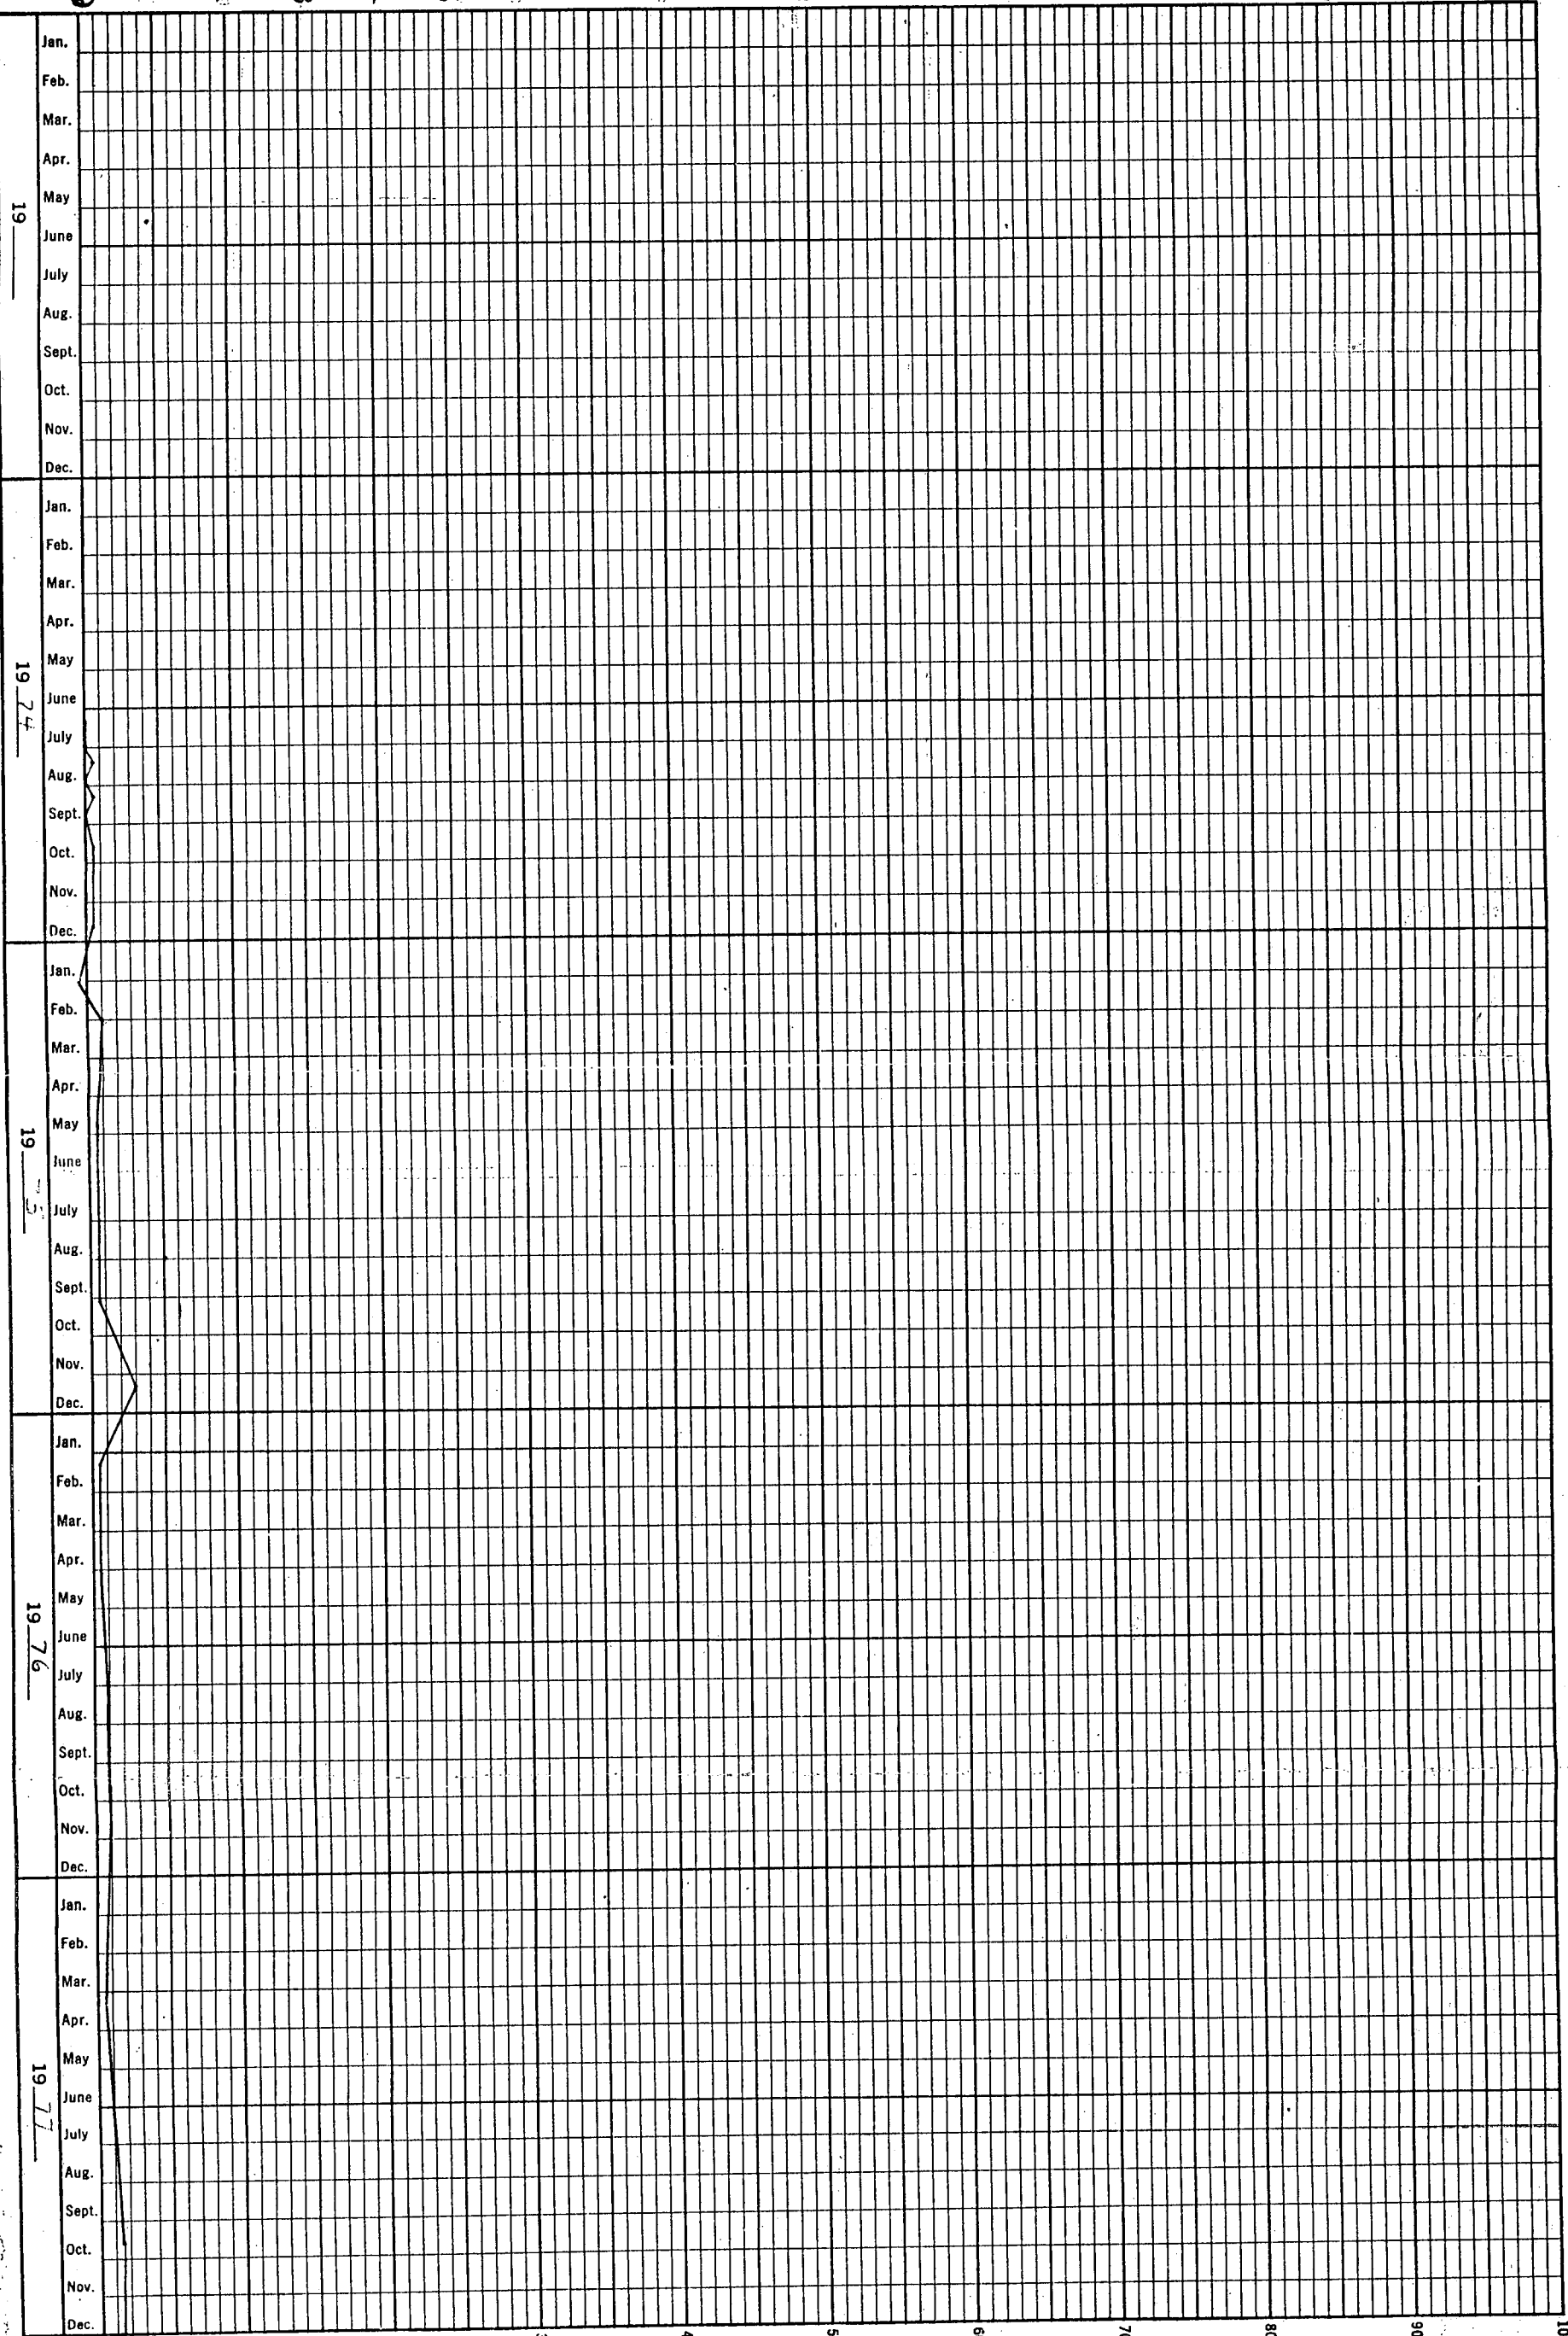
FIGURE C-1(a)

The readings showed a maximum horizontal deflection of .03 ft. which is very small when compared to the readings to date. Graphs showing horizontal deflection versus time are attached as Figures C-1(a) through C-9(a) for 1973-77 and C-1(b) through C-9(b) for 1978-79. Measurements taken on August 23, 1979 and August 27, 1979 were incorporated in the above plots.

Monument # 1 at Station 3+00 (Jocassee Dam)

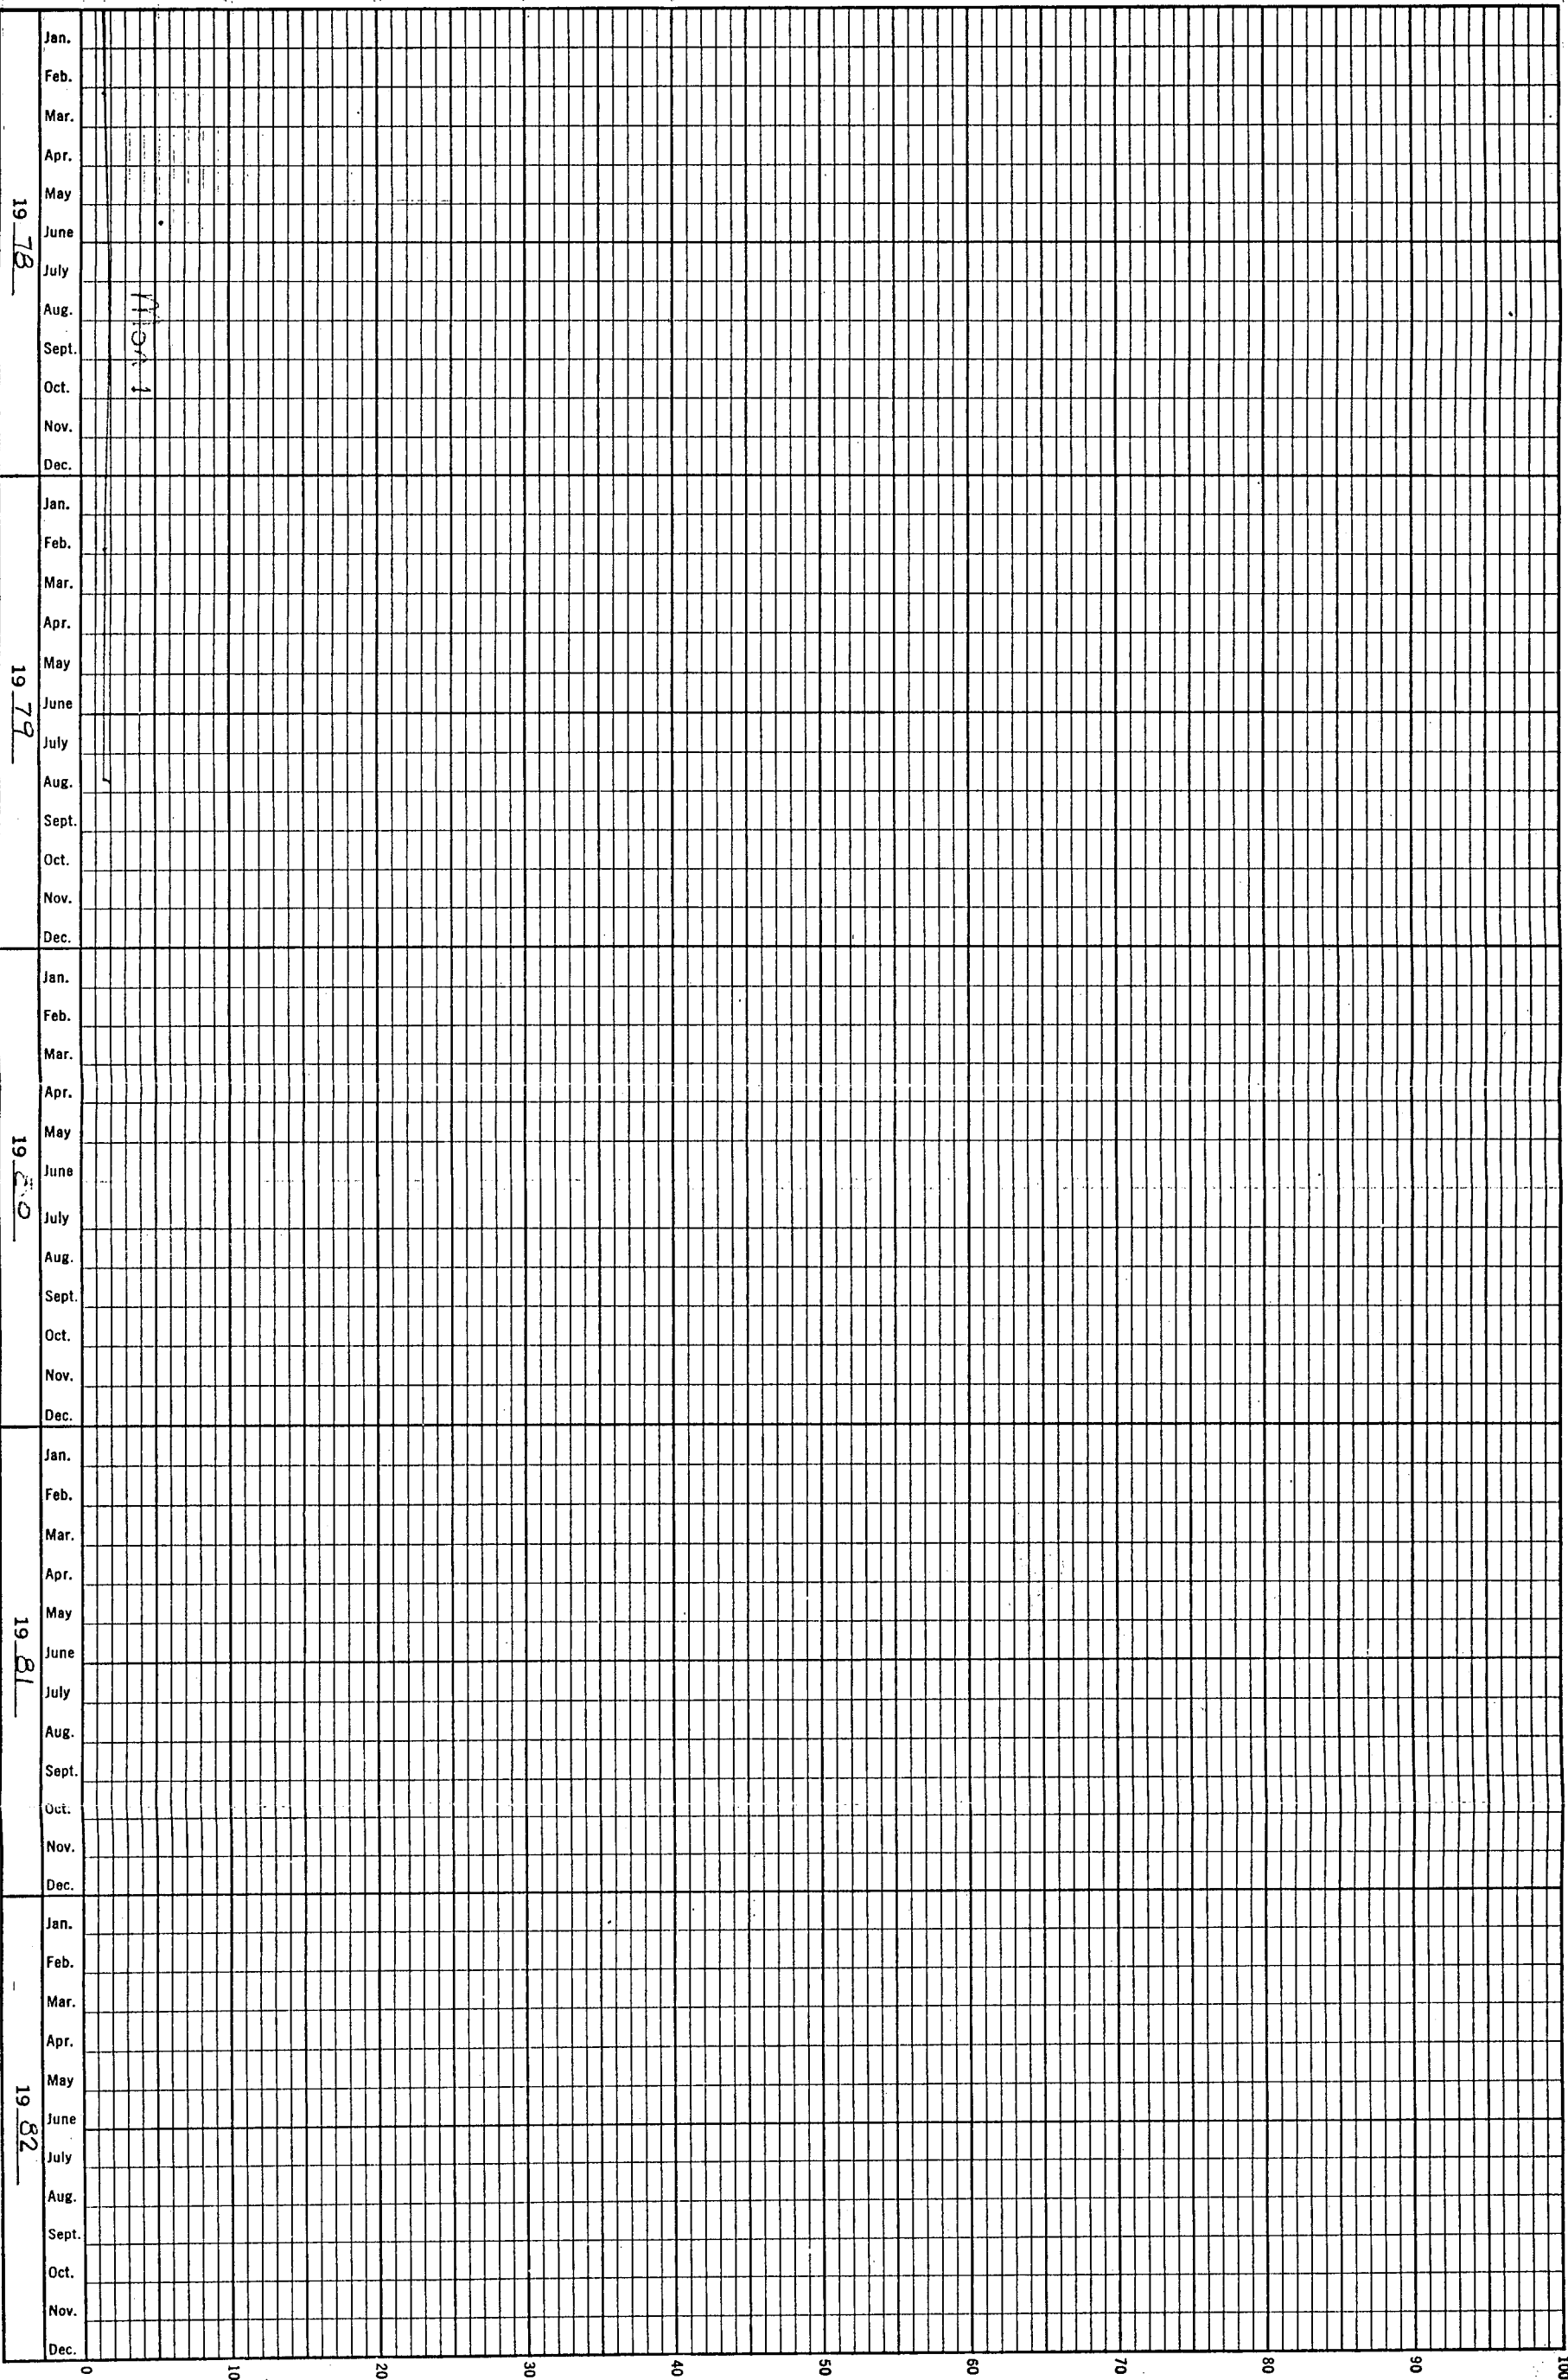
FIGURE C-1(b)

JOCASSEE DAM MONUMENT #1 at STATION 3+00

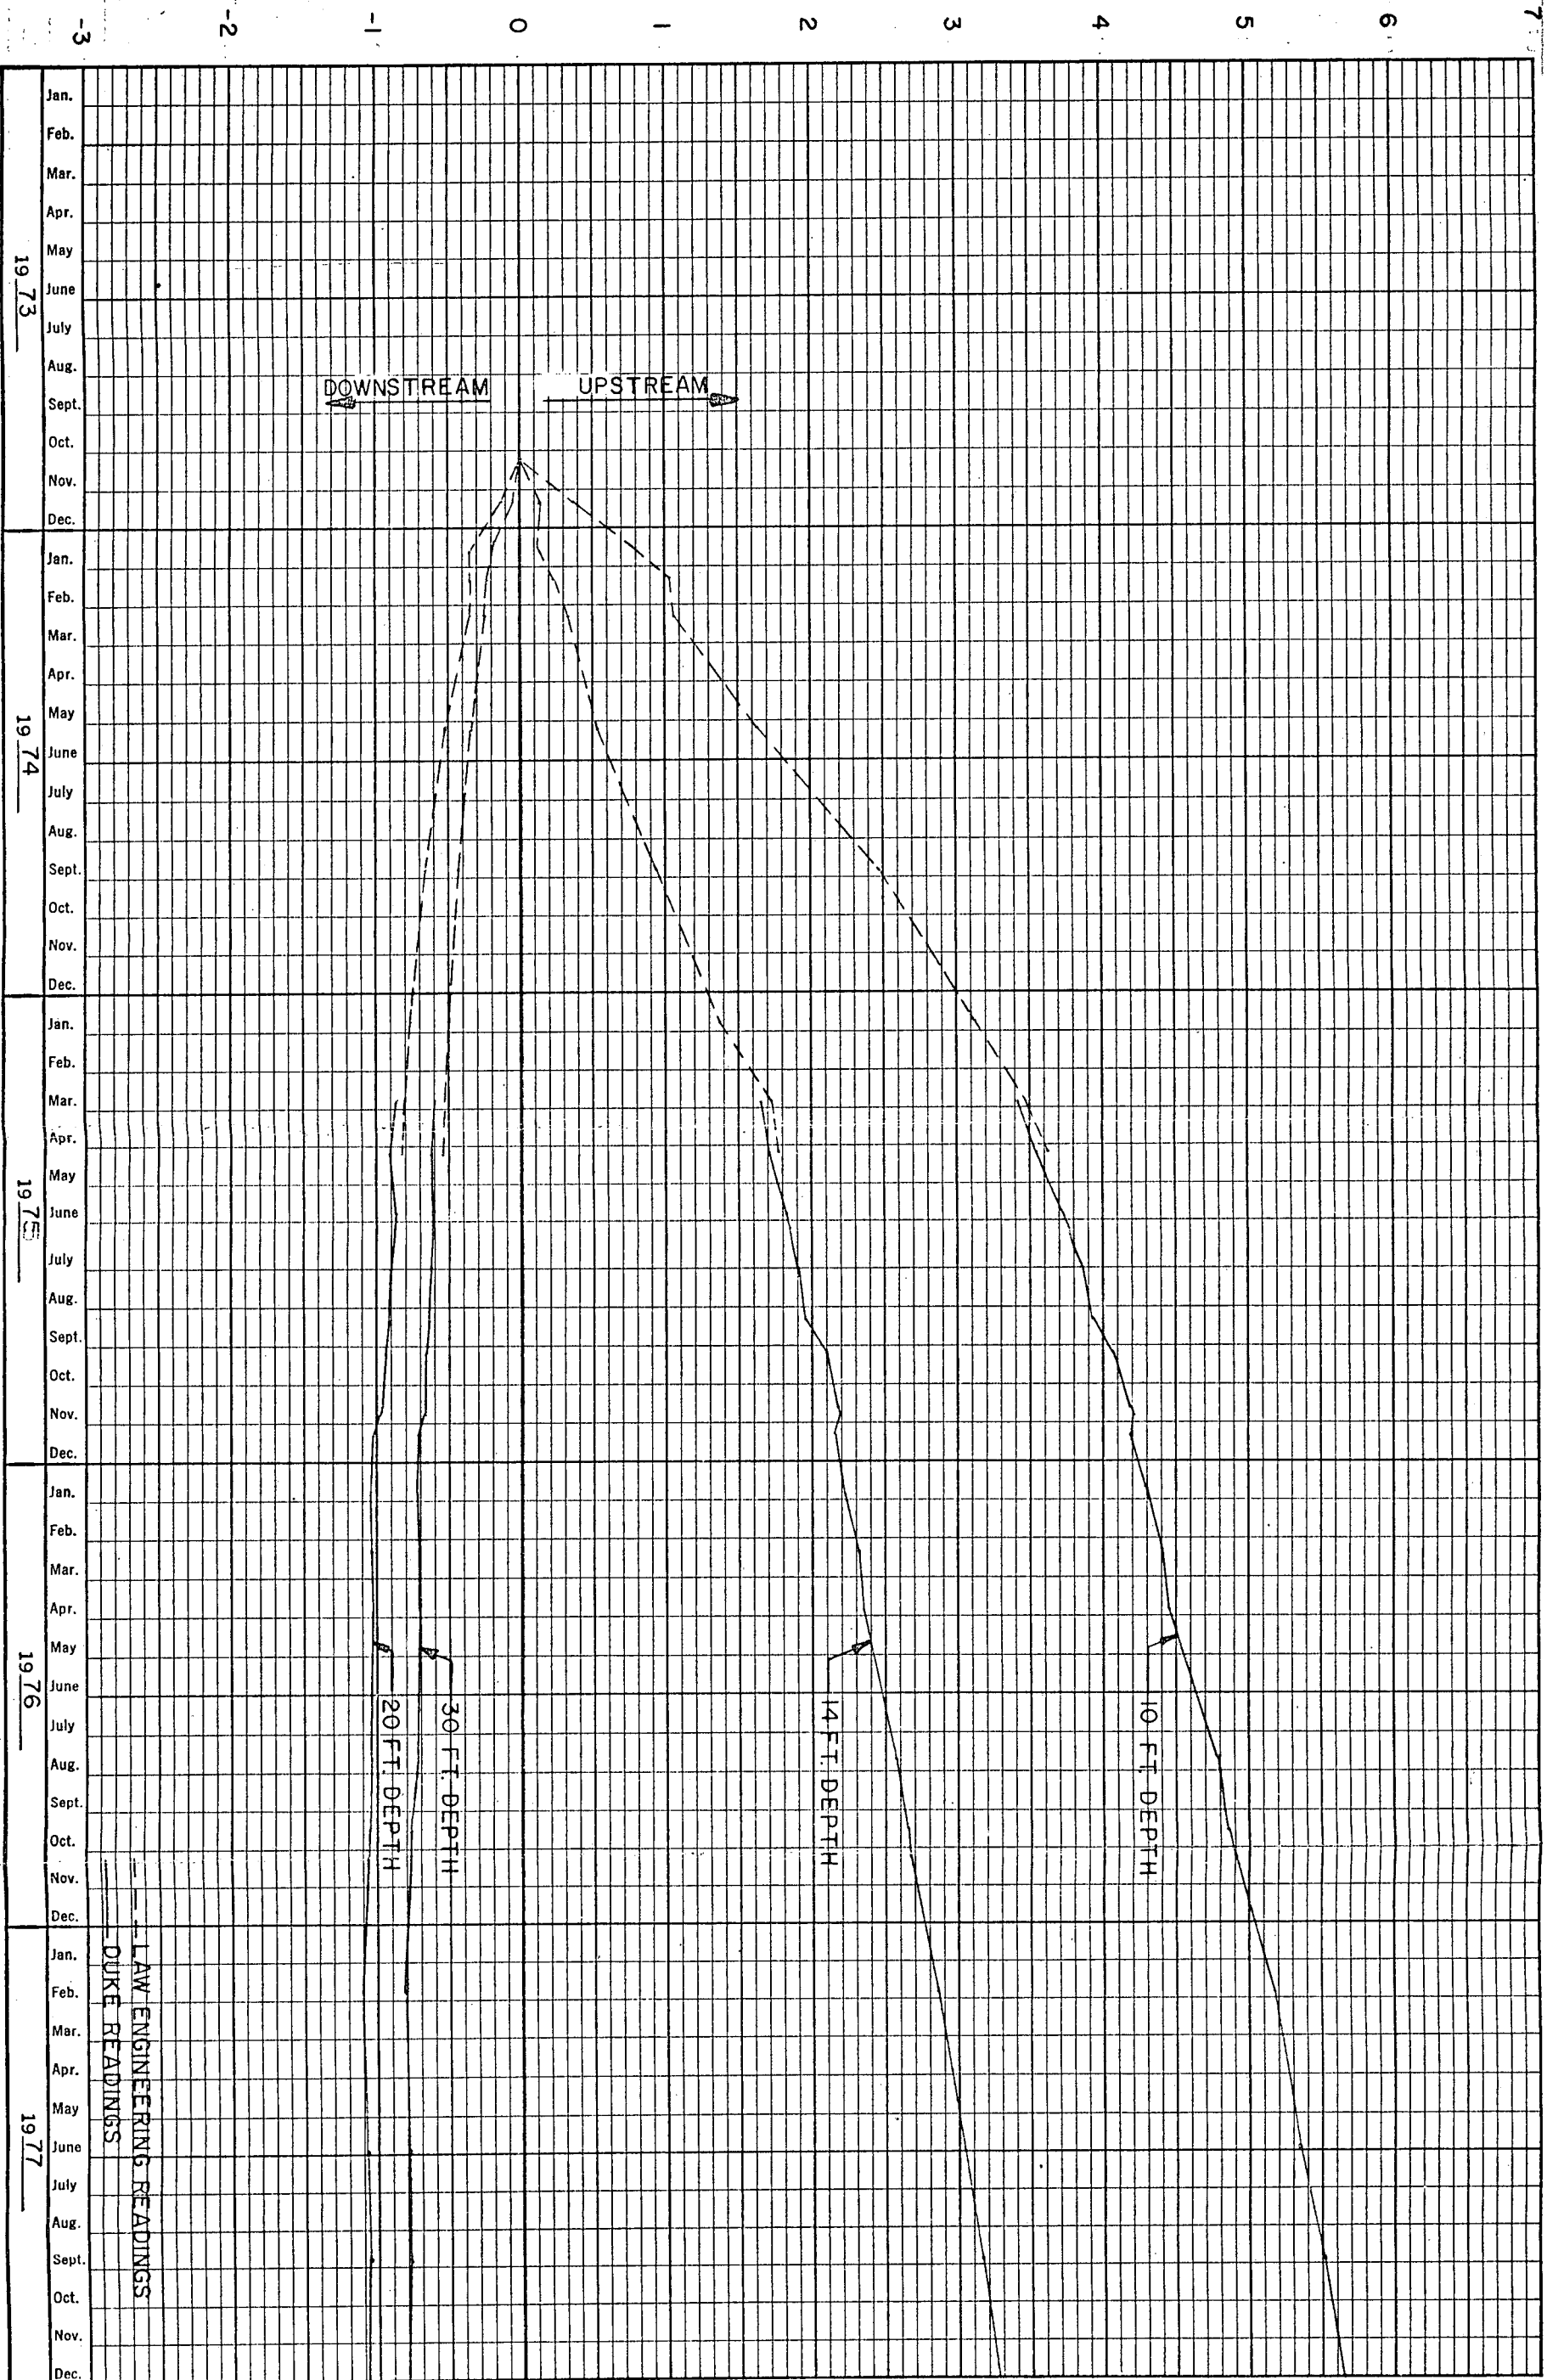
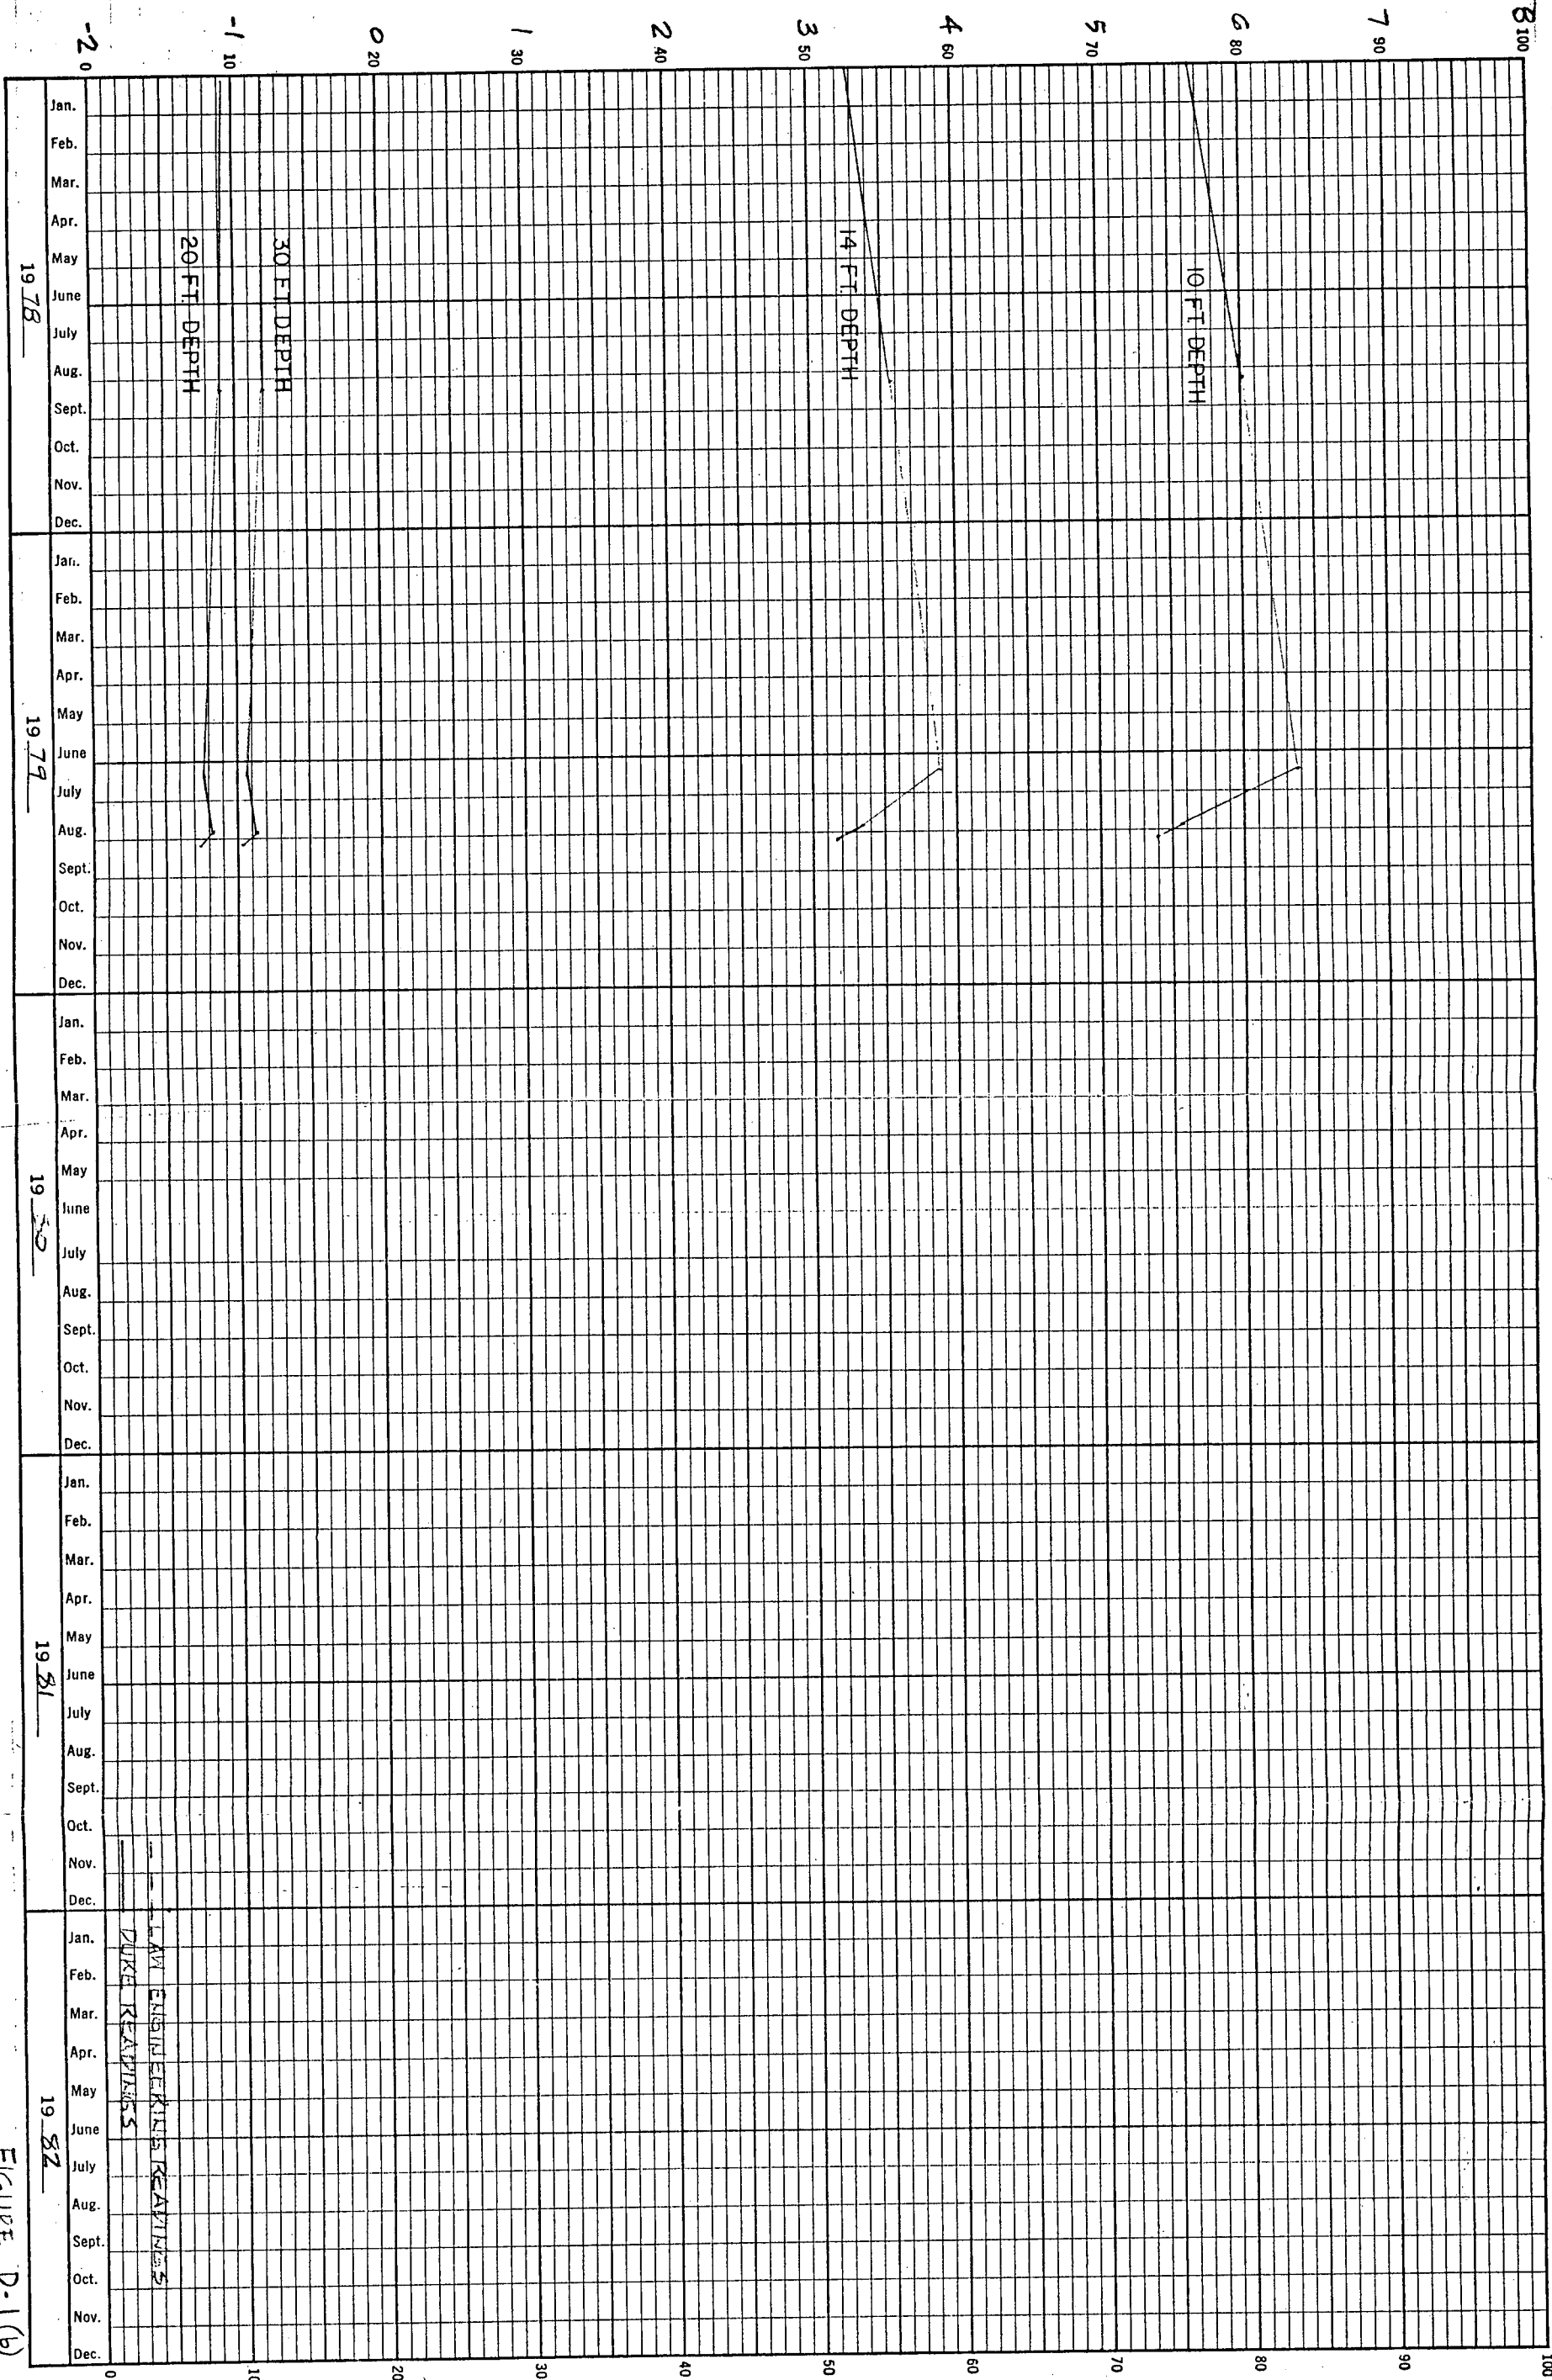
FIGURE D-1(b)
SHEET 2

Prior to the August 25, 1979 earthquake, the slope indicator tubes had shown a maximum deflection in the upstream direction of about 6.5 inches, recorded on July 12, 1979. This deflection was measured at the 10 ft. depth of the tube which is about four feet into the embankment slope.

Readings taken on August 27 and September 4, 1979 show the movement of the tubes at 10 ft. depth to be about 1 inch in the downstream direction, relative to the July 12, 1979 reading, indicating that the shell material moved downstream and closed the crack to some degree.

Figure D-1(a) and (b) and D-2(a) and (b) are plots of Slope Indicator Tube #1 and #2 respectively and show deflection versus time for selected depths

JOCASSEE DAM SLOPE INDICATOR #1 STATION 14+46
