DUKE POWER COMPANY

Jocassee Development
Report on the August 25, 1979
Earthquake and its effect on the
Jocassee Structures

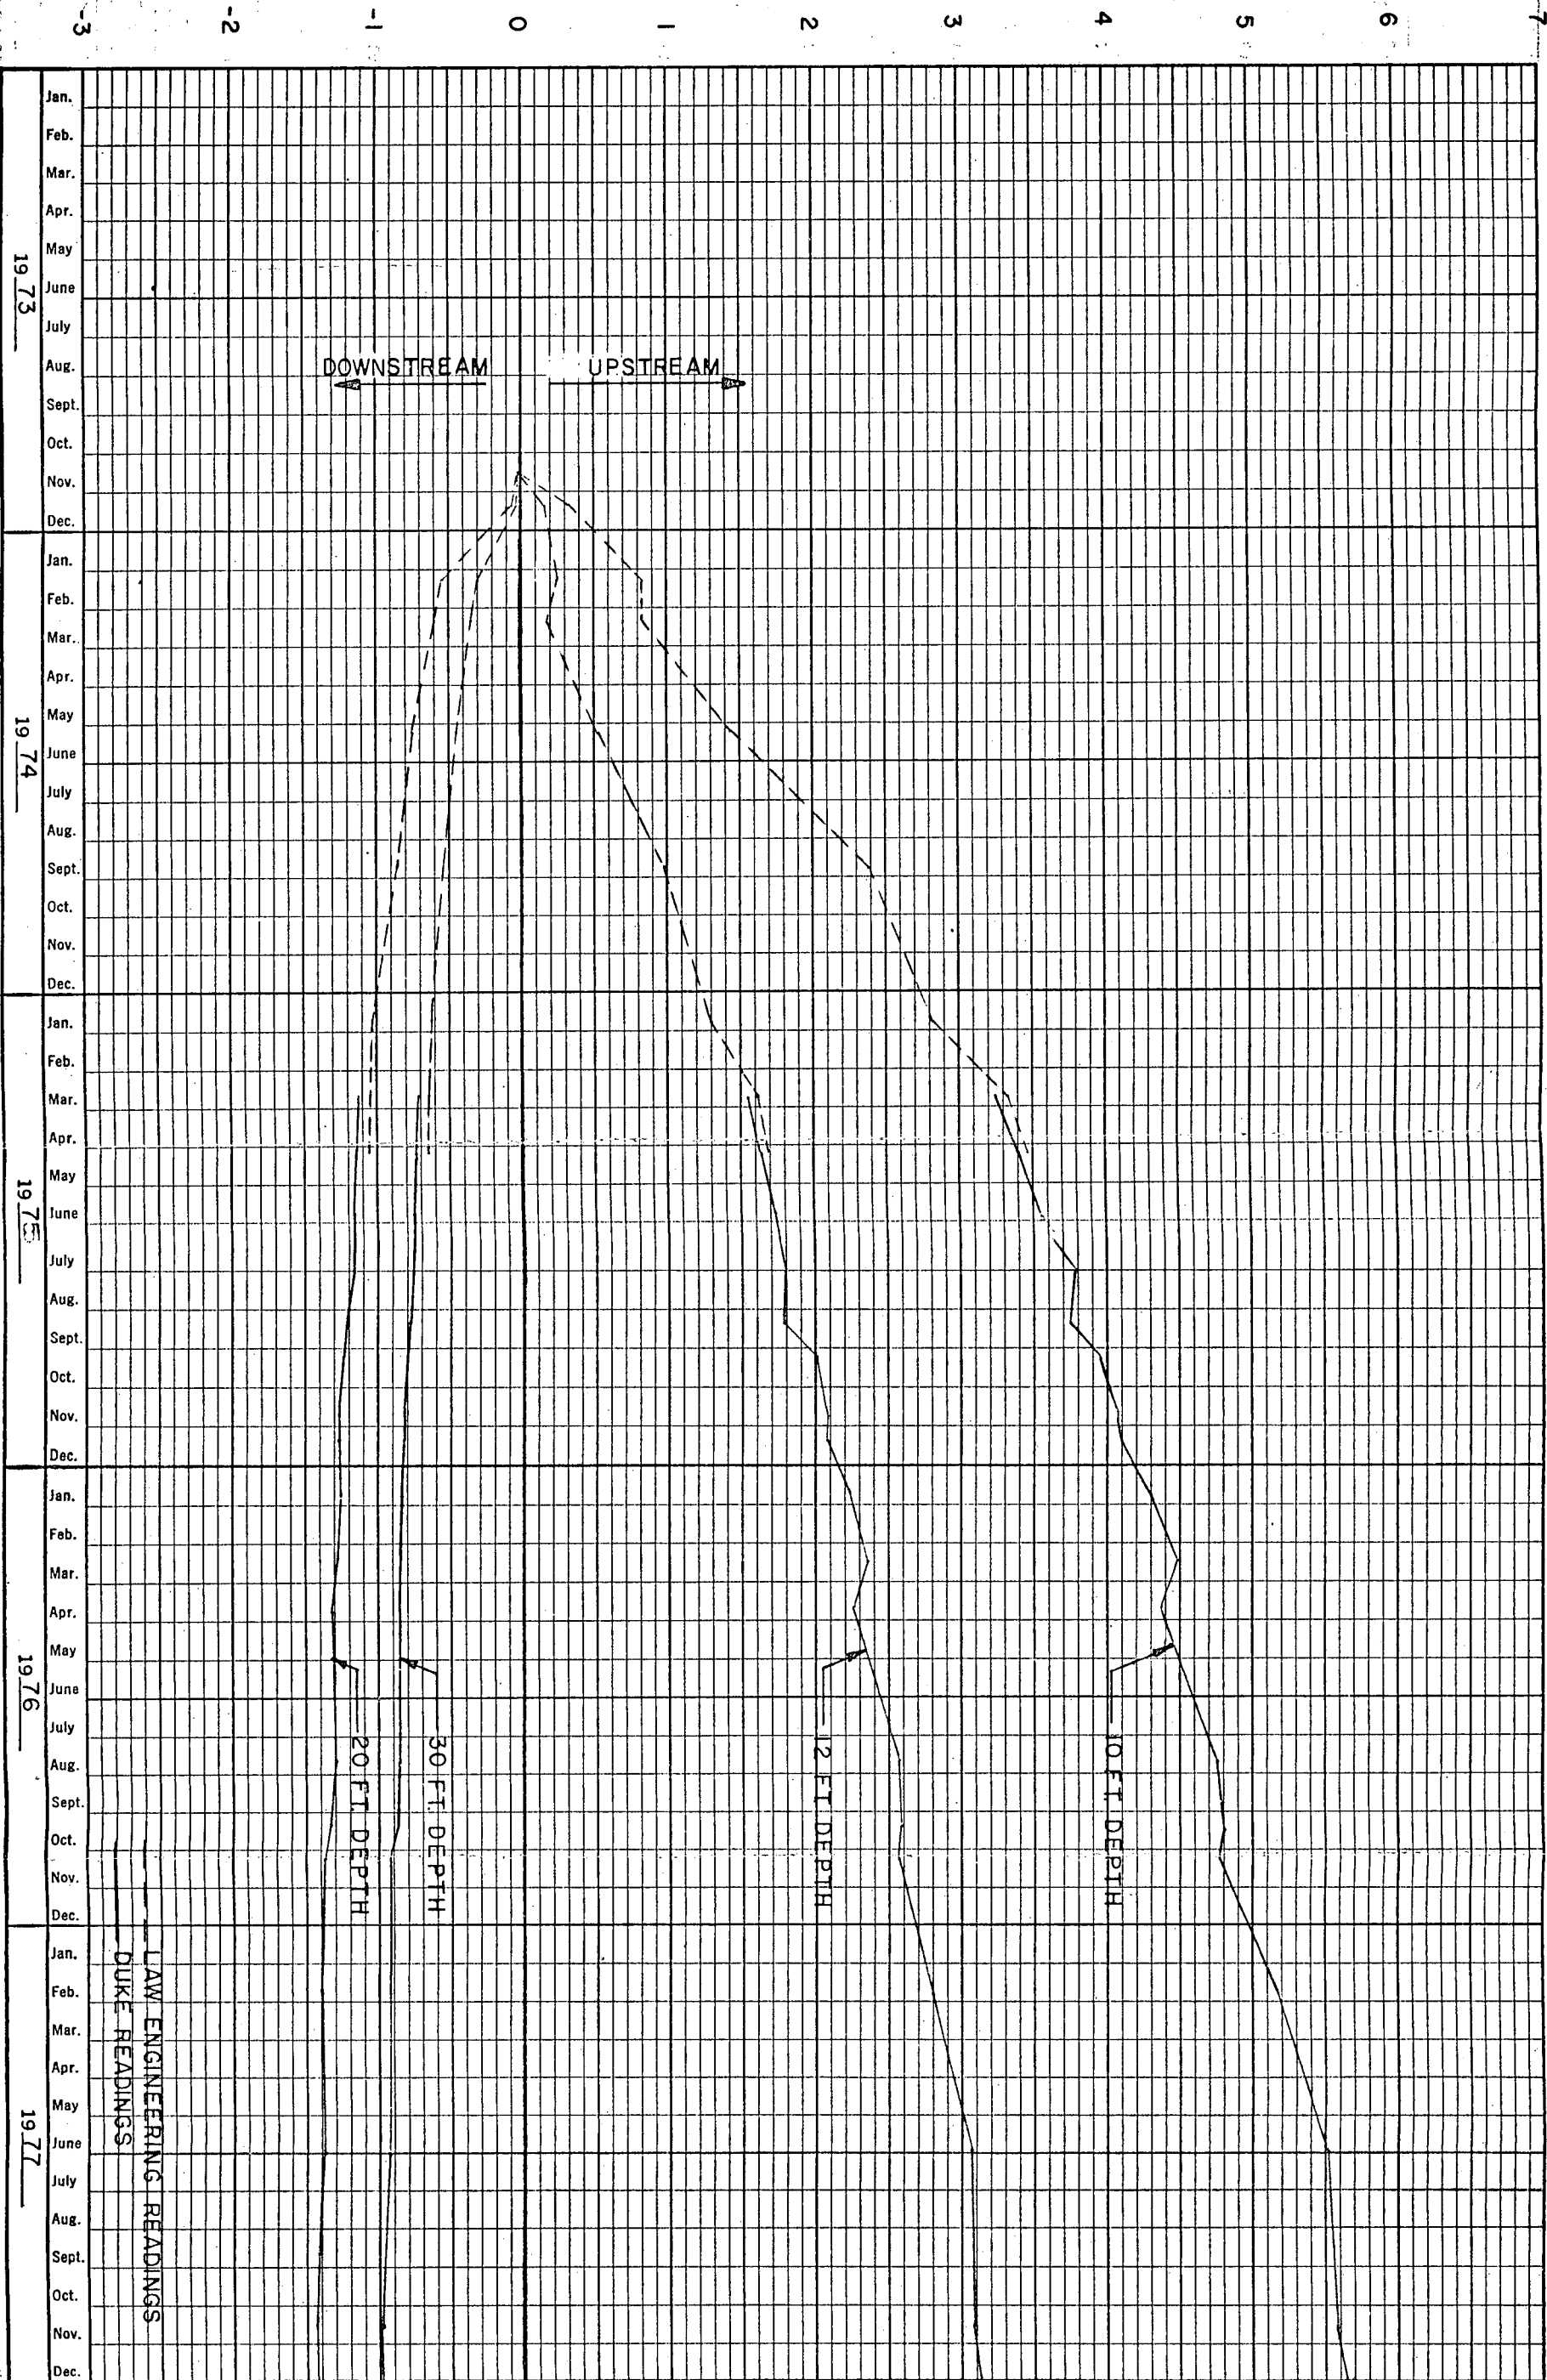
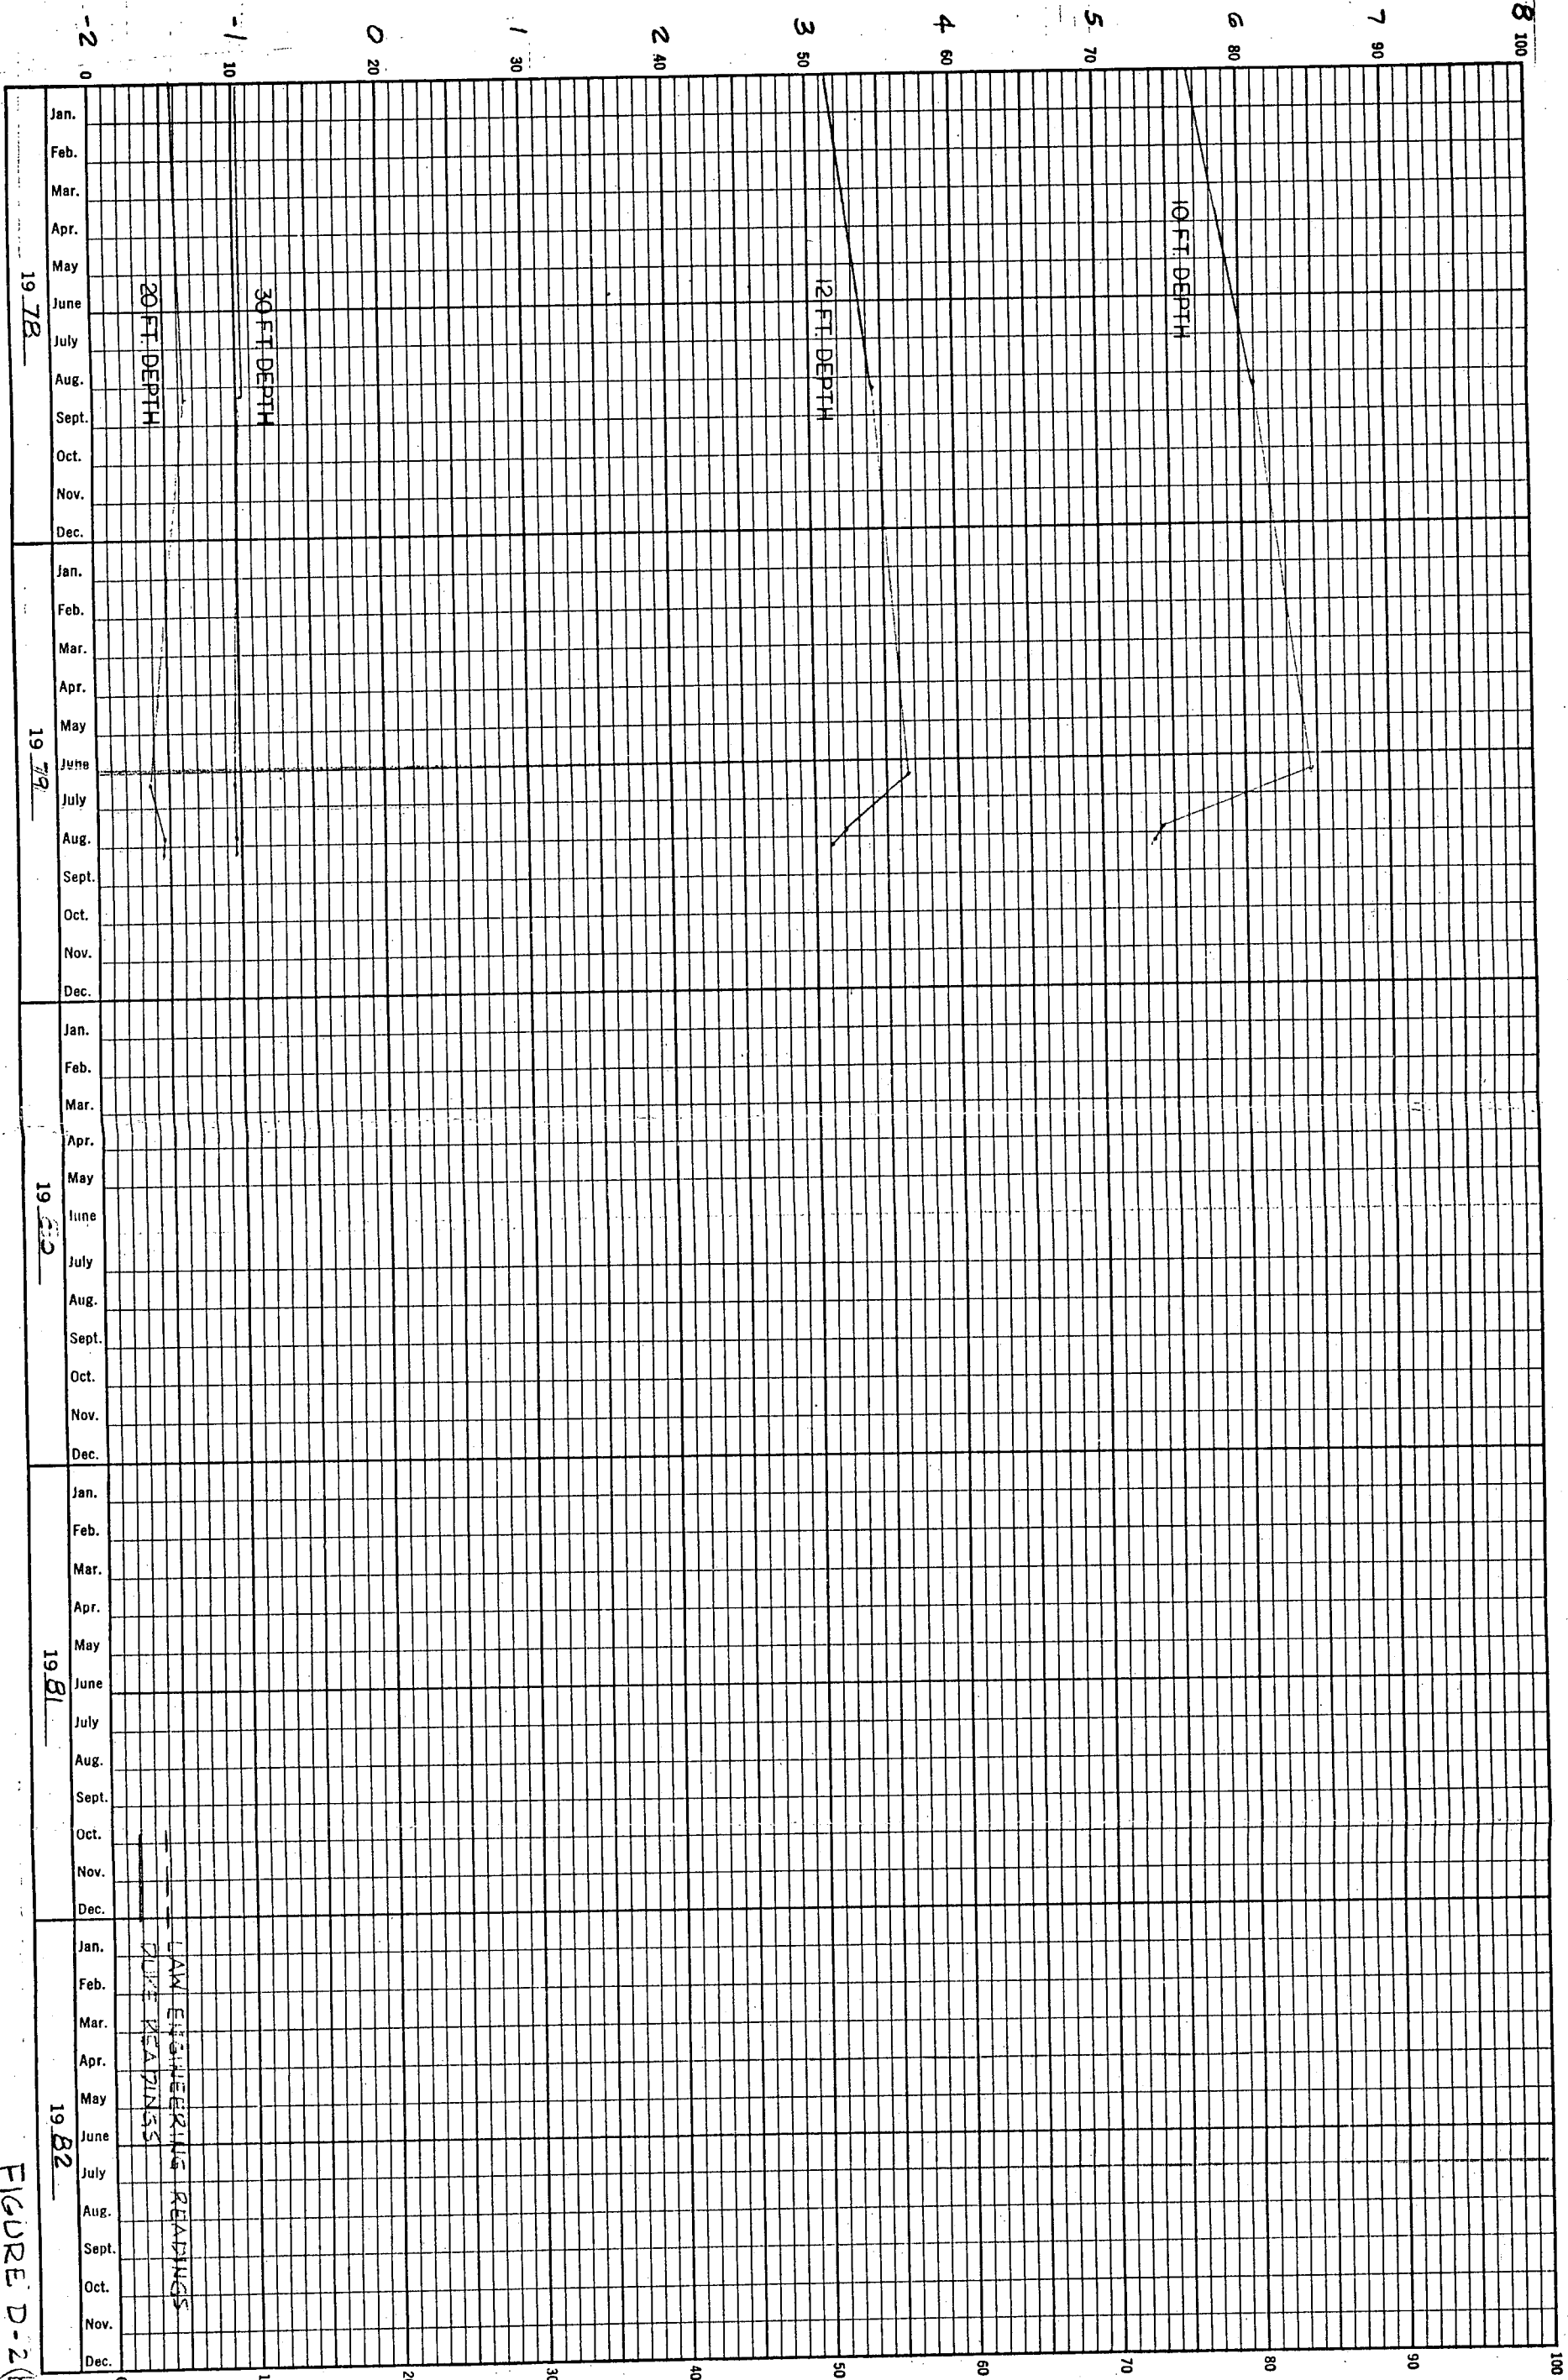
FIGURE D-2(b)
SHEET 2

Prior to the August 25, 1979 earthquake, the slope indicator tubes had shown a maximum deflection in the upstream direction of about 6.5 inches, recorded on July 12, 1979. This deflection was measured at the 10 ft. depth of the tube which is about four feet into the embankment slope.

Readings taken on August 27 and September 4, 1979 show the movement of the tubes at 10 ft. depth to be about 1 inch in the downstream direction, relative to the July 12, 1979 reading, indicating that the shell material moved downstream and closed the crack to some degree.

Figure D-1(a) and (b) and D-2(a) and (b) are plots of Slope Indicator Tube #1 and #2 respectively and show deflection versus time for selected depths

JOCASSEE DAM SLOPE INDICATOR #2 STATION 14+92

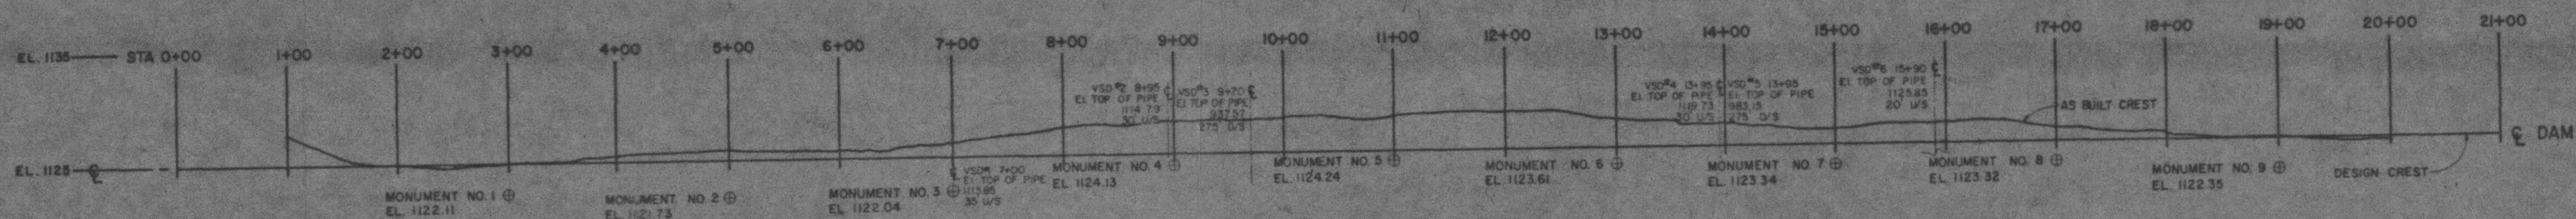
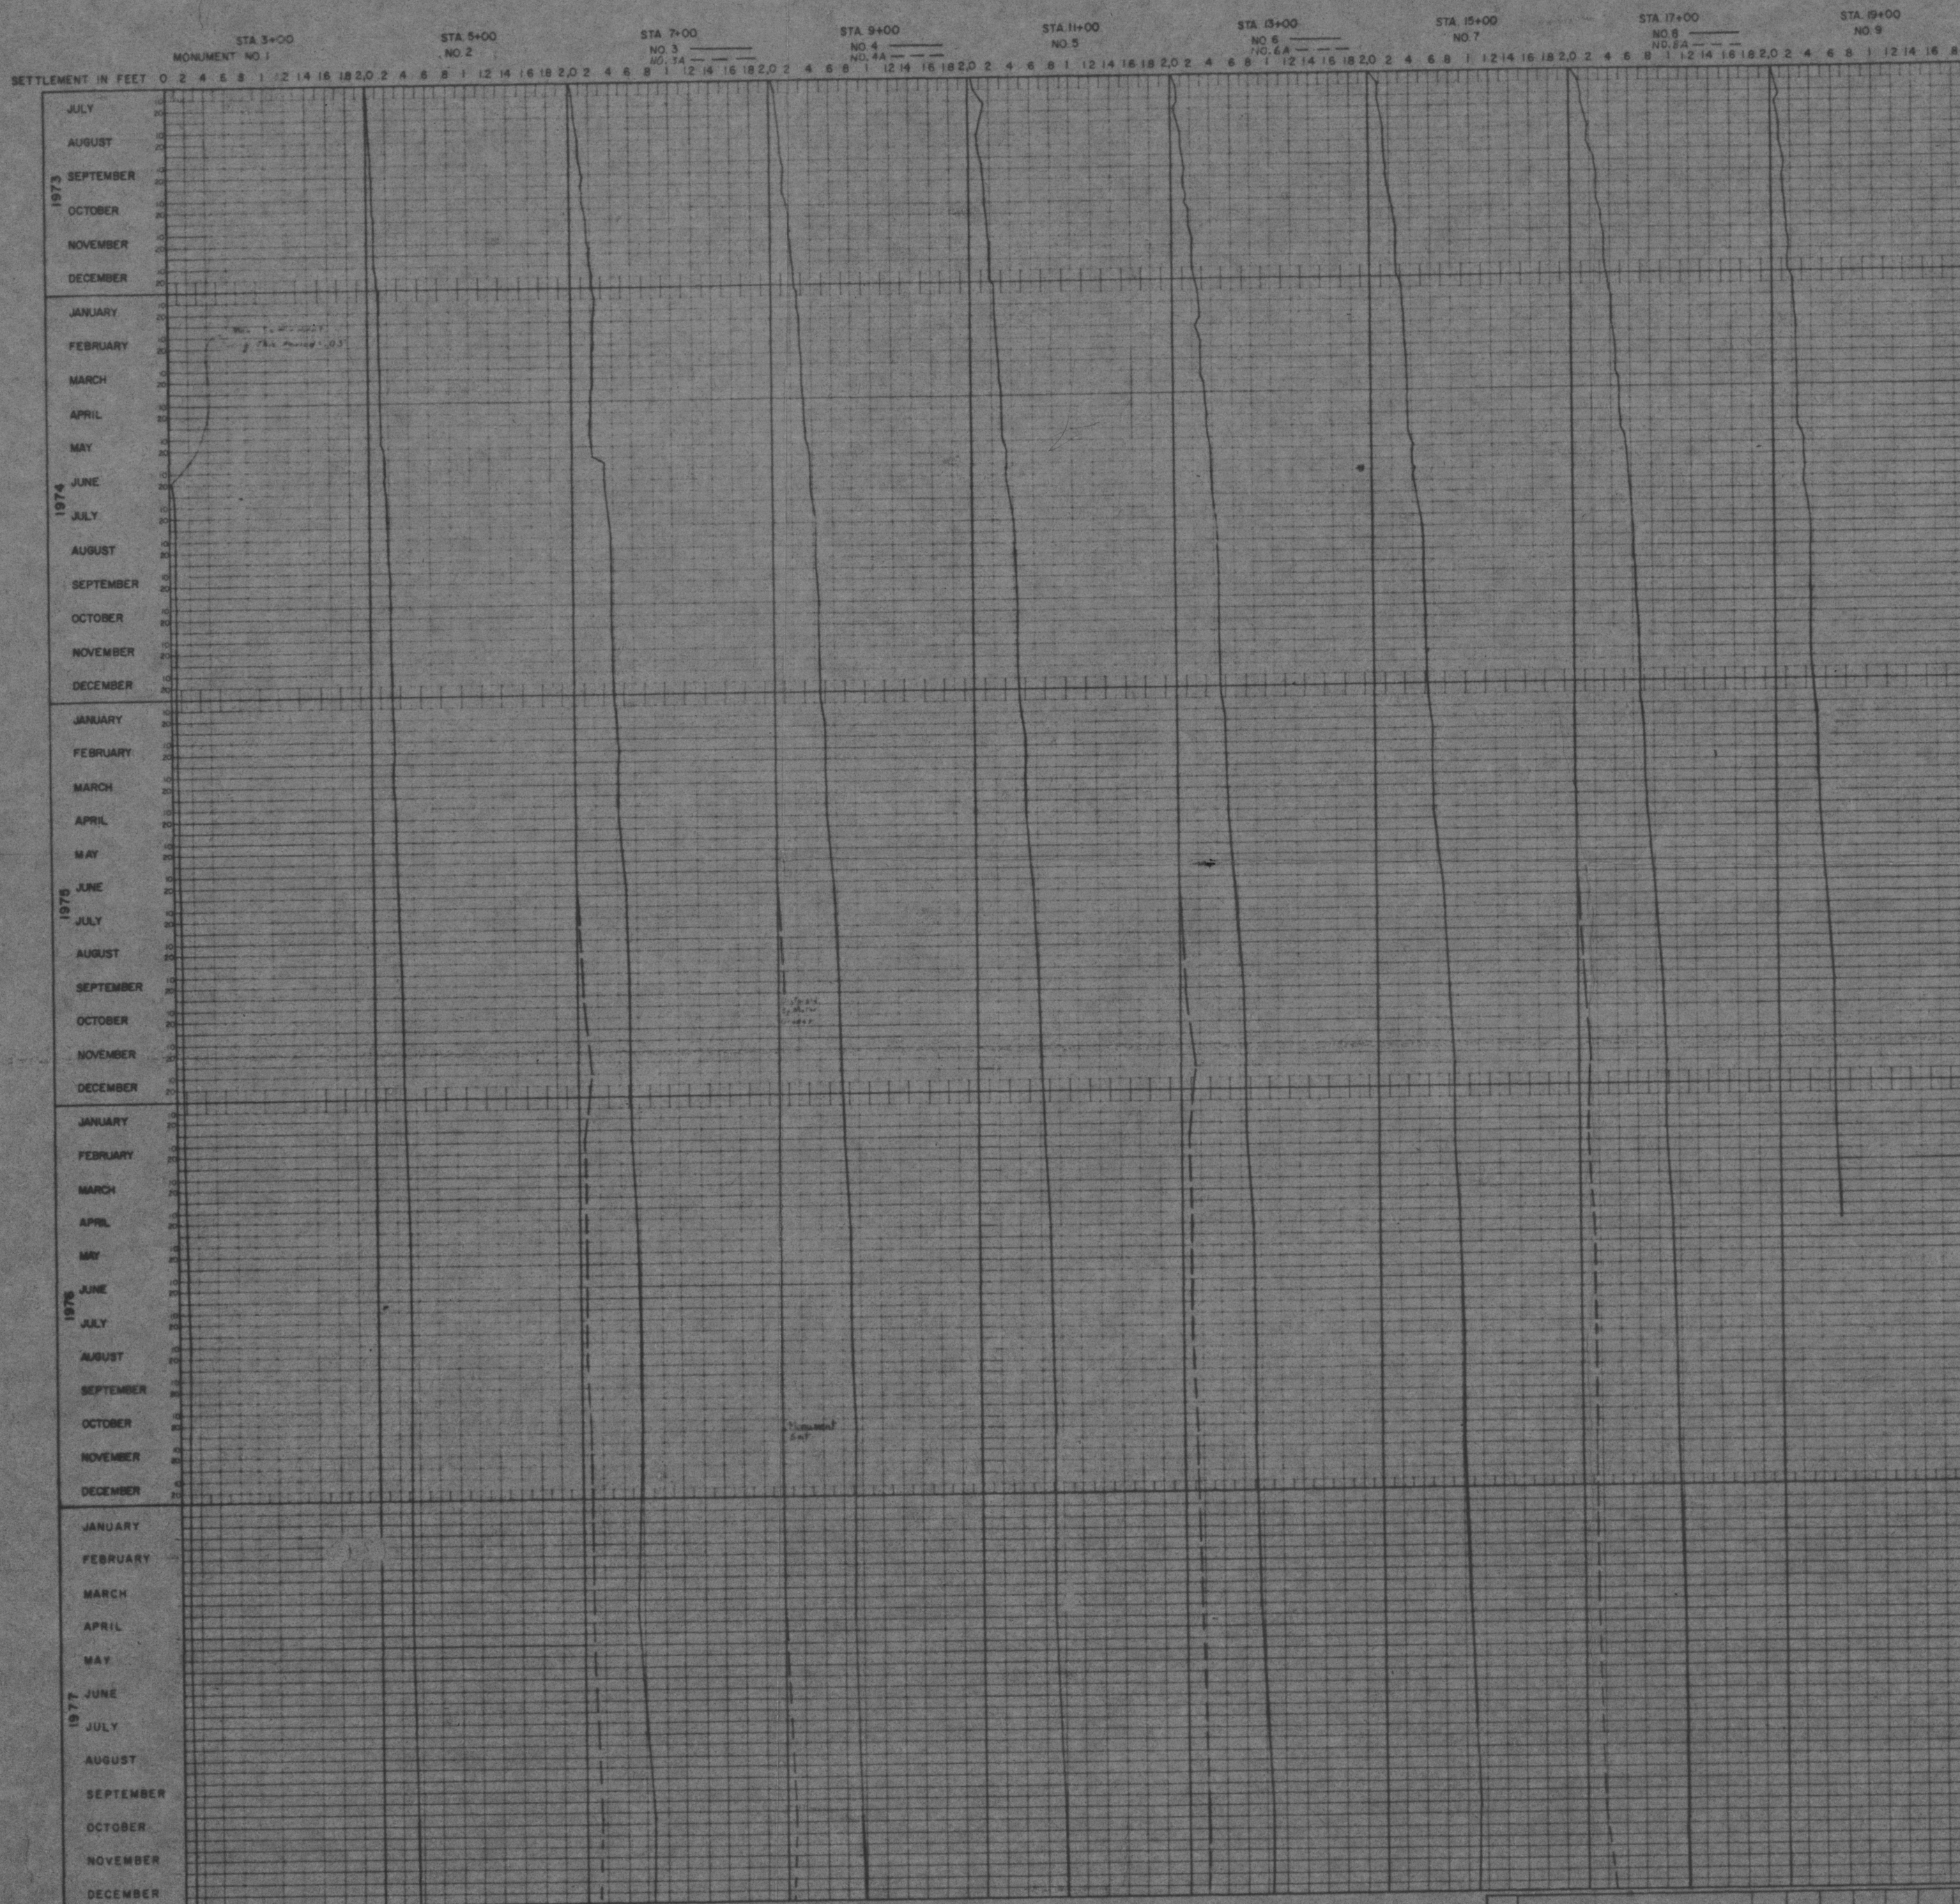
DUKE POWER COMPANY			
JOCASSEE DAM			
SURFACE SETTLEMENT MONUMENTS			
ALONG CREST			
DESIGNED	DATE	CHKD	DATE
CHECKED	DATE	INSPECTION	DATE
DWG. NO. FIGURE B-1

Readings of the monuments had been made on August 23, 1979 and were taken again, following the event, on August 27, 1979. The maximum vertical settlement recorded was .06 ft. However, the closure error for the vertical measurement was .08 ft. which is considered excessive. A resurvey on September 5, 1979 showed a maximum vertical settlement of .01 ft. with the closure error of .03 ft. which is within the usual accuracy. The movement due to the earthquake, if any, is very small, when compared to the total settlement recorded to date.

Graphs showing settlement versus time are attached as Figures B-1 for 1973-77 and B-2 for 1978-79. The graphs were plotted using data taken on August 23, 1979 and September 5, 1979.
