October 8, 2015

**SUBJECT: HONEYWELL INTERNATIONAL, INC. – NUCLEAR REGULATORY
COMMISSION SPECIAL INSPECTION REPORT 40-3392/2015-007 AND
NOTICE OF VIOLATION**

Report No.: 40-3392/2015-007

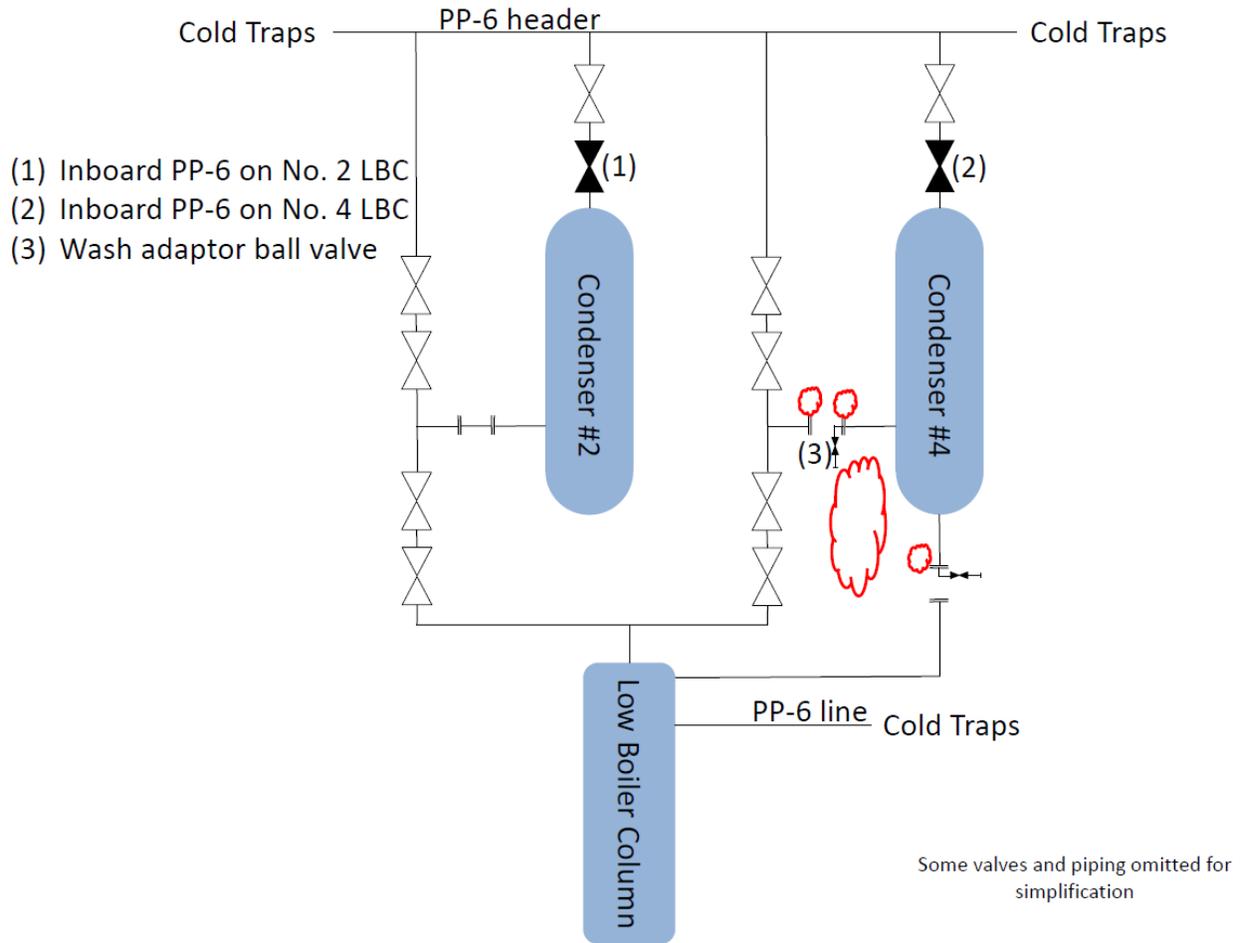
Figure 1: Simplified Diagram of the Low Boiler System and Release Points

Each of the LBCs share a common PP-6 header and, once the No. 2 LBC was aligned to the header, UF₆ was inadvertently charged into the No. 4 LBC through a PP-6 inboard isolation valve that was leaking through. A leaking isolation valve and three improperly secured temporary flanges provided a release path for UF₆ to be released from the distillation system. As the operator was leaving the area, UF₆ smoke began filling the sixth floor of the distillation side of the FMB and migrated outside the FMB through primarily the building ridge vent.

- Inadequate vacuum on PP-6: The PP-6 header on the sixth floor in distillation was the primary means to evacuate the LBCs. Operators believed that the test on the line performed on July 31 demonstrated that it had adequate vacuum at the time, but it may not have had adequate capacity.
- Line breaking activities were left incomplete: The UF₆ line break flanges were left “four-bolted” on July 31. The job was left in a “holding pattern” pending the resolution by operations for establishing better vacuum to complete the line break activities.
- Lack of recognition by operations that the No. 4 LBC was not in a safe configuration. Operators should have verified that the flanges were secured prior to opening the PP-6 valve on the No. 2 LBC.

- Leaking PP-6 inboard isolation valve on No. 4 LBC: At the time the PP-6 valve on the No. 2 LBC was opened, the PP-6 valve on the No. 4 LBC was believed to be closed. It apparently leaked by, allowing UF₆ into the No. 4 LBC. The licensee performed a post-incident inspection of the valve which showed a considerable amount of UO₂F₂ and contaminants that had built-up on the valve. This build-up prevented the valve from seating properly.
- Leaking isolation valve used on No. 4 LBC: The licensee performed a post-incident inspection on an isolation valve attached to one of the blind flanges and determined that it could hold pressure if oriented exactly in the closed position. However, the nut that connected the handle to the stem was loose, and the valve could “free-wheel” past the stop points. Slightly over-rotating the handle would open the valve.

Contrary to the above, on July 31, 2015, the No. 4 LBC was left unattended after it was opened, and hazards were not properly controlled. Specifically, line breaking on the No. 4 LBC was followed by a period of down time when the blind flanges on the system were not properly secured. This provided a release pathway for UF₆ and contributed to the event on August 1, 2015. This is an apparent violation (AV 40-3392/2015-007-02, Failure to Follow Line Breaking Procedure)

The inspectors noted that the licensee had not implemented a routine preventative maintenance (PM) activity to check the seats on LBC valves despite the potential they could become fouled by the contaminants in the system. As immediate corrective actions prior to restart of the distillation system, the licensee replaced the No. 4 PP-6 inboard isolation valve that was leaking by and washed out the blocked vacuum piping. The licensee also intended to develop a periodic PM activity to check the LBC valve seats for contaminants.

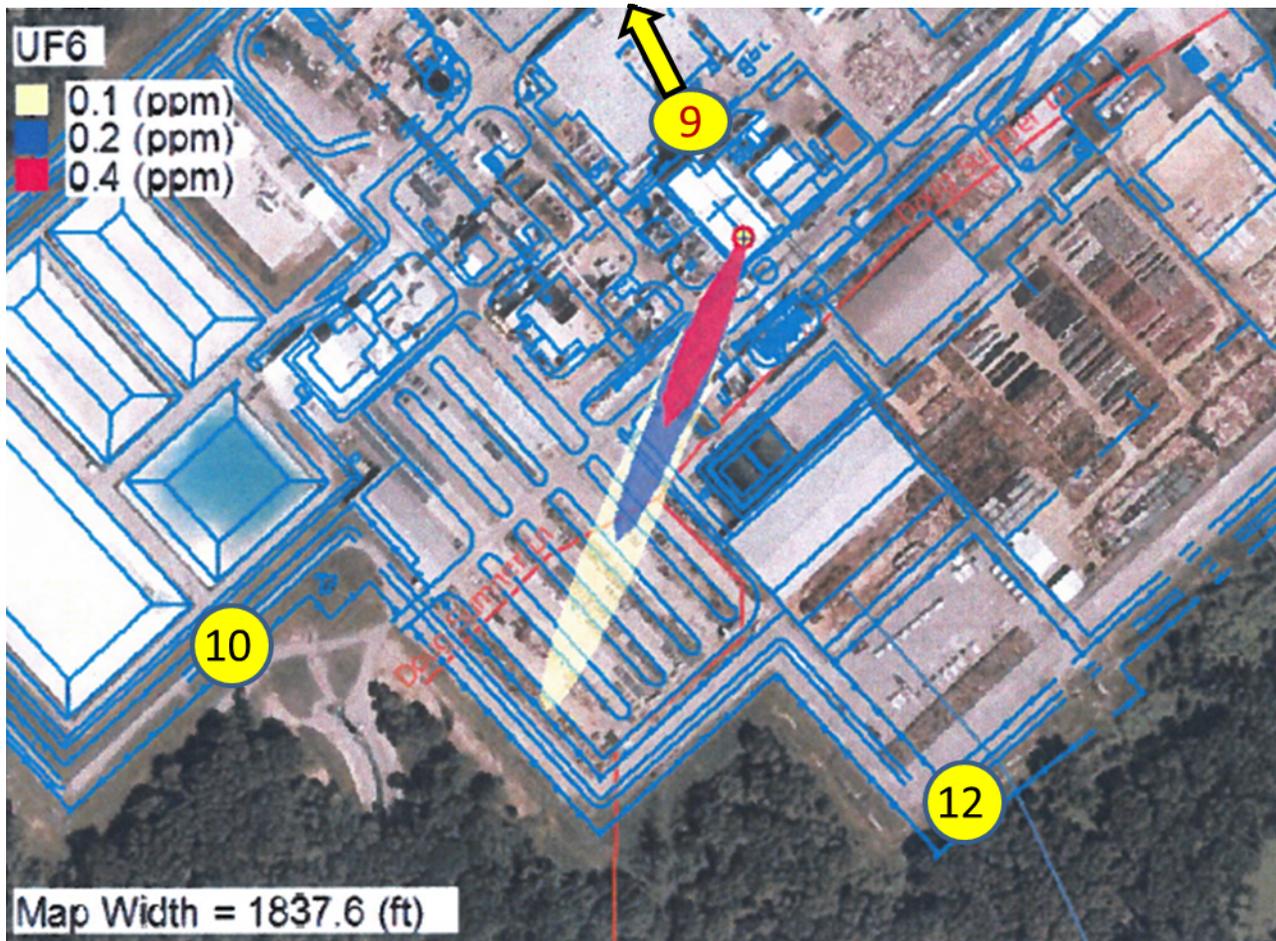
Figure 2: NRC Plume Model with Approximate Location of Air Monitors

The inspectors determined that any UF₆/HF that travelled beyond the fence line would have been of such low concentration as to pose no safety hazard requiring response by offsite organizations to protect the public. The bases for this conclusion is as follows:

- The inspectors reviewed weekly radioactive air monitoring reports for the fence line and found that the activity results were within Honeywell license limits. The "fence line" radiation readings were taken when the licensee removed target filters from sample locations permanently installed on the fence and scanned them for radiation. Although a reading was above the licensee's administrative limit which required an investigation to be conducted, it was well below any regulatory limits and within the range of historical levels for minor process upsets. Figure 2 shows the location of the air monitors. The elevated reading was from Sample Point 10 which was relatively downwind from the FMB.

As discussed in Section B, the inspectors reviewed weekly radioactive air monitoring reports for the fence line, and found that the activity results were within Honeywell license limits. Although one reading was above the licensee's administrative limit which required an investigation to be conducted, it was well below any regulatory limits and within the range of historical levels for minor upset conditions. The licensee took radiation surveys of various areas inside the plant property downwind of the release and did not detect any radiation readings above background. The HF detectors downwind did not detect any measurable increase in HF concentration but were not located in a position such that they would have detected the plume.
