**LOST CREEK ISR, LLC**

# MEMO

**Date:** July 28, 2015

**Subject:** Incident Investigation for Release of Yellowcake through Dryer 1 Packing

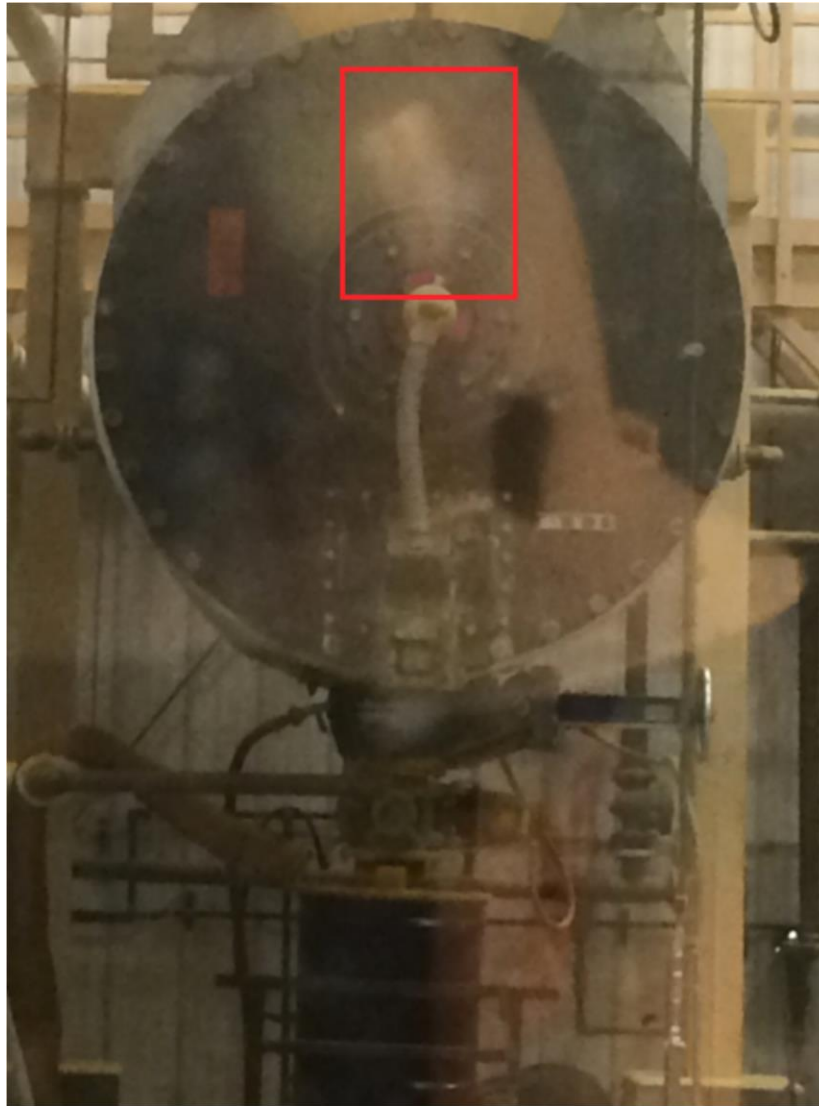
On Sunday July 19, 2015 at approximately 08:00, the RSO visually inspected the side of dryer 1 and determined that the released amount of uranium was relatively small (see residue on side of dryer 1 in Figure 1) compared to other dryer incidents and that performing work in the dryer was safe for standard dryer operations PPE (coveralls, rubber boots, respirator, gloves, and head cover). The breathing zone sample of the dryer operator during the incident had less uranium on it than other routine work such as star valve removals would cause. The plant operator and dryer operator went into the dryer room and tightened the packing and tested the vacuum at approximately 09:30, and the dryer was loaded at approximately 10:15.

The direct cause of this incident was a packing that was too loose. The root cause of this incident was that the dryer operator did not know to ensure the packing on the dryer was sufficiently tight.

Figure 1: Residue from Release through Dryer 1 Packing

1. Ensure that all dryer operators are knowledgeable in how to tighten the packing on the dryer.
2. Review, and amend as necessary, the dryer operations SOPs to ensure they adequately address what to do in this circumstance.
3. Seal any opening in the dryer room wall that could lead to release of material during upset conditions.
4. Sample the air in front of the control room as part of the monthly airborne uranium sampling in the plant. This will continue for the next 6 months to make sure there are no detectable levels of uranium coming through holes in the wall during normal operating conditions.

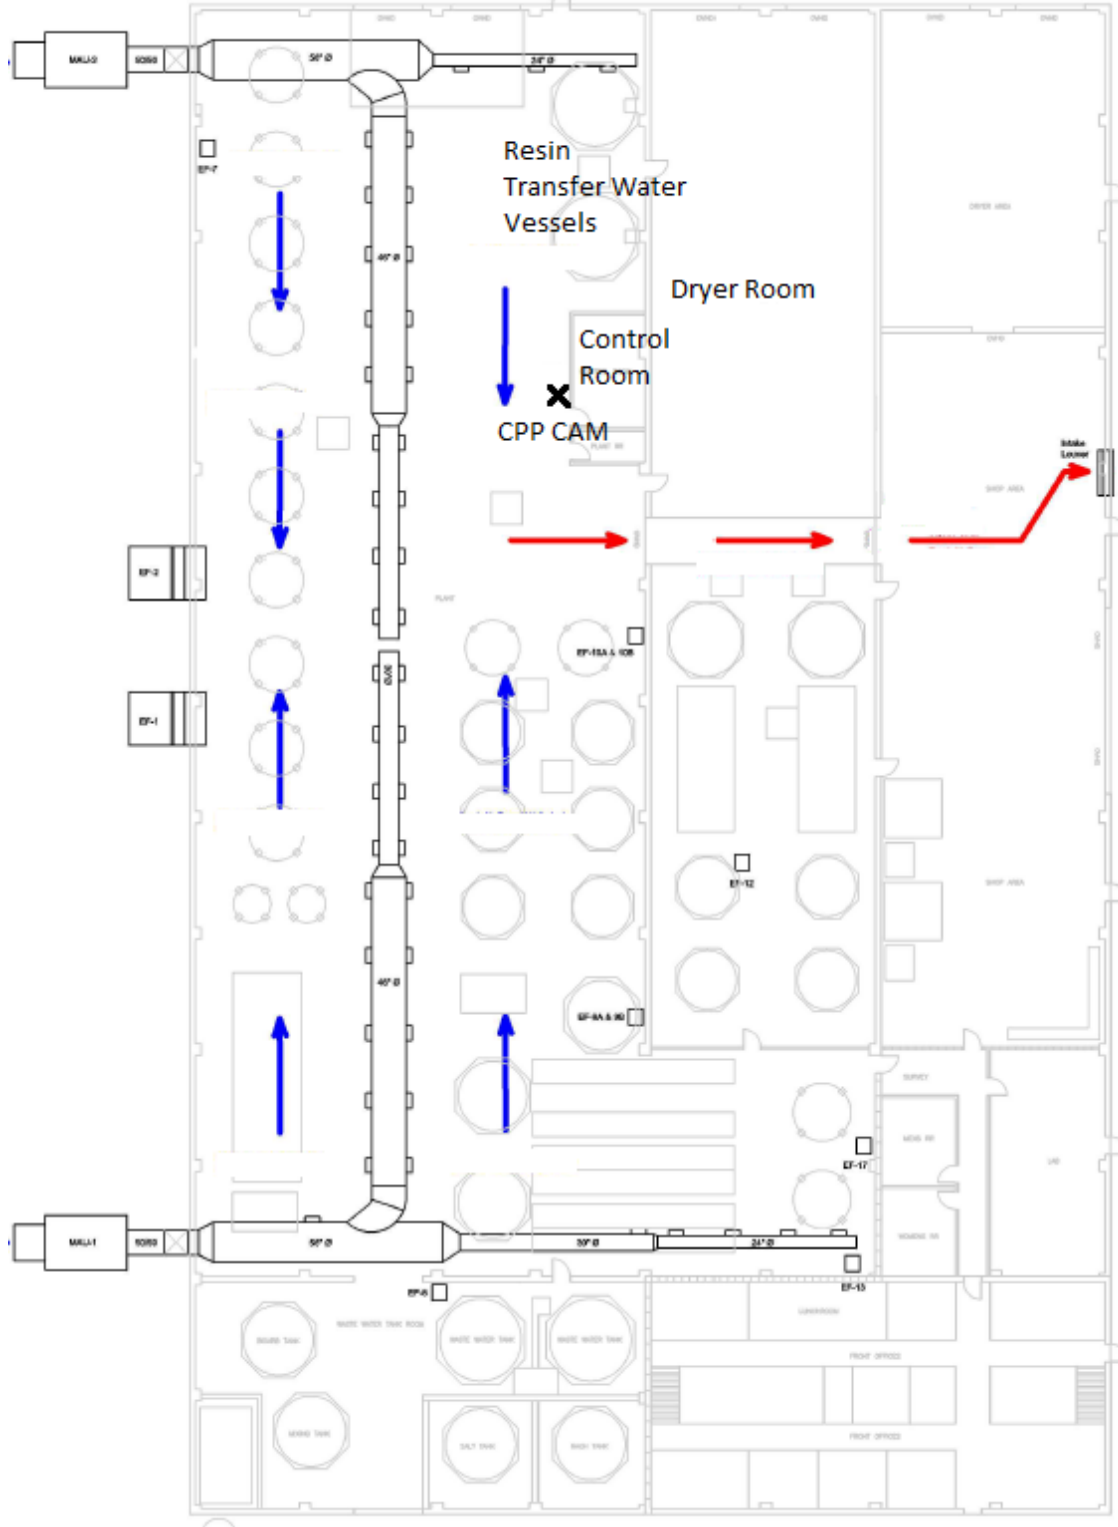
In order for uranium to be collected on the CPP CAM filter the airborne uranium would have to leave the dryer room. Based on the airflow of the plant ventilation (see Figure 2) the most likely place for a release from the dryer room detected on the CPP CAM would have to come from the wall shared by the control room/resin water transfer area and the dryer room.

A plant maintenance worker and the RSO inspected the wall above the control room and behind the Resin Transfer Water Vessels. There were two potential holes noted where the insulation meets the I-beam on the ceiling. The holes appear to have some yellow residue settled on the insulation within a few inches of the hole. Due to obstructions and safety considerations the residue was not sampled.

Figure 2: Plant Ventilation Air Flow
