# **SIGNIFICANT OPERATIONAL EXPERIENCE**

## **7 MAJOR INDUSTRY EVENTS WITH REGULATORY IMPLICATIONS**

Presented by John Thompson  
NRR/ADRO/DIRS/IOEB

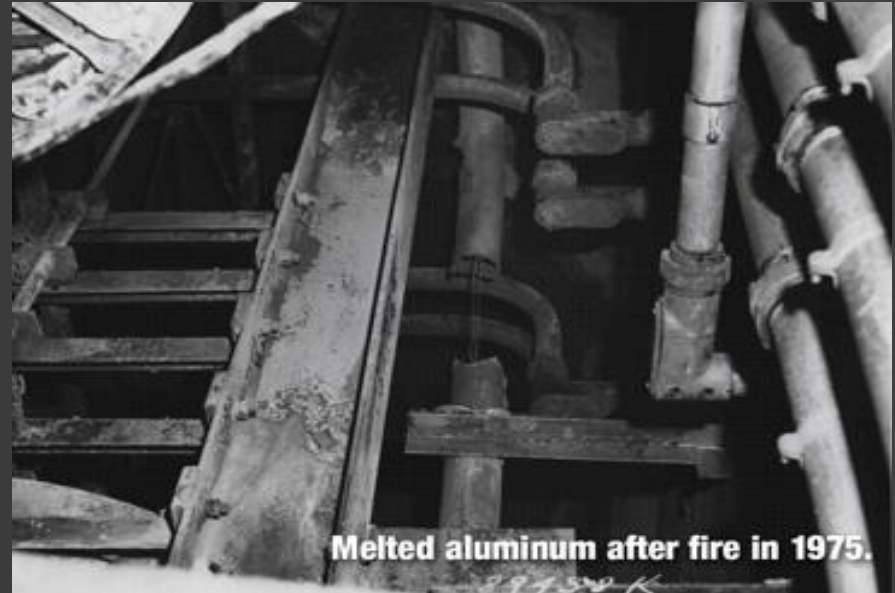
Melted aluminum after fire in 1975.

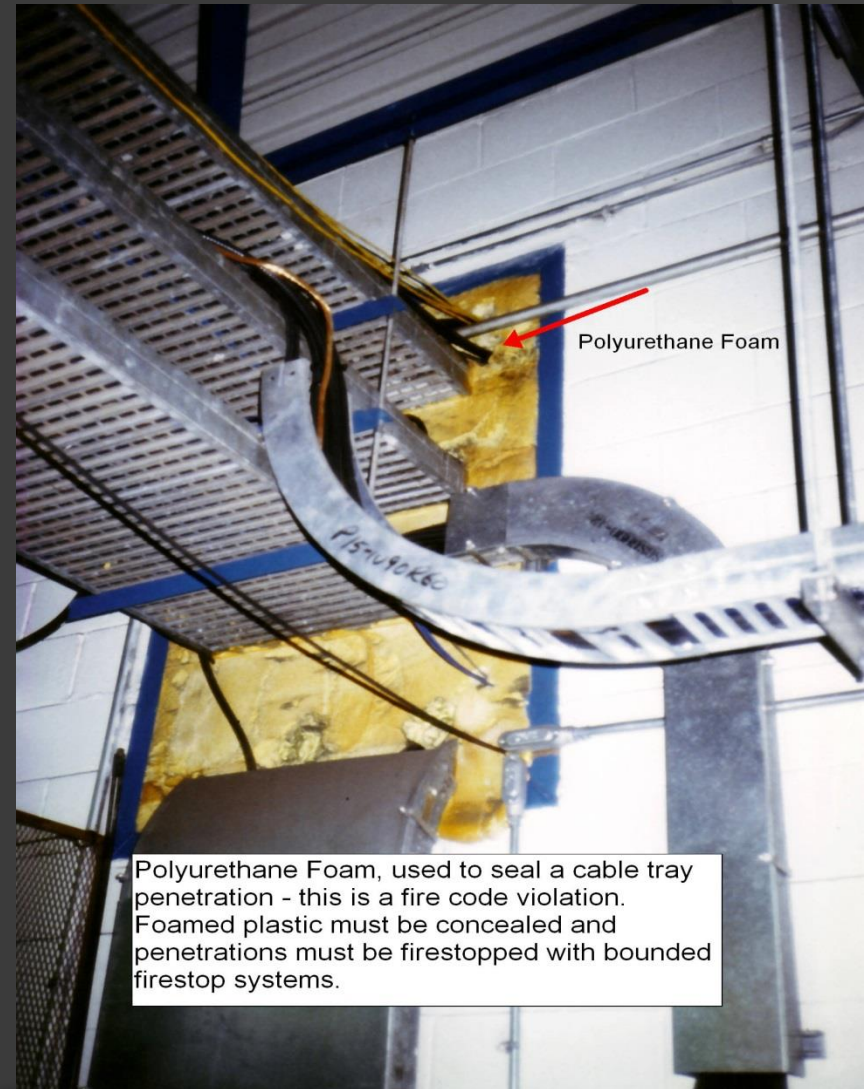
Polyurethane Foam, used to seal a cable tray penetration - this is a fire code violation. Foamed plastic must be concealed and penetrations must be firestopped with bounded firestop systems.

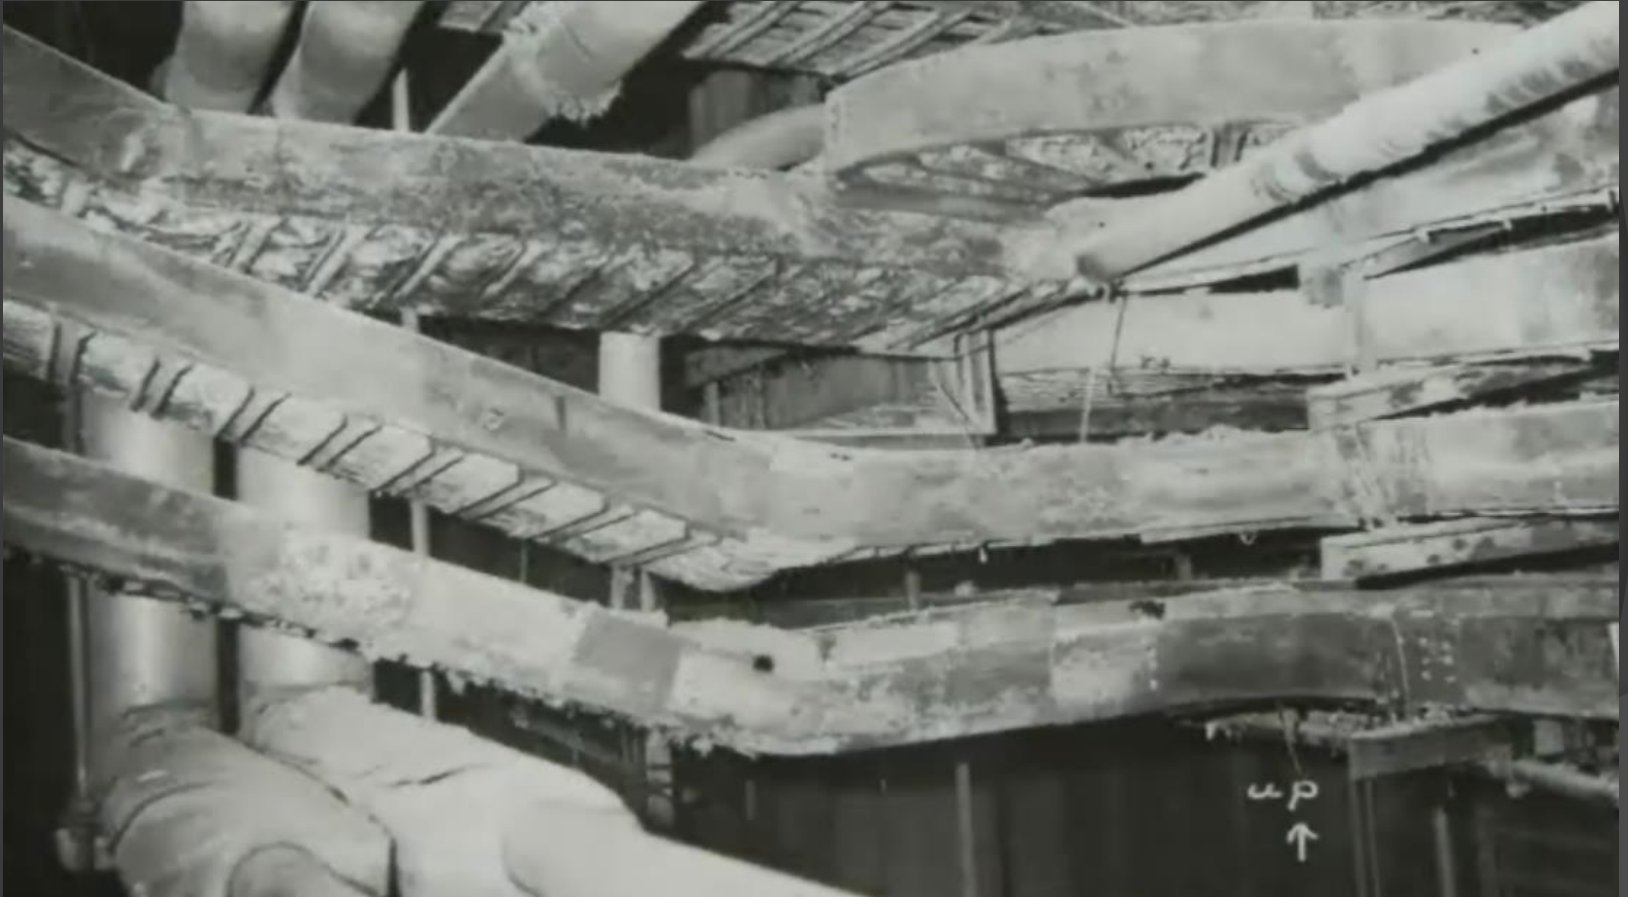
# Browns Ferry Damage in Cable Spreading Room

A major fire burned for 7 hours and caused significant damage to approximately 1600 electrical cables that control Units 1 and 2. Unit 1 lost all emergency core cooling systems (ECCS) and the ability to monitor power from the control room. There was no core damage due to actions taken by the operators. It took 15 hours to achieve a stable situation. This event revealed major design weaknesses in the area of fire protection and led to the creation of Appendix R, 10 CFR Part 50 (Fire Protection).

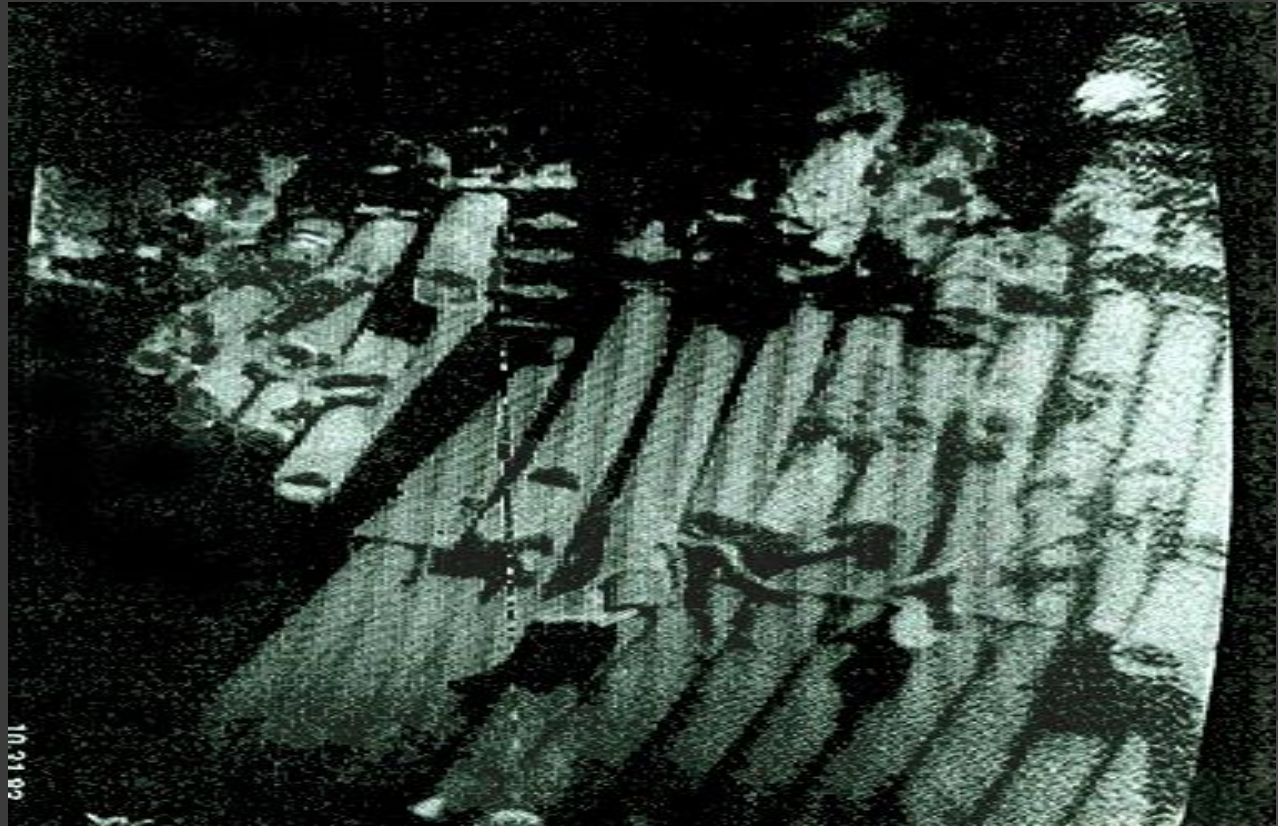
Photo of  
damaged fuel

Approx. 44%  
of the core  
melted

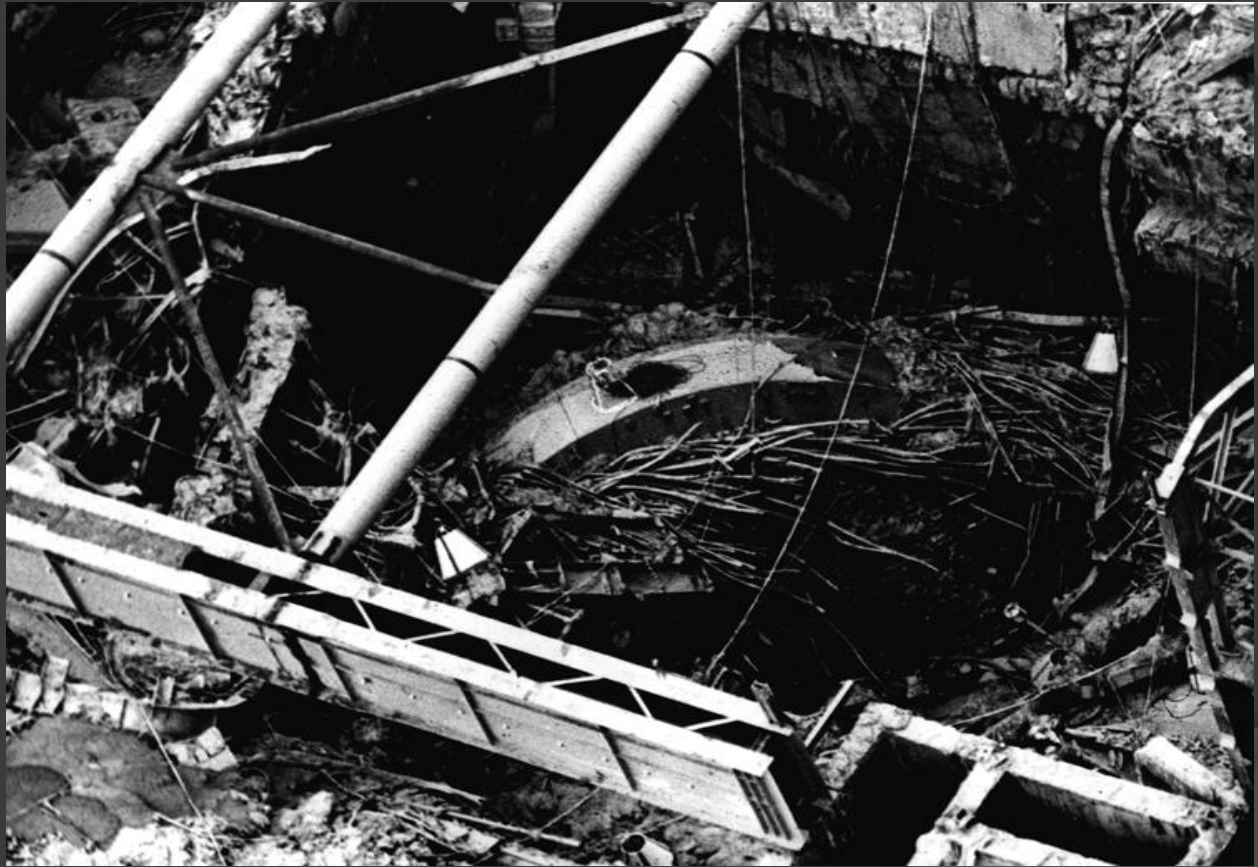
# Chernobyl Unit 4, Shortly After the April 25, 1986 Accident

- About two to three seconds later, a second explosion threw out fragments from the fuel channels and hot graphite. There is some dispute among experts about the nature of this second explosion, but it is likely to have been caused by the production of hydrogen from zirconium-steam reactions.
- The graphite (about a quarter of the 1200 tons ejected) and fuel became incandescent and started a number of fires, causing the main release of radioactivity into the environment.
- Two workers directly died as a result of the blast. The other casualties included firefighters who attended the initial fires on the roof of the turbine building. All these were put out in a few hours, but radiation levels on the first day in the turbine hall were estimated to range from 5-150 Sieverts/hr (15,000 rads/hr), causing 28 acute radiation sickness deaths – six of which were firemen – by the end of July 1986.

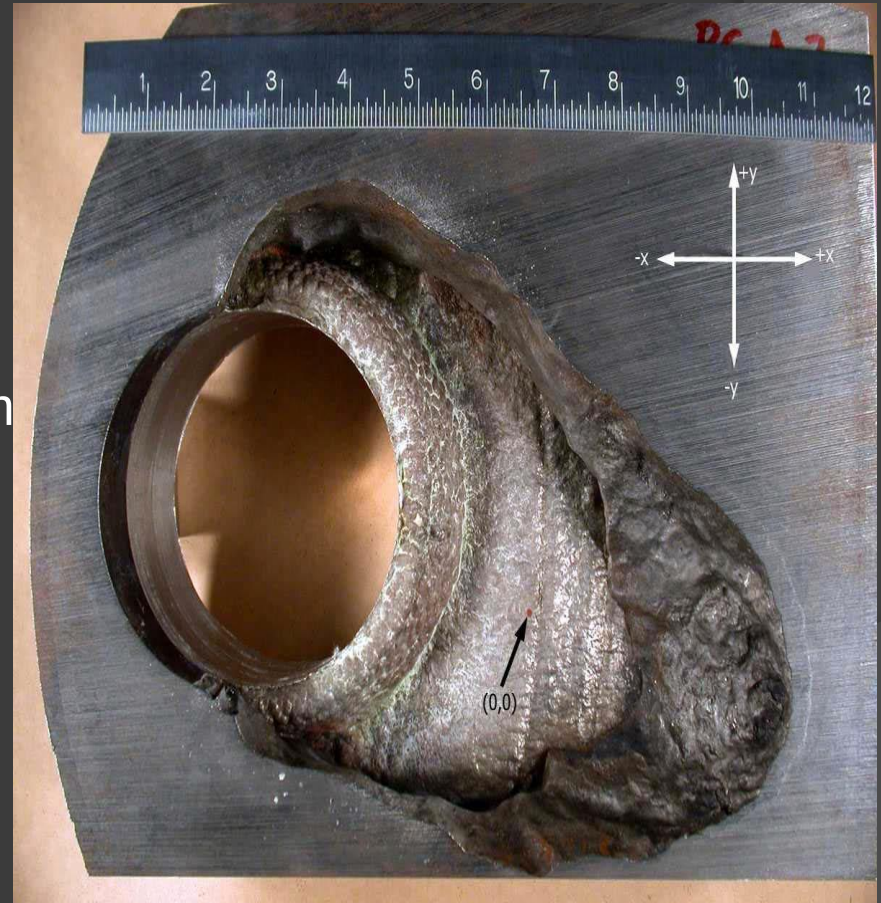
An undetected reactor coolant system (RCS) leak in a control rod drive mechanism (CRDM) nozzle flange resulted in severe degradation of the reactor pressure vessel head (RPV) due to boric acid corrosion.

- During the Refueling Outage (RFO), while removing a machining apparatus from CRDM nozzle no. 3, the nozzle tipped downward.
- Inspections revealed wastage of the steel RPV head material adjacent to the nozzle.
- The wastage extended 5 inches downward and was about 5 inches at its widest part.
- The minimum thickness of the RPV head remaining was only 3/8 inch of the stainless steel cladding on the underside of the RPV head.

- Understanding the importance to remove all boric acid deposits from the RPV head
- Recognize the need to conduct 100% bare metal inspections best to find any leaks through the RPV head penetrations
- Importance of NRC verification of licensee supplied information
- NRC missed several opportunities to identify this problem

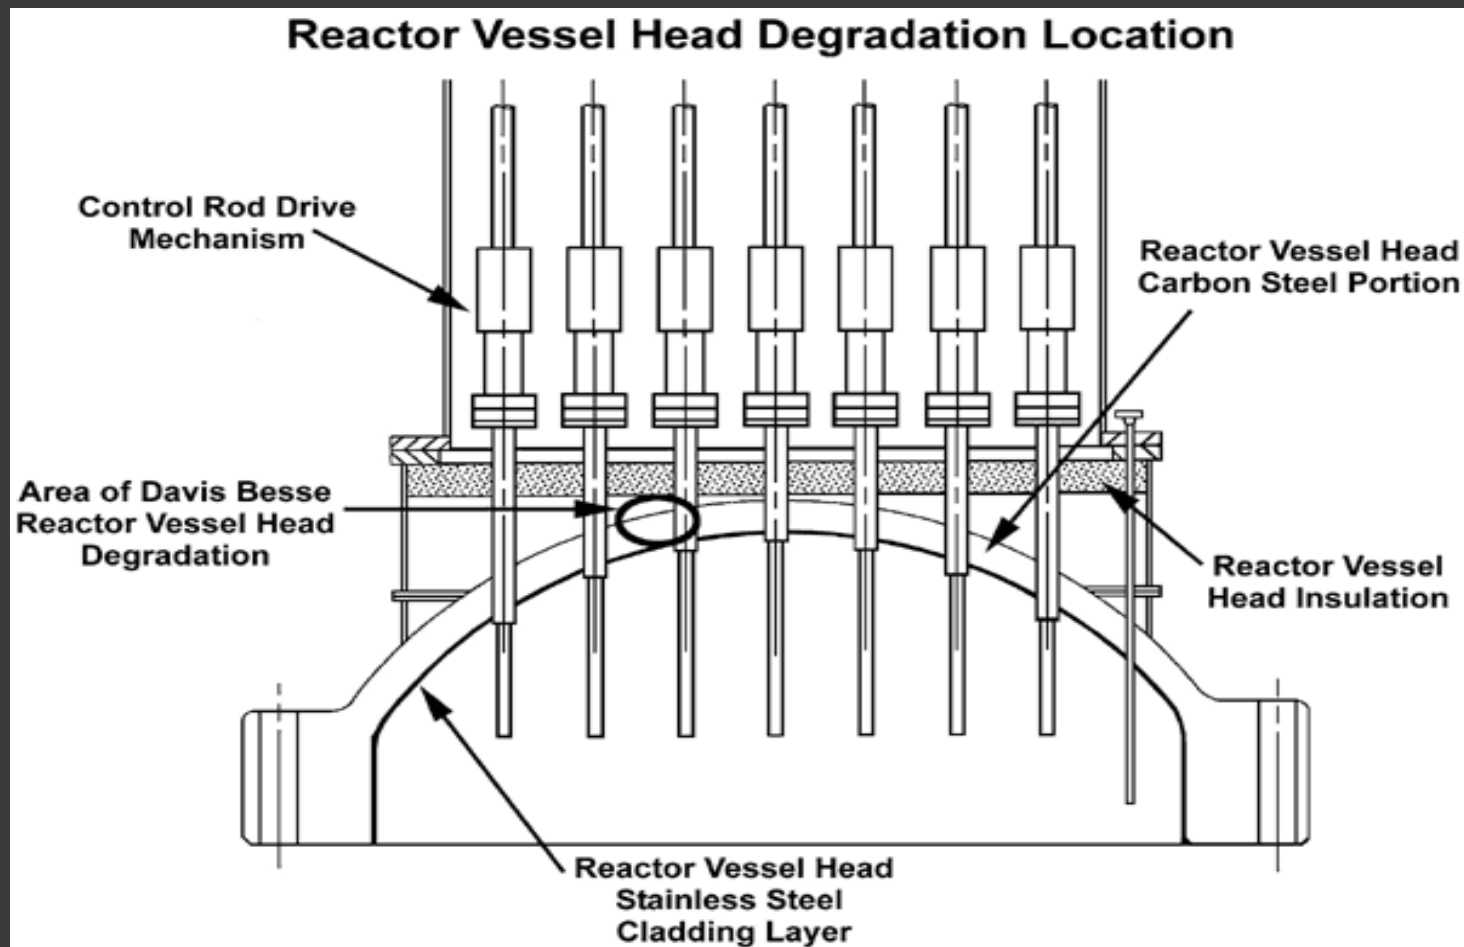
# Davis-Besse RPV Head Corrosion (Cont'd)

- The event led to a large-scale degradation of reactor vessel head – together 5 control rod drive nozzles were cracked and three cracks went through the pressure boundary.
- The degradation mechanism was boric acid corrosion due to leaks through cracks in the nozzles.
- NRC issued orders to all PWRs on enhanced inspection requirements.
- Required consideration of operating experience in licensing decisions.
