DUKE POWER COMPANY
OCONEE UNIT 2

Report No.: UE-270/74-3

Facility: Oconee Unit 2, Seneca, South Carolina

Identification of Event: Missing guide pin from valve 2LP-12

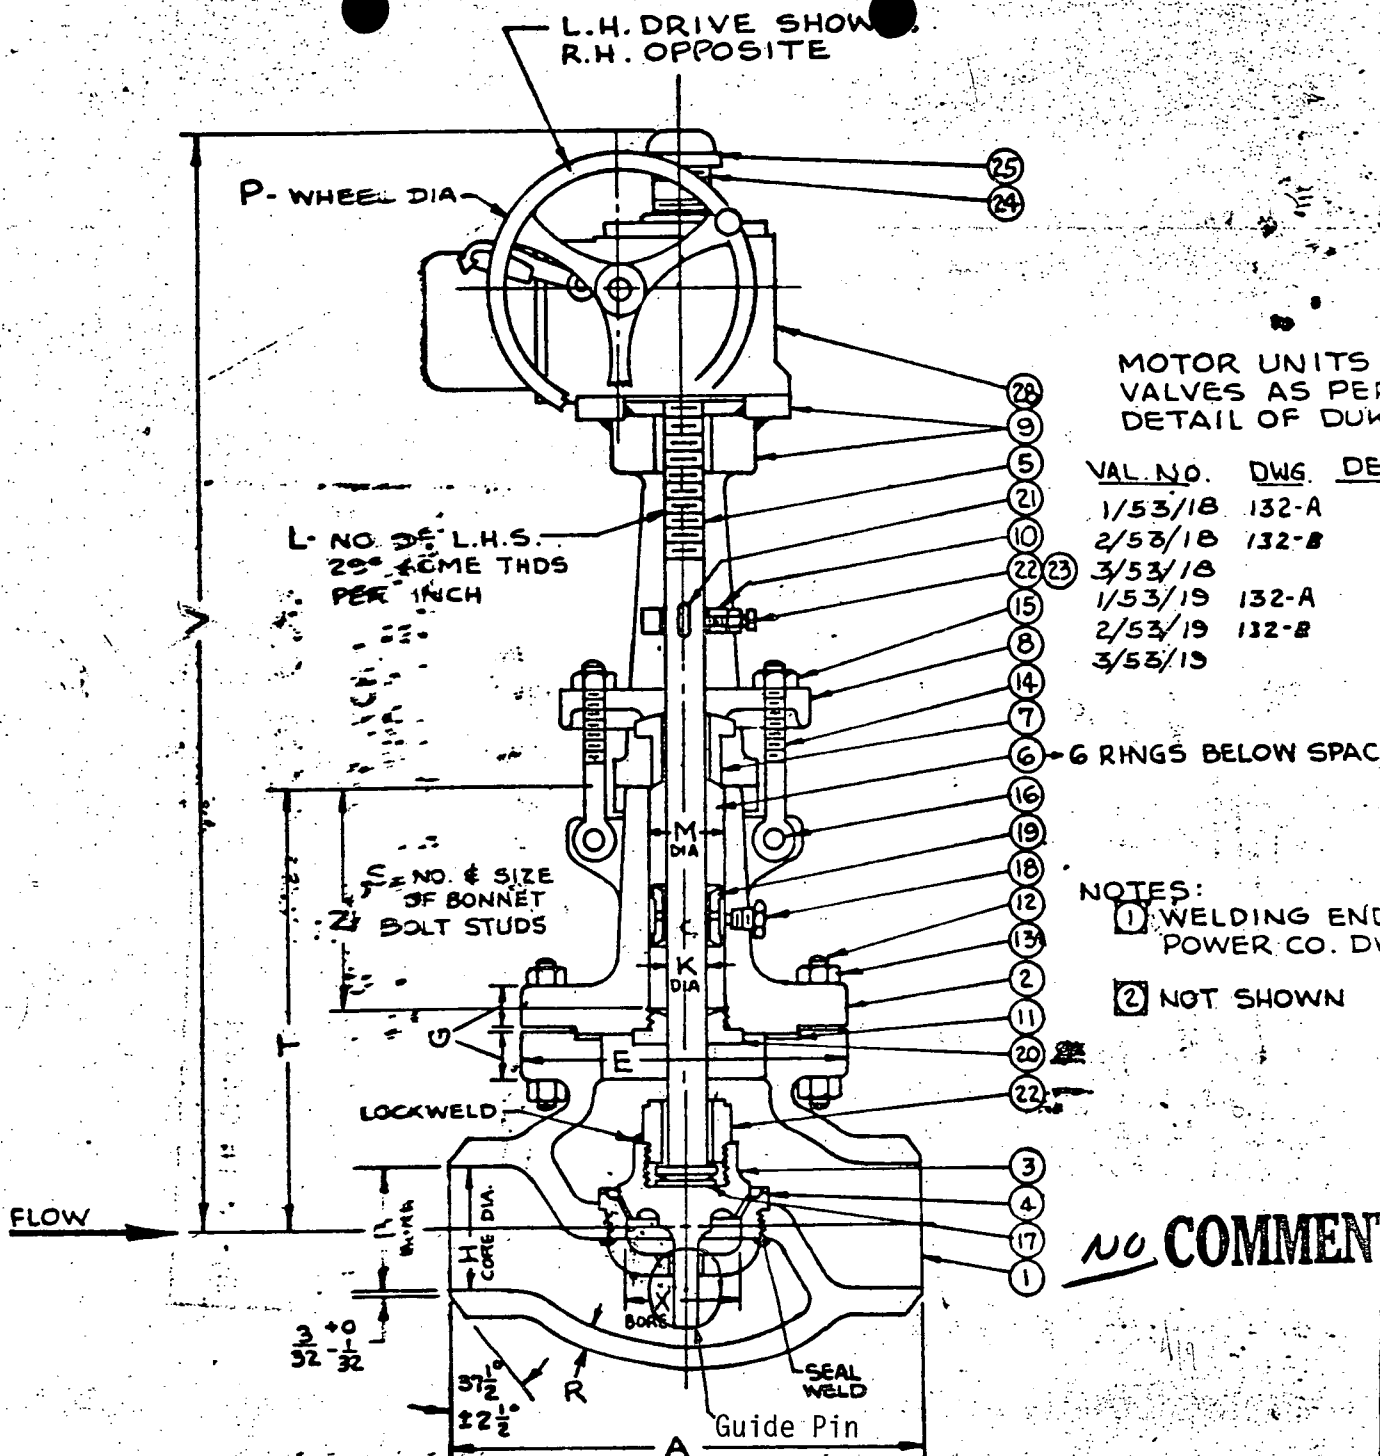
Figure 1. 2LP-12

On June 30, 1974, it was observed that low pressure injection flow in the decay heat removal mode could not be throttled below 4,000 gpm using valve 2LP-12 (outlet valve from low pressure injection cooler 2A). It was noted that the valve stem was not traveling full stroke. Disassembly of the valve on July 1, 1974 revealed that the guide pin on the base of the valve disc had broken off (see Figure 1) and the valve seat was cracked. A visual inspection of the valve indicated that the guide pin, made of 304 stainless steel with dimensions 3/4 in. by 4 in., was missing. The location of this part is not known at this time.

The apparent cause for the failure of the guide pin in valve 2LP-12 is cavitation damage when operating in the decay heat removal mode. Consultation with the Crane Company, manufacturer of the valve, and Babcock & Wilcox reveal that operation at flow rates less than 3000 gpm could cause cavitation to occur.

Procedures are being revised to ensure flow rates of at least 3000 gpm in 2LP-12 and similar valves to eliminate the possibility of cavitation.

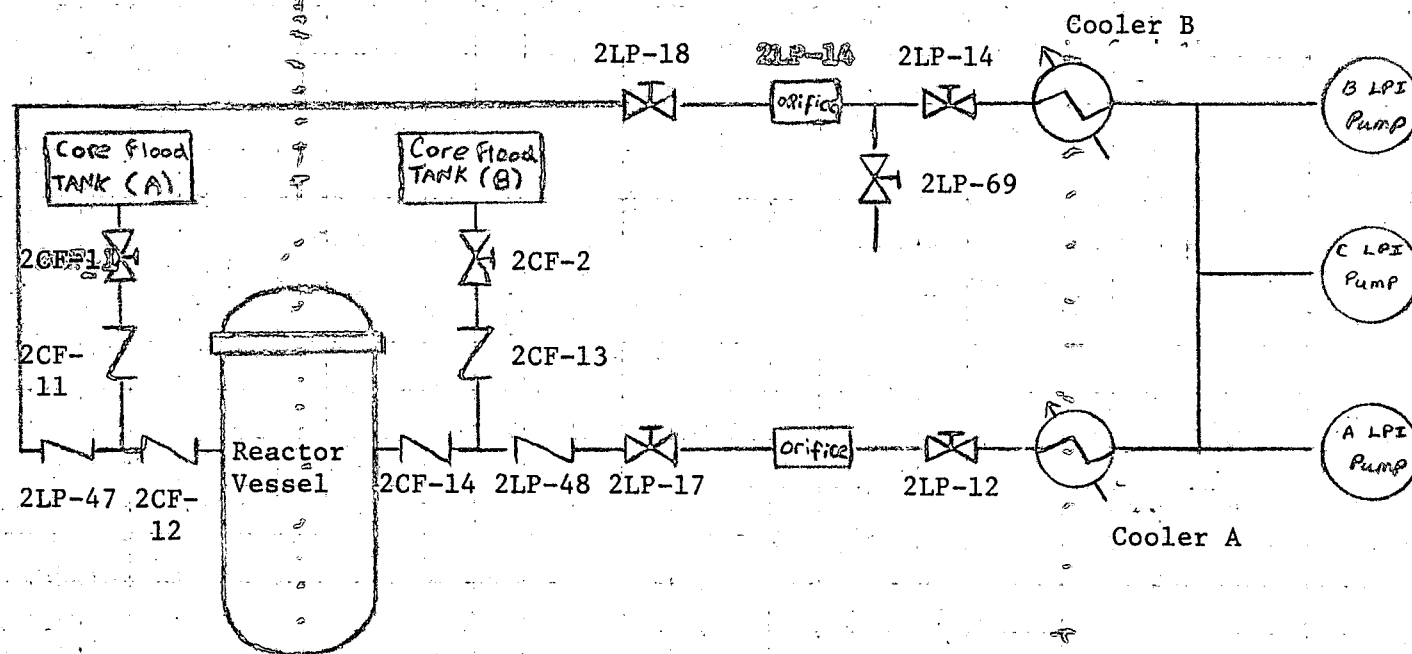
Figure 2. Simplified Low Pressure Injection System

The location of valve 2LP-12 in the low pressure injection system is shown in Figure 2. There are two check valves, 2LP-48 and 2CF-14, and one Engineered Safeguards (ES) valve, 2LP-17, between 2LP-12 and the reactor vessel.

redundant paths for low pressure injection flow. Valve 2LP-12 does not receive an ES signal but is open during reactor operation. The dimensions of the missing part (3/4 in. by 4 in.) are such that it could only prevent full opening or closing of the eight-inch valves 2LP-45, 2CF-14 or 2LP-17 should it interfere. This would only reduce the flow of water through one redundant path to the core. However, these three valves have been satisfactorily tested.
