Re: Oconee Nuclear Station  
Docket Nos. 50-269, -270, -287

OCONEE NUCLEAR STATION  
STEAM GENERATOR TUBE LEAK  
STATUS REPORT

September 24, 1977

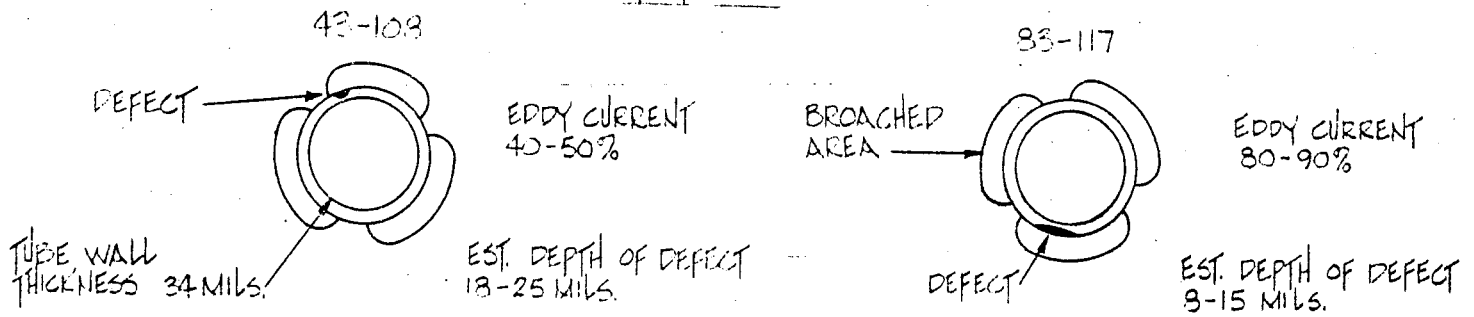
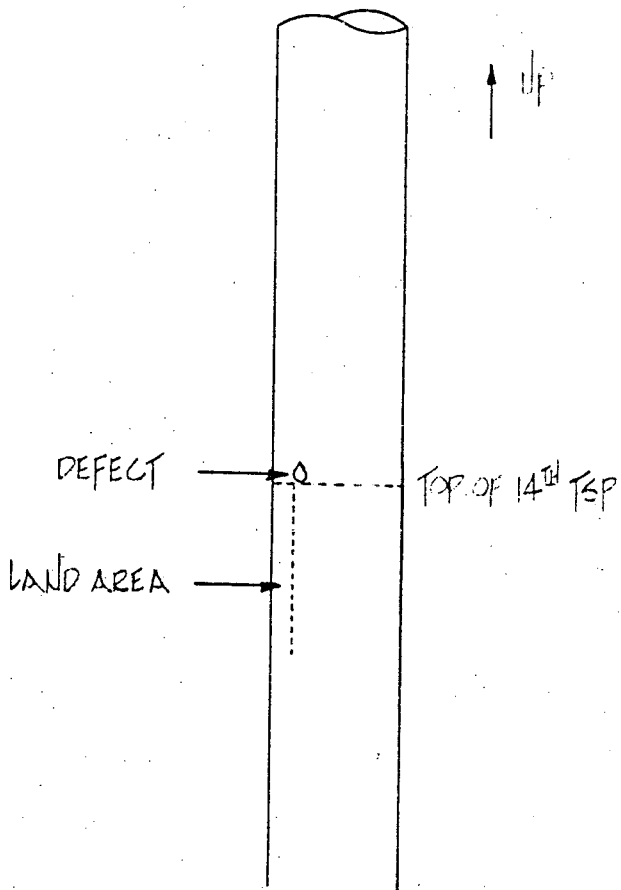
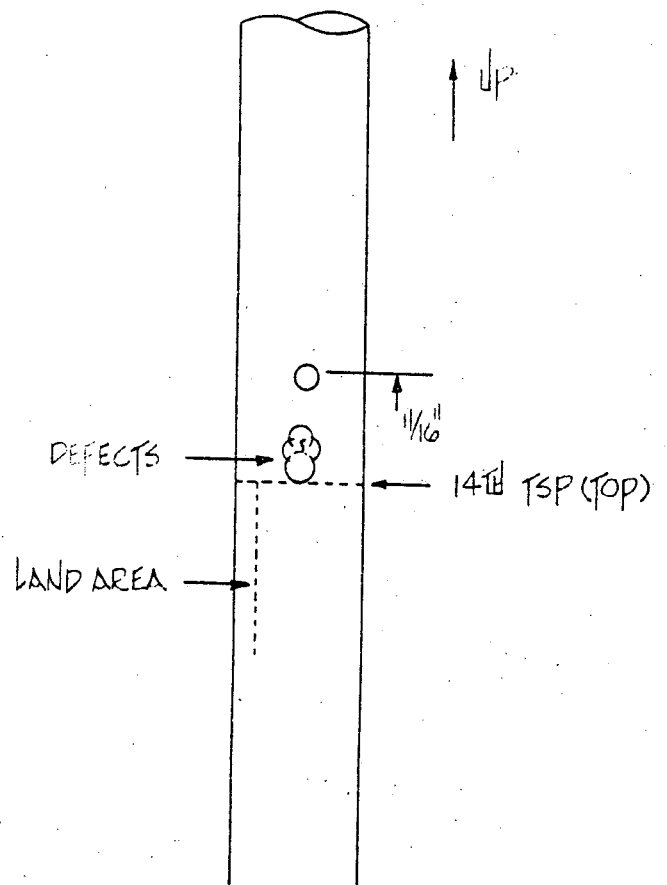
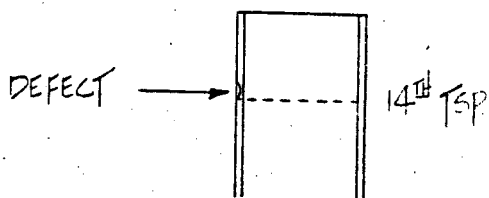
FIGURE 2

Due to the large number of defective eddy current indications, some of which indicated 90%-100% through wall, it was considered essential to obtain tube samples from the periphery for examination. A technique was developed and two tubes were removed and visually inspected on site, with detailed metallurgical analyses to be performed at a later date. The first tube removed was 43/108 which had an eddy current indication of 45-50% through wall at just above the 14th support plate. A visual inspection revealed an eroded area 1/8 inch long and 1/16 inch wide approximately .020 inches deep.

The second tube removed was 83/117 which had an eddy current indication of 80-90% through wall. This tube had erosion wear along a greater area approximately 1 inch long but appeared only to be about 0.010 inches deep. It appeared that the relatively large area of these defects caused the eddy current interpretation to be significantly overestimated. A diagram of these two defects is provided in Figure 2.

1. Information will be provided in a subsequent status report on the metal-lurgical examination conducted on removed tubes 43/108 and 83/117. This information is expected to be available by December 15, 1977.
