Oconee Unit 2

DUKE POWER COMPANY
OCONEE UNIT 2

Report No.: AO-270-74-11

Identification of Occurrence: Power level cutoff exceeded during transient xenon conditions

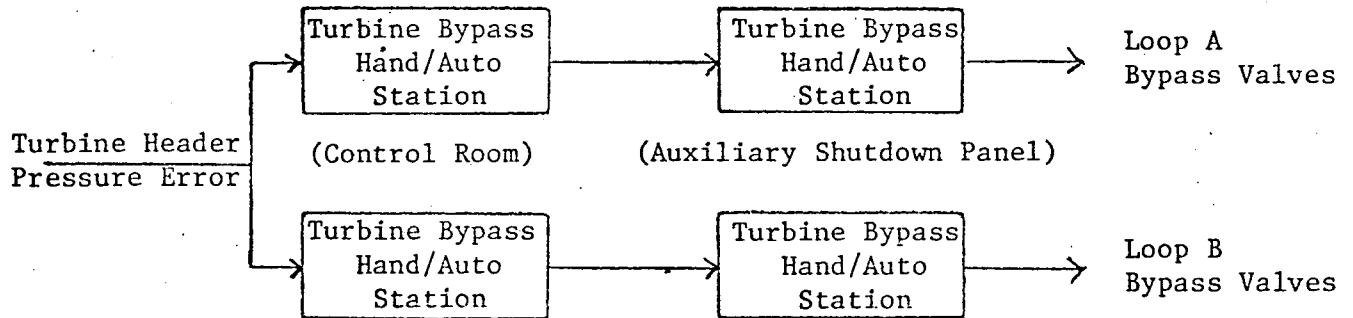
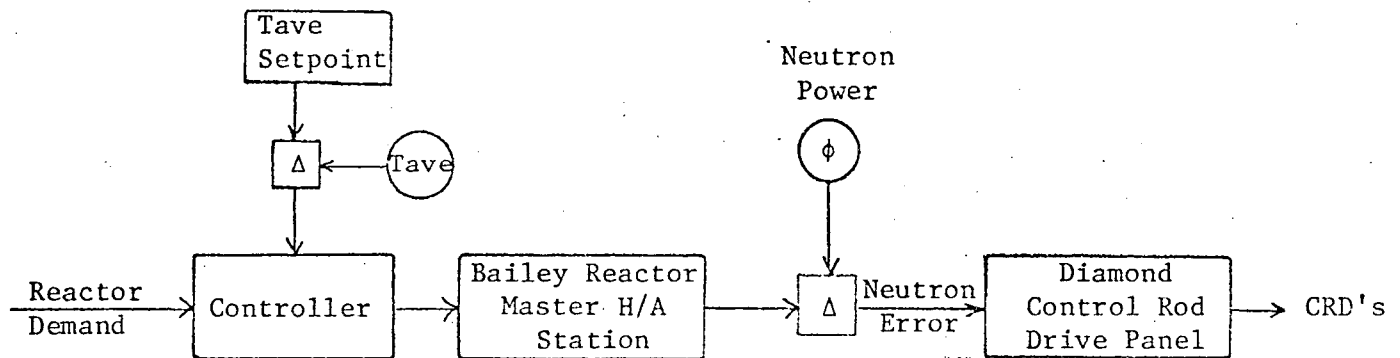
Refer to Figure 1 for a schematic arrangement of the ICS stations involved.

Oconee Technical Specification 3.5.2.5.d does not allow reactor power to be increased above 82.5 percent full power unless xenon reactivity is within 10 percent of the value for operation at steady-state rated power. Reactor power was increased above 82.5 percent full power each time by the Integrated Control System in response to the opening of the A loop turbine bypass valves. As the bypass valves opened, dumping steam directly to the condenser, the ICS increased reactor demand in order to hold unit load. The bypass valves opened improperly because of two failed modules within the turbine bypass valve controls. While reactor power was still above 82.5 percent full power, the control operator, in error, increased reactor power further above the power level cutoff in order to return the unit average temperature to normal.

The two failed modules in the turbine bypass valve control section of the ICS were replaced and a functional check performed to verify their correct operation.
