PLANT NAME: OCONEE UNITS 1, 2, & 3

RE: Oconee Nuclear Station
Docket Nos. 50-269, -270, -287

OCONEE NUCLEAR STATION

FUEL ASSEMBLY 1D40

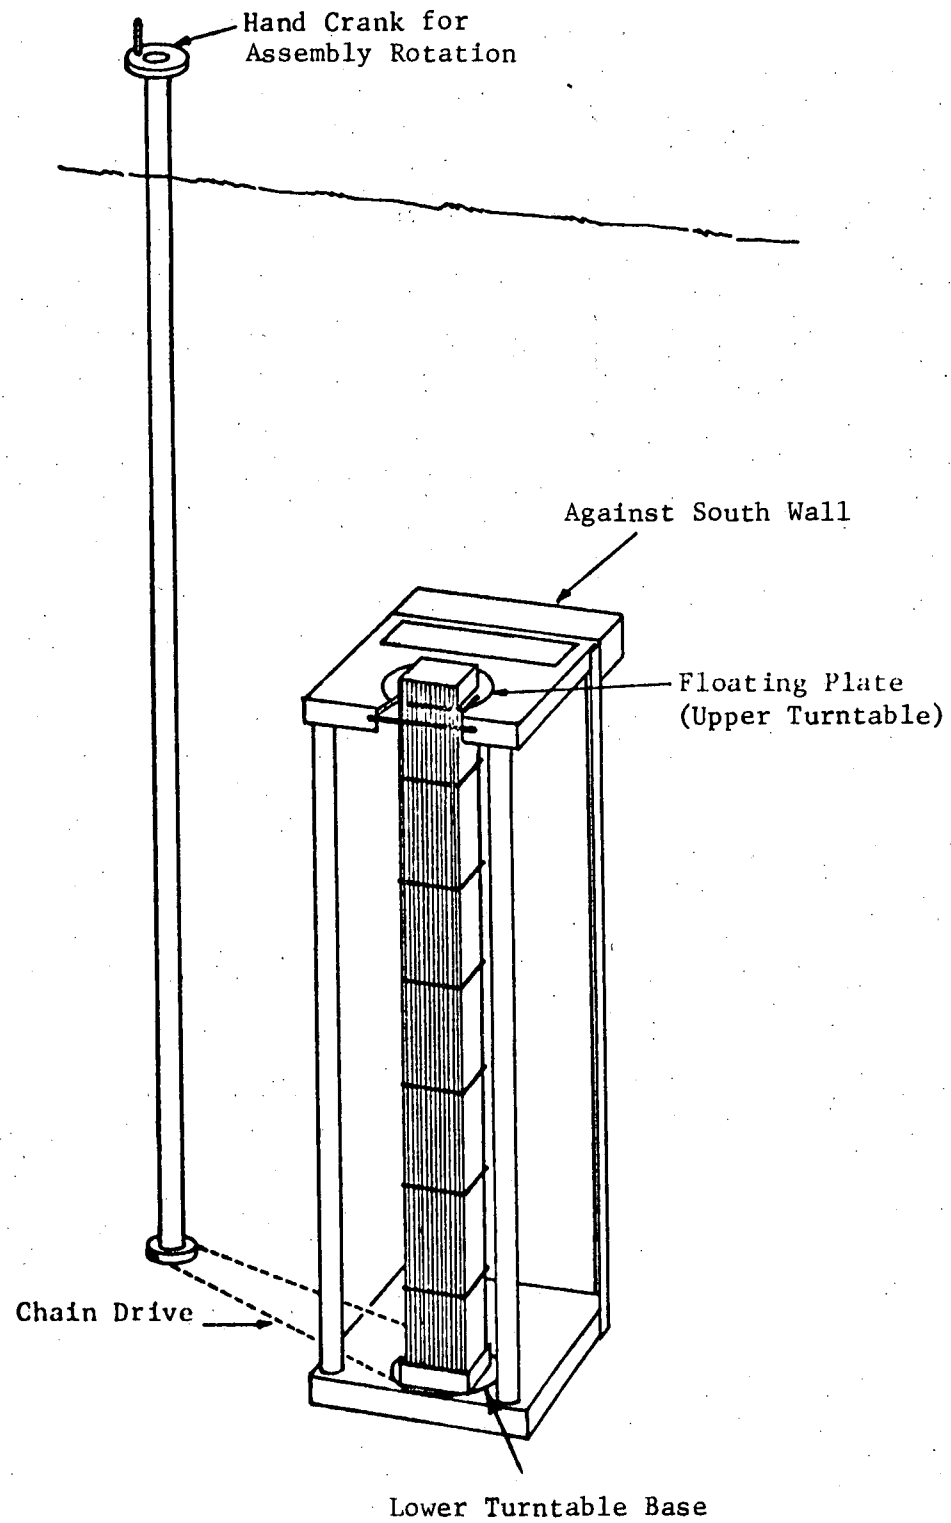
Figure 1. Line Scan Test Frame

Since the initial refueling of Oconee 1 in late 1974, a post-irradiation examination (PIE) program has been conducted for Oconee 1 fuel. This work has been performed by the NSSS/fuel vendor, the Babcock and Wilcox Company. The PIE equipment includes a jib crane/hoist and an assembly examination frame known as the line-scan tester (LST). The major features of the LST are illustrated in Figure 1. Using the PIE crane, an assembly is translated into the front cut-out area of the upper plate, secured at the top with locking clamps, and ungrappled from the crane. (This operation is reversed for assembly removal.) Once in the LST, an assembly can be rotated continuously in either direction in order to position various faces of the assembly to where the measurement heads are located (the south wall). Rotation is accomplished manually with a hand crank that drives the lower turntable plate. The upper plate is free-floating and ideally follows the assembly during rotation.

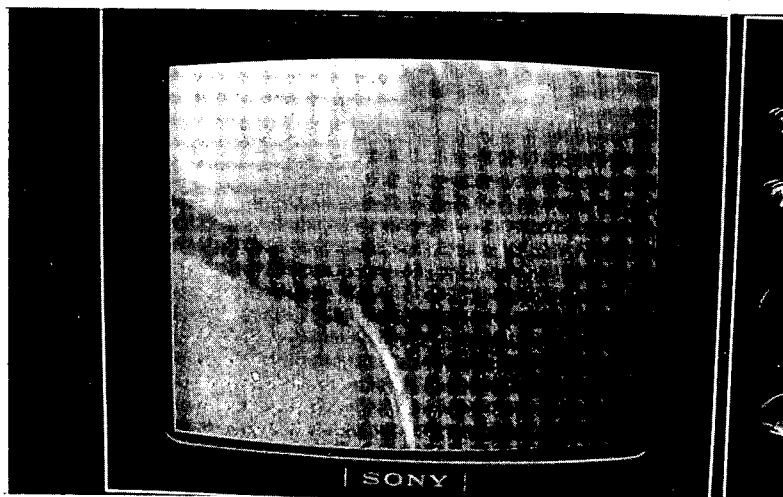
Photographs of the bent rod are shown in Figure 2 (taken from videotape images). These and other portions of the videotape footage show the bend to be uniform, with no sign of crimping or cracks. Figure 3 shows sketches of the rod, with approximate dimensions (scaled from the videotape). There is no evidence of damage to adjacent fuel rods or to the intermediate spacer grid below the bend.

View Approximately Perpendicular to Face B
