Re: Oconee Nuclear Station  
Docket Nos. 50-269, -270, -287

OCONEE NUCLEAR STATION  
STEAM GENERATOR TUBE LEAK  
STATUS REPORT

September 24, 1977

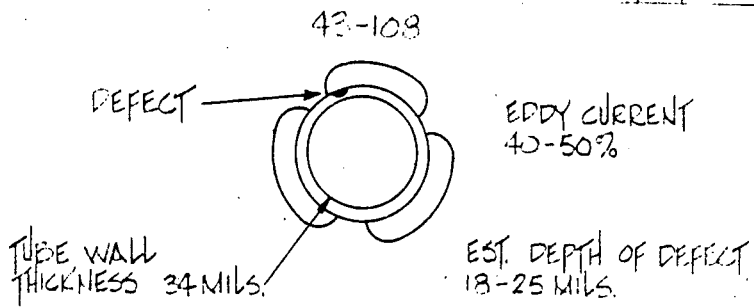
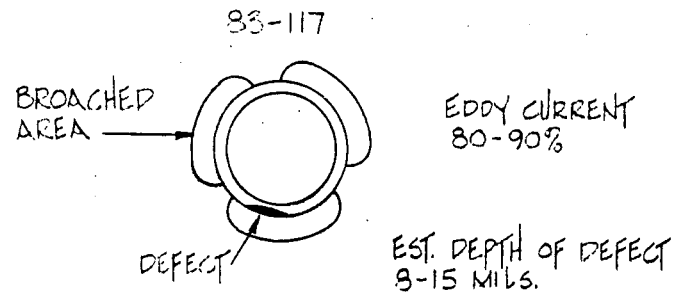
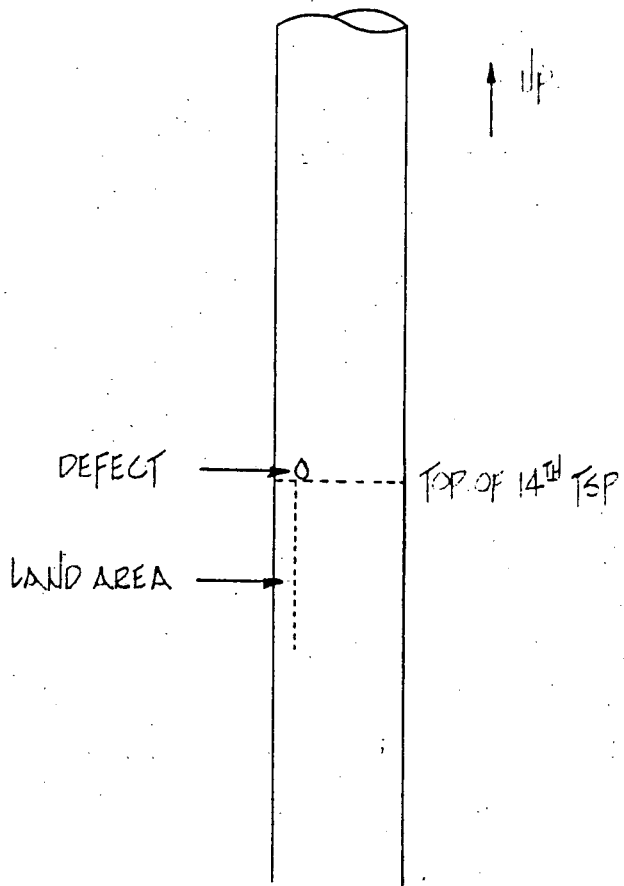
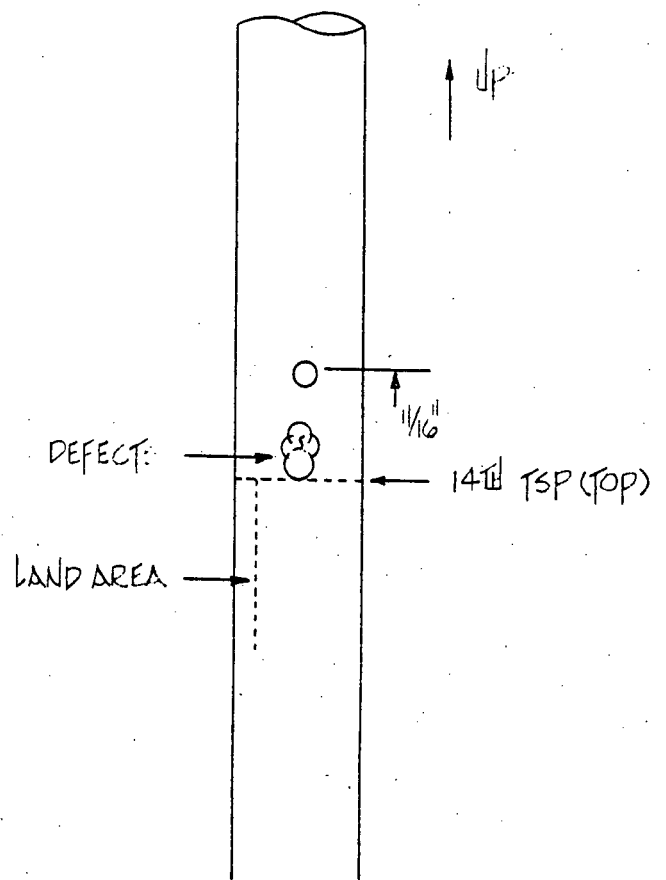
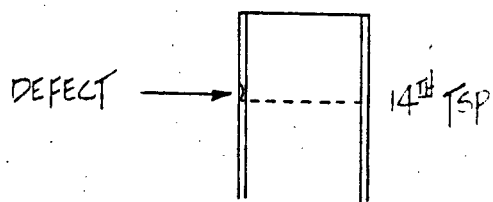
FIGURE 2

Due to the large number of defective eddy current indications, some of which indicated 90%-100% through wall, it was considered essential to obtain tube samples from the periphery for examination. A technique was developed and two tubes were removed and visually inspected on site, with detailed metallurgical analyses to be performed at a later date. The first tube removed was 43/108 which had an eddy current indication of 45-50% through wall at just above the 14th support plate. A visual inspection revealed an eroded area 1/8 inch long and 1/16 inch wide approximately .020 inches deep.

The second tube removed was 83/117 which had an eddy current indication of 80-90% through wall. This tube had erosion wear along a greater area approximately 1 inch long but appeared only to be about 0.010 inches deep. It appeared that the relatively large area of these defects caused the eddy current interpretation to be significantly overestimated. A diagram of these two defects is provided in Figure 2.
