Subject: LER: 2016-001, System Actuations during Manual Scram in Response to
Frazil Ice Blockage and Residual Transfer
James A. FitzPatrick Nuclear Power Plant
Docket No. 50-333
License No. DPR-59

LICENSEE EVENT REPORT (LER)

System Actuations during Manual Scram in Response to Frazil Ice Blockage and Residual Transfer

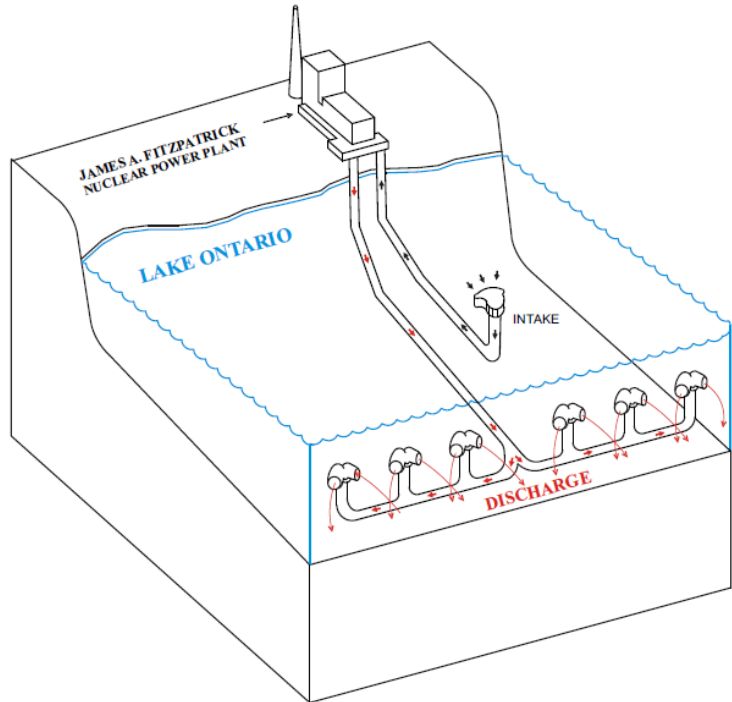
James A. FitzPatrick's (JAF) Ultimate Heat Sink [EIS designation: BS] is Lake Ontario. Water from Lake Ontario is transported via a water intake structure. The intake structure is an underwater concrete structure on the lakebed. Lake water enters the intake structure, travels through the intake tunnel, and enters the intake bay. The intake bay is located inside the screen house building. The enclosed intake bay area is also called the screenwell.

Frazil ice is a natural phenomenon in lakes and water ways, including Lake Ontario, when water freezes into loosely formed needle-like crystals. Surface water becomes supercooled when it loses heat rapidly to cold air without freezing. Turbulence, caused by winds, can mix the supercooled water throughout a body of water. The supercooled water encourages the formation of small ice crystals (frazil ice). Ice generally floats, but due to frazil ice's small size relative to current speeds, it can be carried to the bottom very easily. Frazil ice is more likely to occur when air temperatures decrease below freezing and when there is little ice cover on the lake, no cloud cover, winds are present, and the sun has set. Frazil ice has a negative impact on plant operations when it adheres to the intake structure. Supercooled water can reduce the intake structure surface temperatures below freezing then ice forms directly on the surface or frazil ice slush could drift into the structure and adhere to it. Since the intake structure actively draws in water it may draw in frazil ice. The intake structure entrance includes rack bars to screen large debris, consisting of 88 metal bars. These metal bars would normally be an optimal surface for frazil ice accumulation; however, deicing heaters are located in each.
