**RE: LQD 2014-2015 Annual Inspection Report, Uranium One, Willow Creek ISR Project, Permit No. 478**

# IN SITU MINE INSPECTION REPORT

<b>Permit Number:</b>	PT0478	<b>Permittee:</b>	URANIUM ONE USA INC
<b>Inspection Date:</b>	12/29/2015	<b>Inspector(s):</b>	Luke McMahan
<b>Report Date:</b>	3/16/2016	<b>Participant(s):</b>	Scott Schierman, Kevin Filbert
<b>Last Inspection:</b>	10/23/2014	<b>Current Bond:</b>	\$21,672,638
<b>Inspection Reason(s):</b>	Annual	<b>Field Conditions:</b>	Calm, intermittent snow fall, light snow cover, ~10° F, all areas accessible
		<b>Approval Date:</b>	4/18/1978

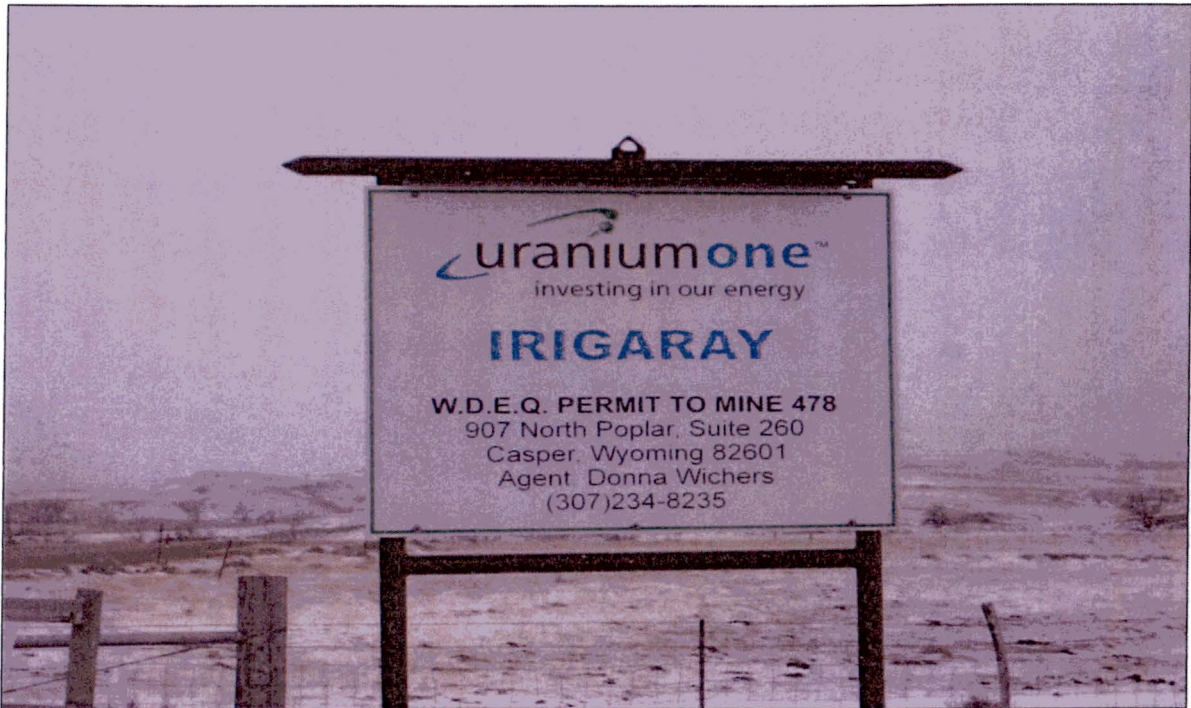
**Photo #1:** Irigaray Site project sign.

Inspection Topic	Inspection Date	Proposed Resolution Date
<b>Signs</b>  Update Mine Identification signs at Christensen Ranch and Irigaray with the current agent/contact person.	12/29/2015	12/31/2016

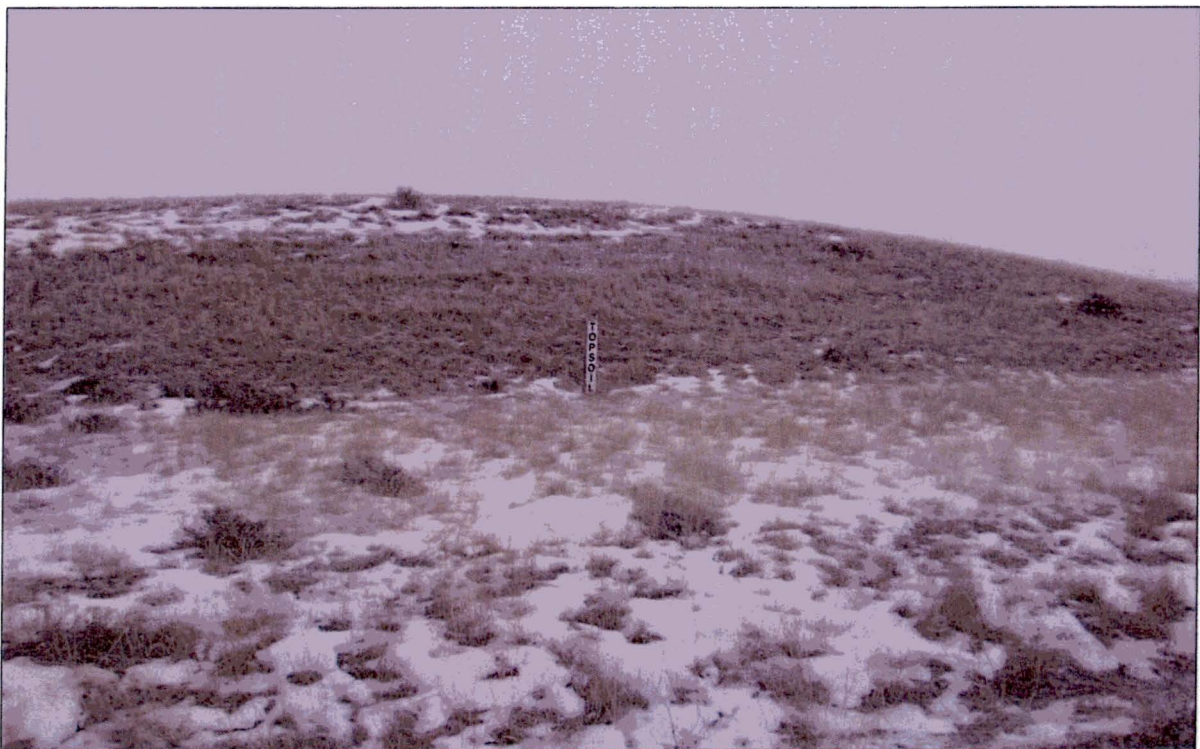
● Surface Water Control	Yes
No WYPDES discharge was occurring at the Willow Creek Mine.	
● Topsoil Stockpiles	Yes
Multiple topsoil stockpiles were viewed in passing. The stockpiles were observed to be well vegetated and stable with no significant erosional effects evident. All topsoil stockpiles observed had topsoil identification signs posted. A view of Topsoil Stockpile #3 is presented in the photo log, Photo #2.	
● Vegetation	Yes
Interim vegetation in CR Mine Units 7, 8 and 10 was observed to be well established (Photo #7 & #8).

**Photo #2:** View of typical topsoil pile identification (Topsoil Stockpile #3).

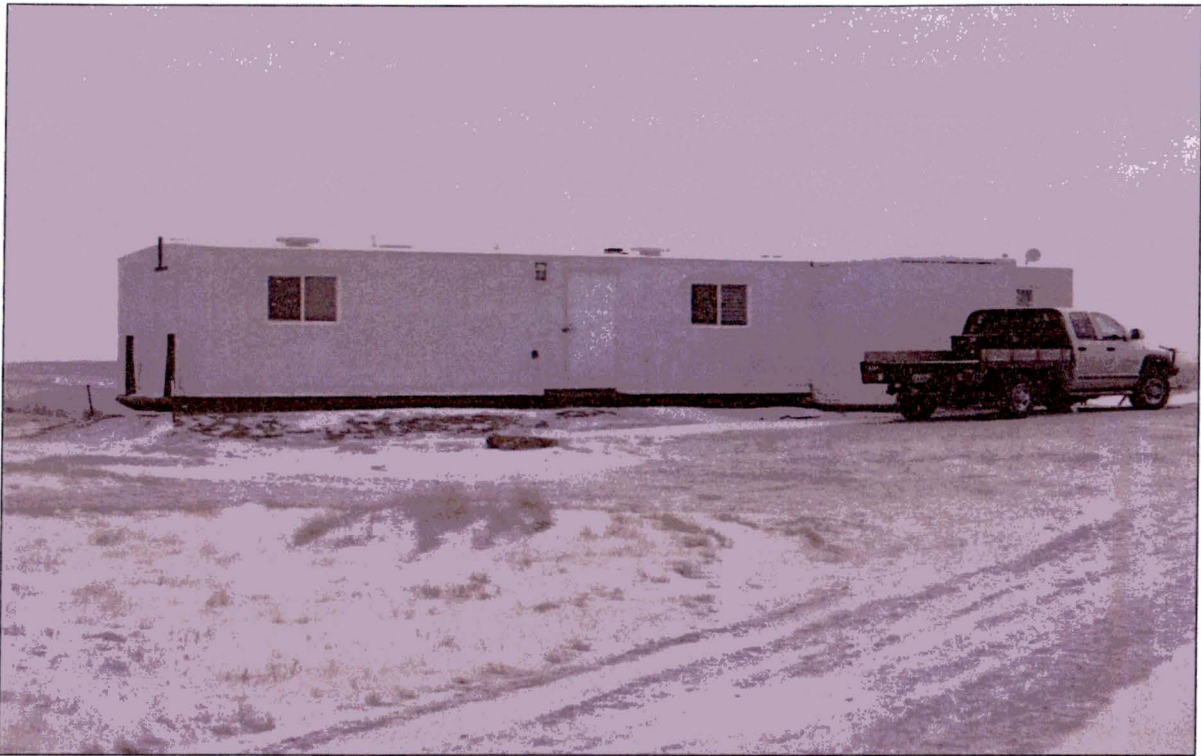
Inspection Topic	In Compliance
● Facilities	Yes
<p><u>Christensen Ranch Site</u>  The construction shop area was viewed during the inspection to verify existing buildings for reclamation bond review. Two steel buildings and two 'trailer house' buildings (Photo #3) are located at the maintenance/construction shop area. Inspection of the site identified that the trailers were not set on a foundation and therefore would not require demolition and disposal of foundation materials. Two steel buildings were identified at the site and are applicable to demolition and surface reclamation requirements. No compliance issues were noted when observing this area. The fuel island was noted to have secondary containment with an earthen berm and no spills were observed (Photo #4).</p> <p><u>Irigaray Ranch Site</u>  Uranium One's operations to redry Honeymoon, Australia dried yellowcake at the Irigaray Site were completed between March and April of 2015.</p> <p>The former 'restoration building' remains on-site and was viewed in passing while inspecting the former Irigaray mine units. Per the Final Status Decommissioning Report, this building was used historically as a wellfield control building for Mine Units 1-5, then a wellfield restoration building, and since completion of wellfield restoration activities, for general storage along with an associated shed. These buildings are located in the former Mine Unit 2 area and approximately 1,700 feet from the southeast corner of the main plant. Uranium One proposes to leave this building and associated shed as post mining features. Report B: Final Status Surveys for Buildings, included with the Final Status Decommissioning Report, documents the results of a release survey of these buildings. The Final Status Decommissioning Report for the Irigaray ISR Site was submitted to NRC in August of 2015 and was in review with NRC at the time of this inspection.</p> <p>The Irigaray Plant was viewed in passing, no issues such as spills around the fuel island, were observed. The fuel island was noted to have secondary containment with an earthen berm.</p>

**Photo #3:** View of 'trailer house' building located in maintenance area of CR Site.

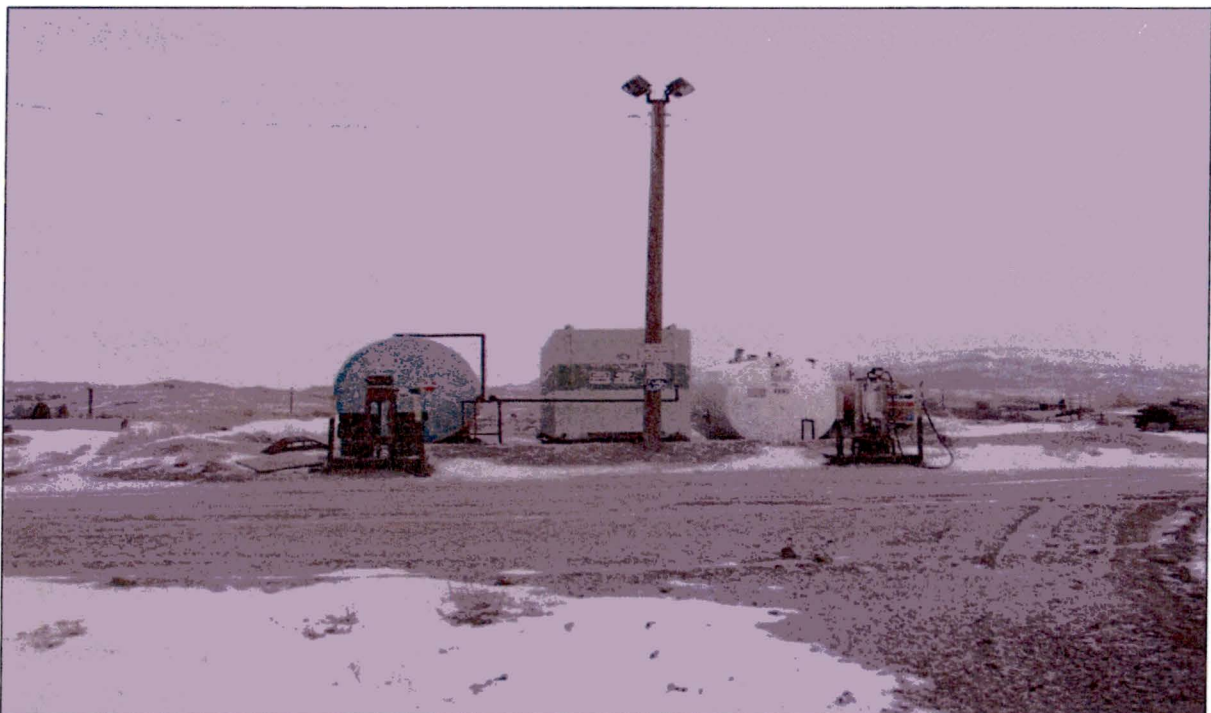
**Photo #4:** View of fuel island located in CR maintenance area, tanks bermed for secondary containment.

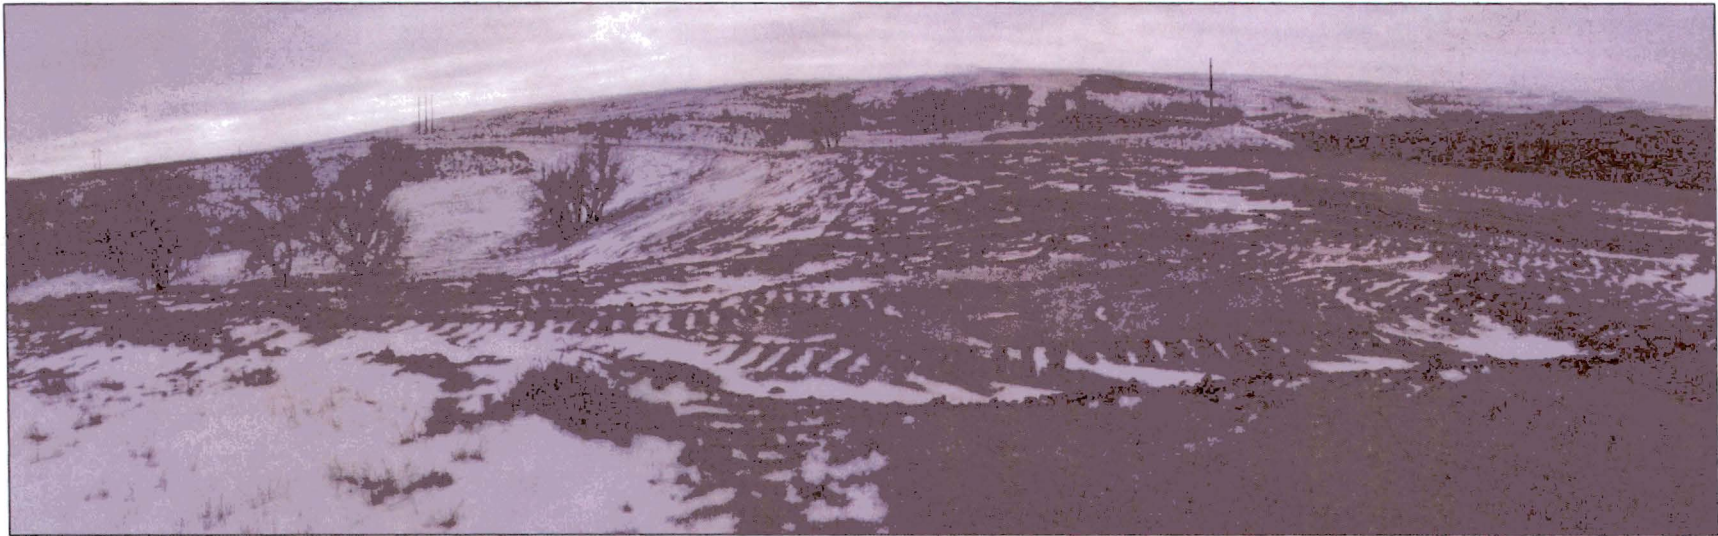
Inspection Topic	In Compliance
● Roads	Yes
During the inspection, road repair work was viewed where flood waters washed out the road embankment where it crosses North Prong Willow Creek in the SE Quarter of Section 8, T44N, R76W (north of MU5 and west of MU7). Although within the permit area, the location of the washout is not within an area of mining activity. The repair of the washed out road embankment was performed by the landowner (was not a mine project) and consists of the rebuilt embankment and a new culvert (Photo #6).	
● Signs	Yes
Mine Identification signs were observed posted at both the Irigaray Site (Photo #1) and the Christensen Ranch Site. Both signs indicated that Donna Wichers is the Agent (i.e. contact person). LQD understands that Donna Wichers is no longer in this position with Uranium One. Therefore, the signs will need to be updated with the current agent/contact person information. Otherwise, the sign was posted with the appropriate information. The address and phone number on the sign remains current for contacting the Uranium One Casper, WY office. Communications with Uranium One following the inspection have indicated that the Mine has arranged to have these signs updated. Multiple access control and radiation safety signs (Photo #5) were also viewed throughout the mine site.

**Photo #6:** View of road and culvert repair constructed by landowner across North Prong Willow Creek, SE Section 8, T44N, R76W.

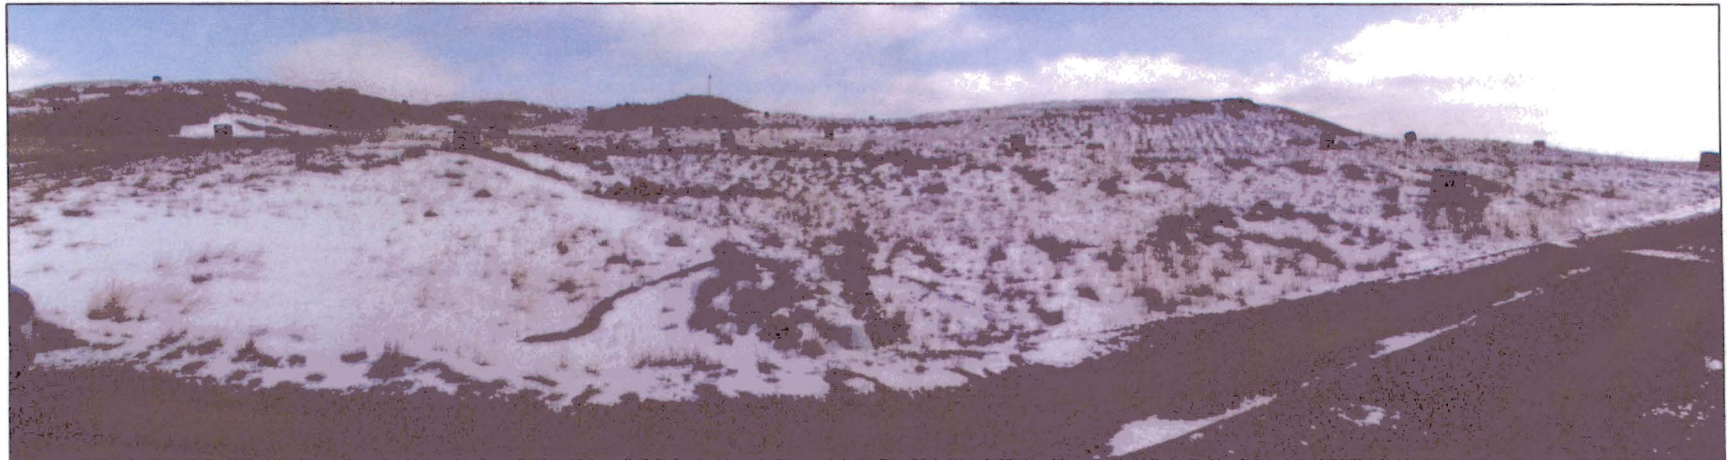
**Photo #7:** View of Mine Unit 8 interim vegetation and sediment control structures.

No violations were issued as a result of this inspection. No new maintenance items were generated as a result of this inspections. Willow Creek Mine is reminded to continue to closely watch, and reinforce sediment control measures as needed in areas of recent disturbance such as Mine Units 8 and 10.

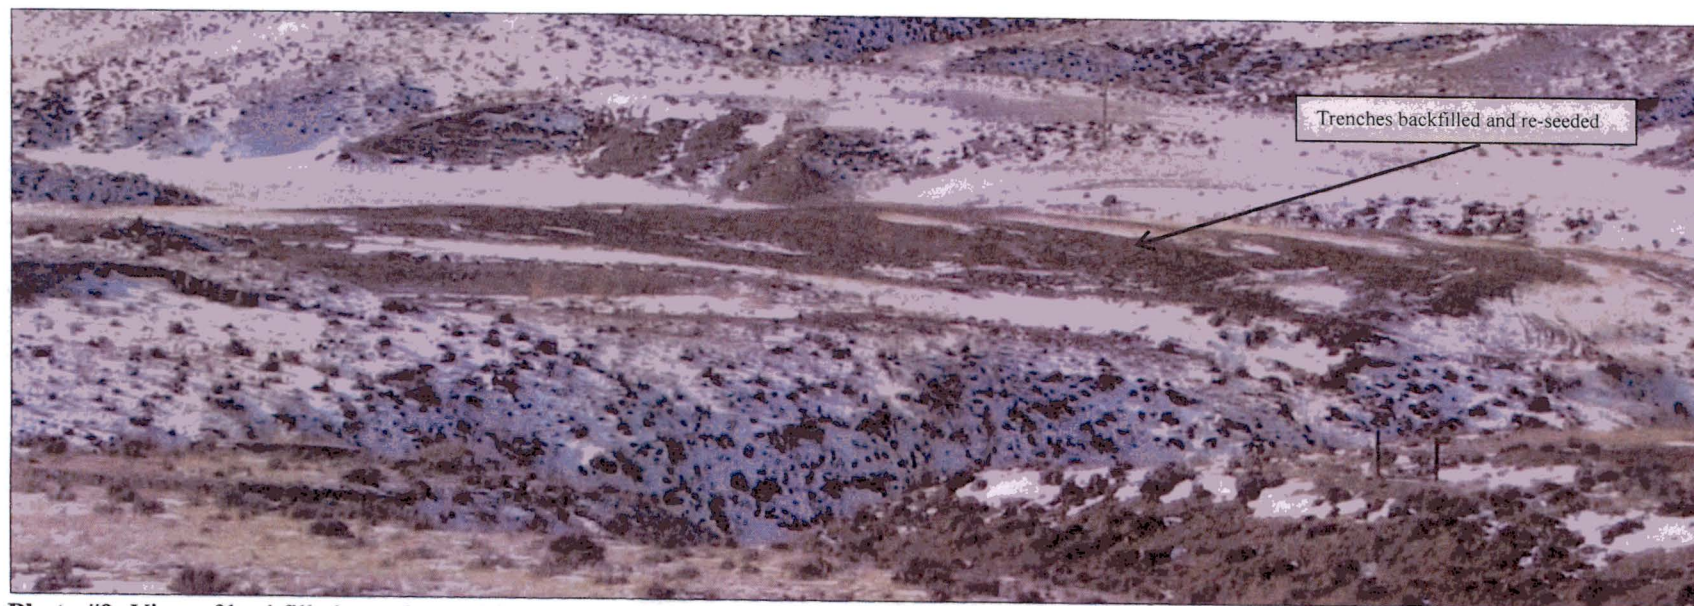
**Photo #9:** View of backfilled trenches at Irigaray Mine Unit 7.
