NL-16-032

SUBJECT: Entergy Transmittal of Indian Point 2 ASME Section XI, IWL Concrete Containment Inspection In Accordance With the Parties' Approved Settlement of License Renewal Contention NYS-24
Indian Point Unit Number 2
Docket No. 50-247
License No. DPR-26

ENTERGY ENGINEERING REPORT IP-RPT-15-00029,
“IP2 ASME SECTION XI, IWL CONCRETE CONTAINMENT
INSPECTION FOR 2015”

IP2 ASME Section XI, IWL Concrete Containment Inspection for 2015

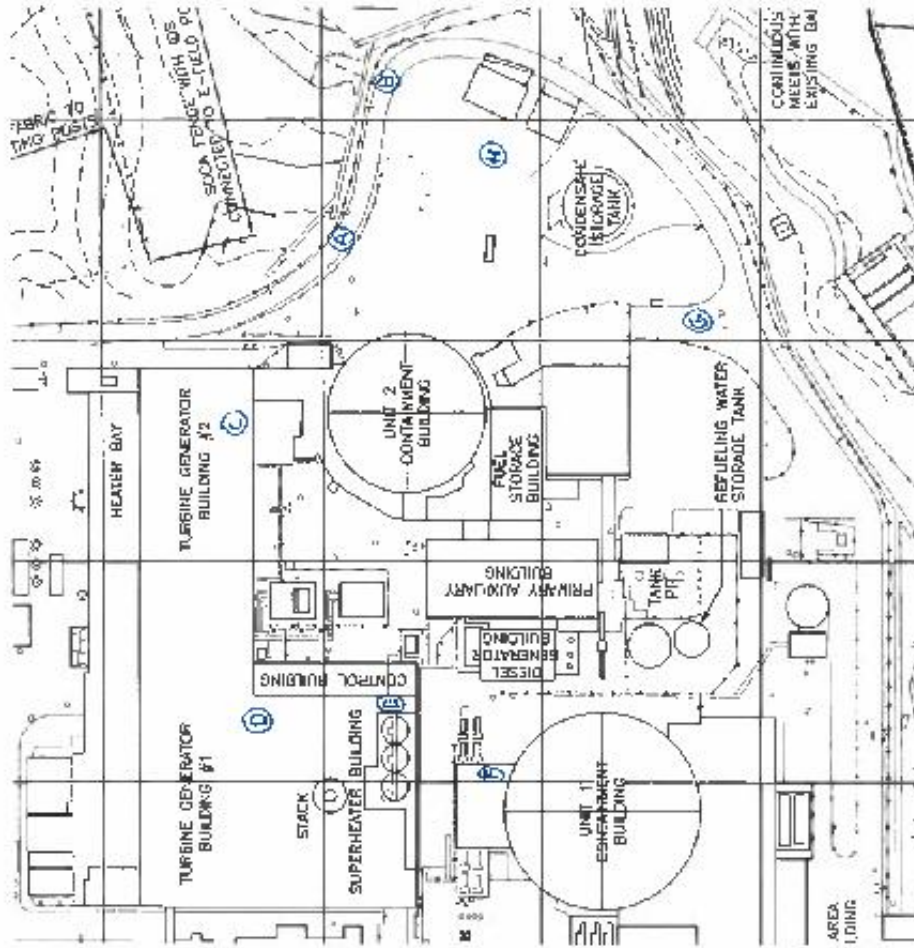
FIGURE 1

Vantage Points Used in Remote Visual Inspection		
Vantage Point	Description	Zones Examined
A	Along edge of road.	Zone 1 from El. 34' to El. 68'.
B	Along edge of road.	Zone 1 from El. 68' to Dome
C	Edge of Turbine Building roof.	Zone 2 from El. 68' to Dome
D	Edge of Superheater Building upper roof.	Zone 3 from El. 68' to Dome
E	Edge of Superheater Building lower roof.	Zone 3 from El. 68' to El. 86'
F	Edge of NSB roof.	Zone 4 from El. 108' to Dome
G	Along edge of road	Zone 5 from El. 108' to Dome
H	On quad north of condensate tank.	Zone 6 from El. 108' to Dome

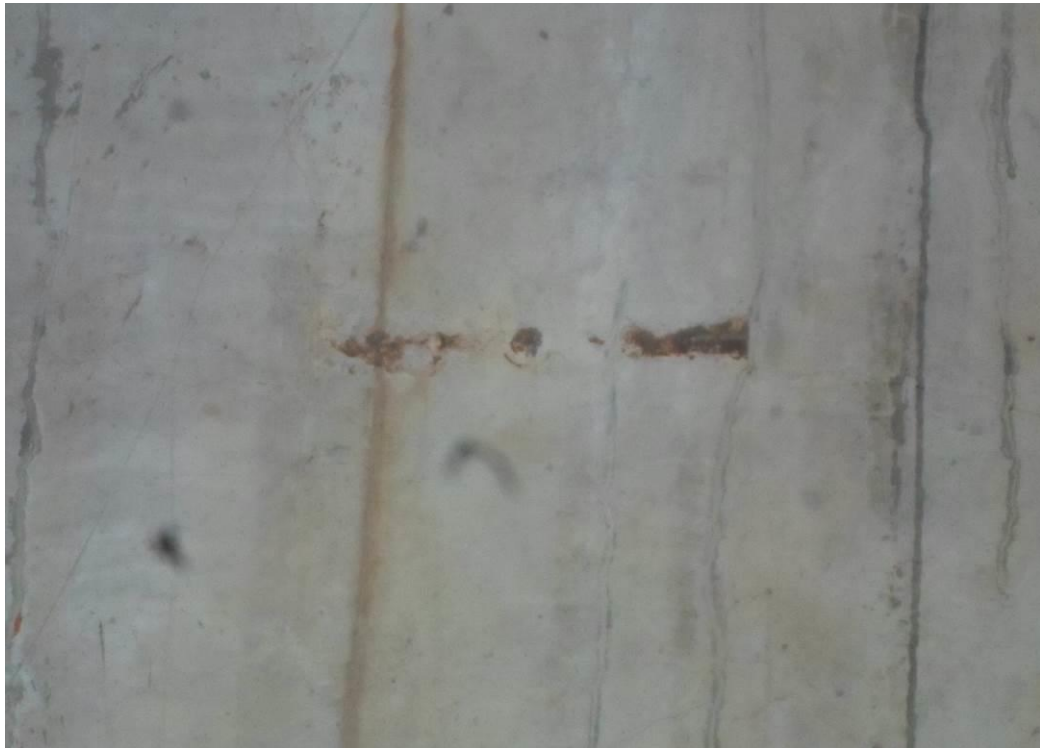
Photo Z3-008

10.	Next to containment area cage, tight vertical crack intersecting horizontal joint with minor separation (<1/16")	JK
11.	Two partially exposed cadwelds near left side due to lack of cover. No spalling. See photos Z3-008 and Z3-008A .	JK

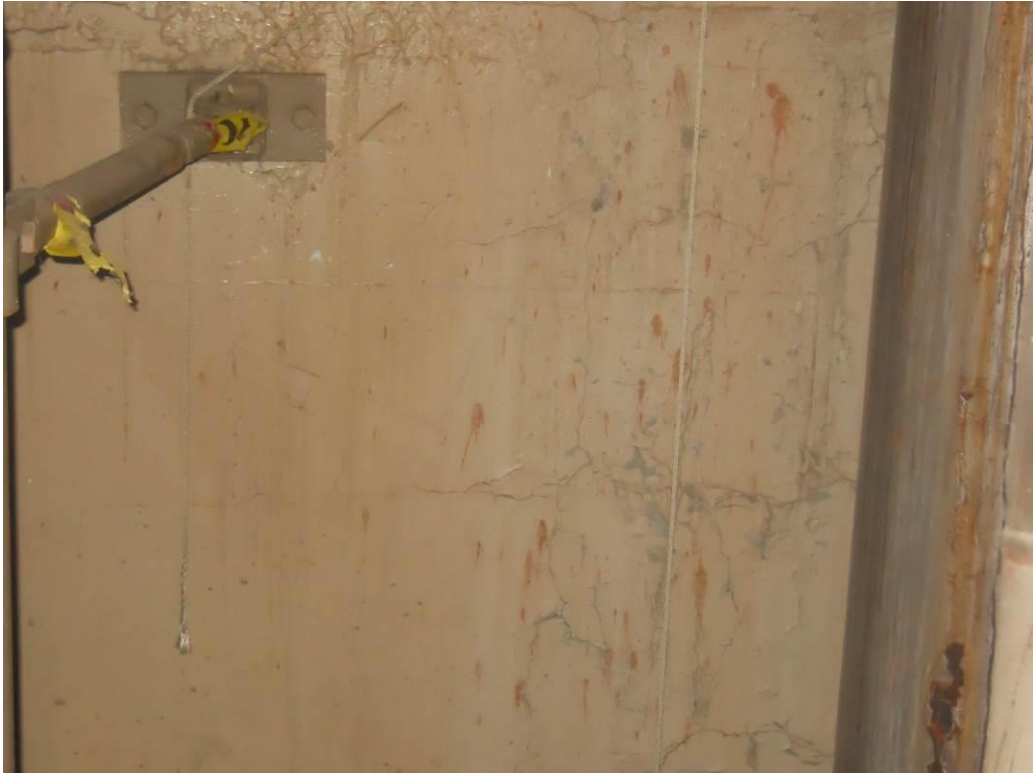
2015 Photo IWL-068-002 Photo Z2-022

4	Hairline pattern cracking (<1/32") at El. 70' approximately 25' from right boundary. Identified in previous inspection. See photo Z2-022 .	JK
5	Joint cracking, pattern cracking and minor spalling at El. 82', behind S/O Relief MS-45C. Identified in previous inspection. See photo Z2-023	JK
6	1-1/2" x 1-1/2" discolored area (rust color) at El. 68' behind MS-42. Same as last inspection. See photos Z2-024 and Z2-024A .	JK
7	Multiple retired anchors left embedded in containment at El. 77'. No degradation to concrete.	JK
8	There is a small void just below roof level behind MS-48A. See photo Z2-020C .	JK
9	Several form tie holes were found not patched. There is also a sloppily formed joint at this location. These are not significant relative to containment structural integrity. See photo Z2-025 .	JK
10	There is a spall behind the column at the far end of the room. See photo Z2-026 .	JK

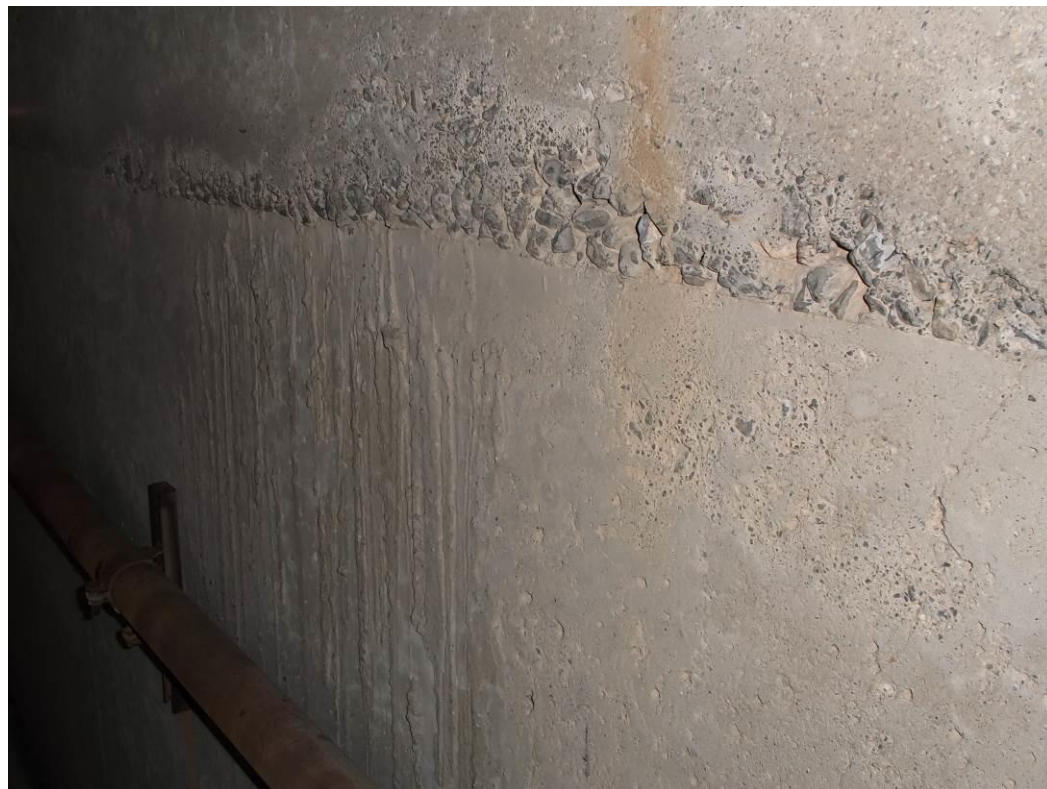
Photo Z5-002

No.	Comment	Initials
1	Three sets of two popouts (approx. 2" dia.) behind the duct (approx. El. 97', El. 102' and El. 107') possibly from unfilled form ties or drilled holes. See photo Z5-001.	<i>AMP 9-28-15</i>
2	Exposed aggregate due to loss of matrix from initial vibration. Cement paste streaks due to improper form work installation is visible. Rust stains appear from surface mounted steel. No change since 2005 inspection. See photos Z5-002, Z5-002A, Z5-002B and Z5-002C.	<i>AMP 9-28-15</i>
3	An additional 10' of inspected elevation (El. 78' – 88') was added to this component and pertain to comment 2 above.	<i>AMP 9-28-15</i>
4	Drop-in anchors were installed to allow scaffold to be built for painting of the vent stack. See sample photos Z5-002A and Z5-002B.	<i>AMP 9-28-15</i>

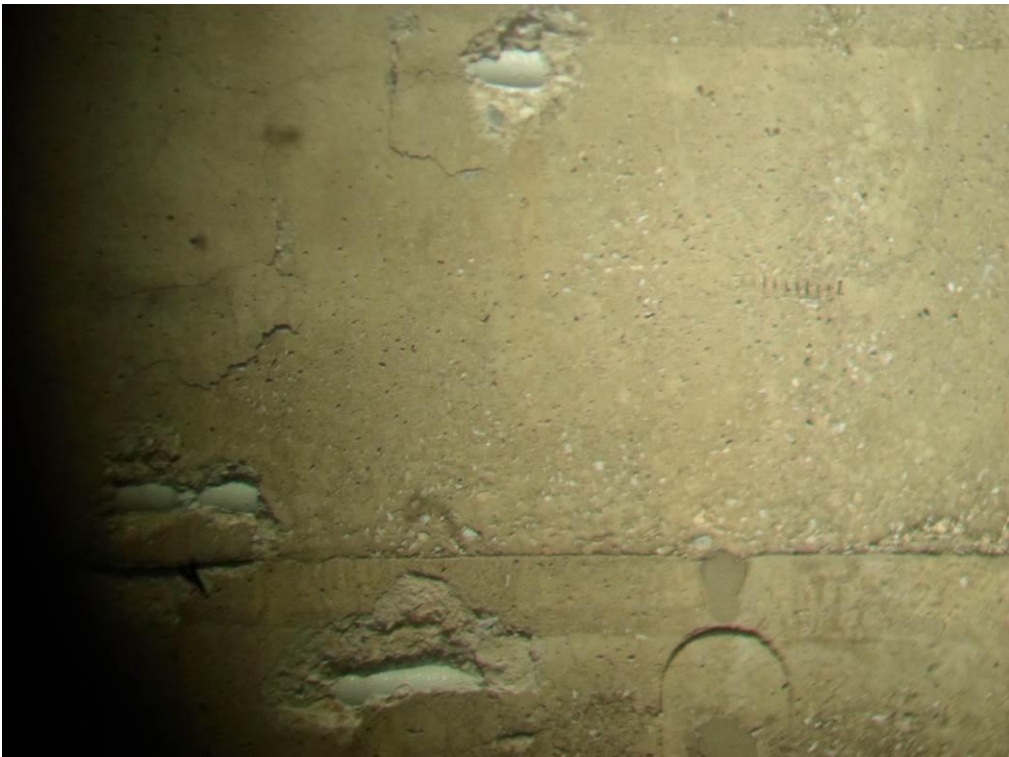
2015 Photo IWL-128-003 Photo Z3-031

2	General joint cracking, local scaling, and pattern cracking between El. 128' and El. 133'. Especially near right side at El. 130'.	JK
3	General joint cracking, local incipient spalls, and bugholes between El. 133' and El. 138'.	JK
4	General joint cracking and pattern cracking between El. 143' and El. 148'.	JK
5	At El. 134' there are rust spots that resemble ribs on rebar. See photo Z3-031.	JK

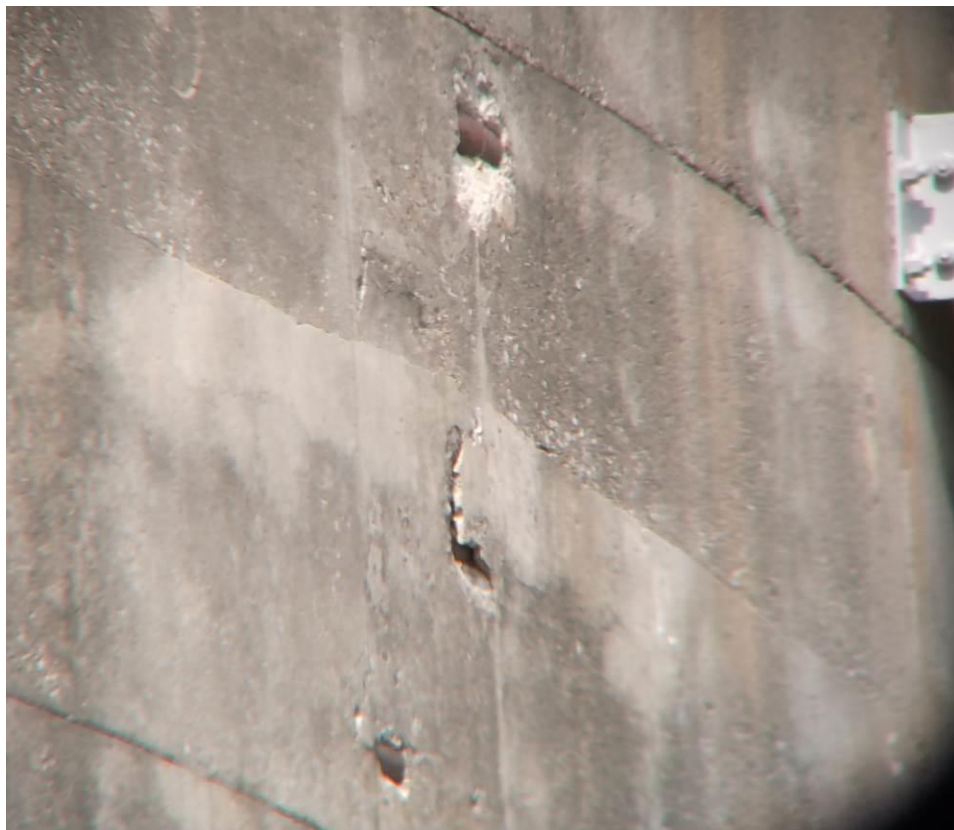
Photo Z4-050

2	<p>Loss of mortar 1/4" deep over an area 2'x6'. This area has remained unchanged since previous inspection. See photos Z4-036, Z4-036A, Z4-036B and Z4-048.</p>	AWD 9-28-15
3	<p>Group located at far right side of zone</p> <ul style="list-style-type: none"> - Signs of delamination and future spalling at El. 142'. Size and shape suggest it is a cadweld. See photo Z4-049. - Exposed cadweld (3" x 2") at Elevation 144'. See photos Z4-049, Z4-050 and Z4-051. - Exposed cadweld (4" x 2") with a 12" x 6" delamination ready to spall at Elevation 145'. See photos Z4-050 and Z4-051. - Exposed cadweld (4" x 2") at Elevation 147'. See photos Z4-050 and Z4-051. 	AWD 9-28-15
