**Subject: License SUA-1341, Docket No. 40-8502  
Willow Creek Project  
December 7, 2015  
Module 2-4 Production Fluid Release from Restored Mine Unit 2  
Christensen Ranch Mine Unit 2**

**Uranium One USA, Inc. - Willow Creek Project  
Spill Report Summary  
Module Building 2-4 Production Fluid Release**

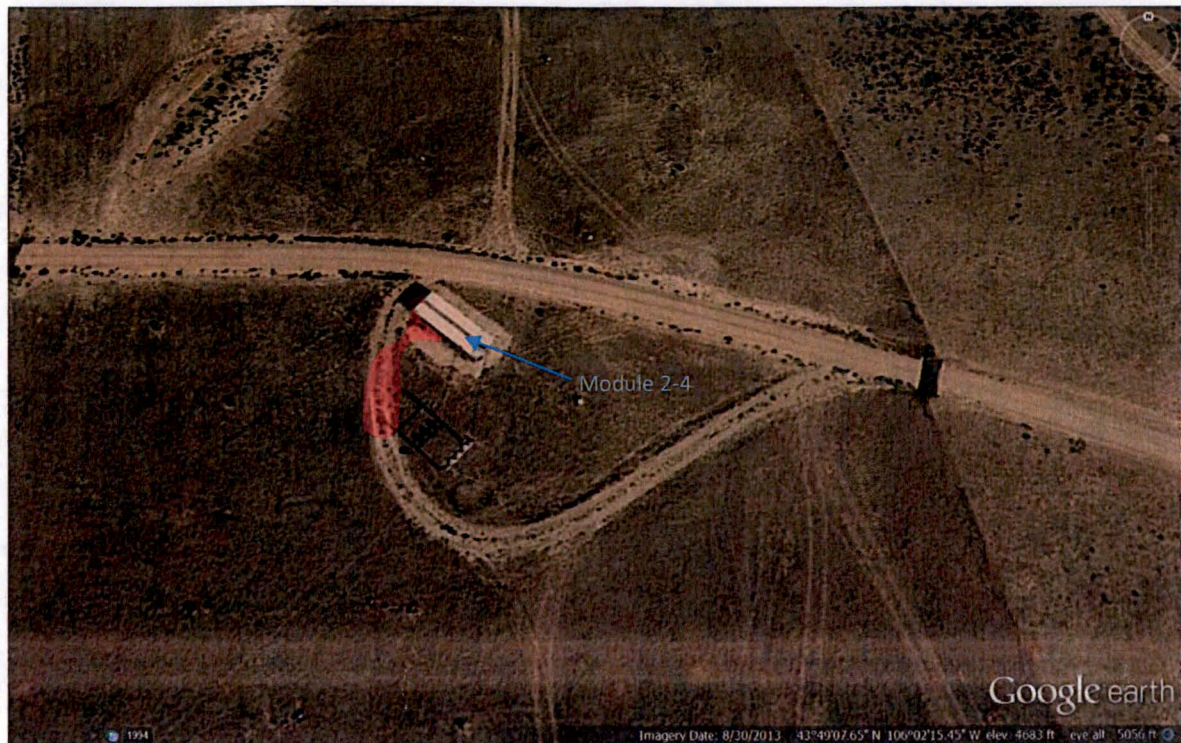
### **Map of Spill Location and Impacted Area**

The release followed the existing grade and ended in a two track road, approximately 80 feet away (see attached photos and map). It is estimated that 765 square feet (0.0178 acres) of soil was impacted. No wildlife, livestock, or surface water was affected. No significant erosion resulted from the spill.

The location and estimated extent of the spill outside the building is shown as light red.

Due to the limited extent of the release, no remediation is anticipated at this time.

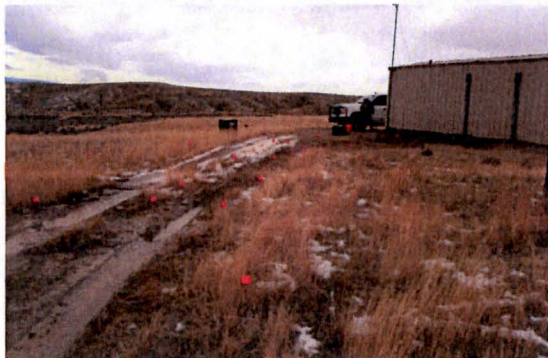
Soil samples both inside the building and the estimated effected area were collected and are available for analysis. Gamma survey results taken at the spill area indicate that soil contamination is minimal and sampling and cleanup will not be required.

Looking northwest along road. Flags show uR meter locations.

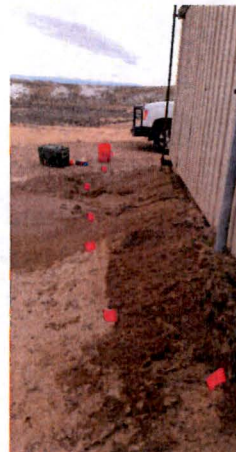
Looking north along west side of building.  
Flags show uR meter locations.
